PROJECT: ATRIUM REPAIR, REMEDIATION, AND/OR REHABILITATION 2021-002

"ATRIUM REPAIR, REMEDIATION, AND/OR REHABILITATION"  
355 AVENUE FRANKLIN DELANO ROOSEVELT,  
SAN JUAN, P.R. 00918

CLIENT:  PRIDCO	PROJECT:  PHASE II - ATRIUM REPAIR, REMEDIATION AND/OR REHABILITATION OF PRIDCO MAIN OFFICE BUILDING SAN JUAN, PUERTO RICO	DESCRIPTION:  INDEX OF DRAWINGS	PROJECT NO.:  2021-002	THIS DRAWING OR PRINT DESPICT THE DESIGN EFFORT OF CARRASQUILLO ASSOCIATES ISSUED FOR REVIEW SOLELY AS AN INSTRUMENT OF THE SERVICE BEING RENDERED. IT REMAINS THE PROPERTY OF THIS OFFICE, SHALL BE USED ONLY BY AUTHORIZED PERSON, AND SHALL NOT BE COPIED OR REPRODUCED OR EXHIBIT UNLESS IN WRITING IS GRANTED. IT SHOULD BE RETURNED UPON REQUEST.

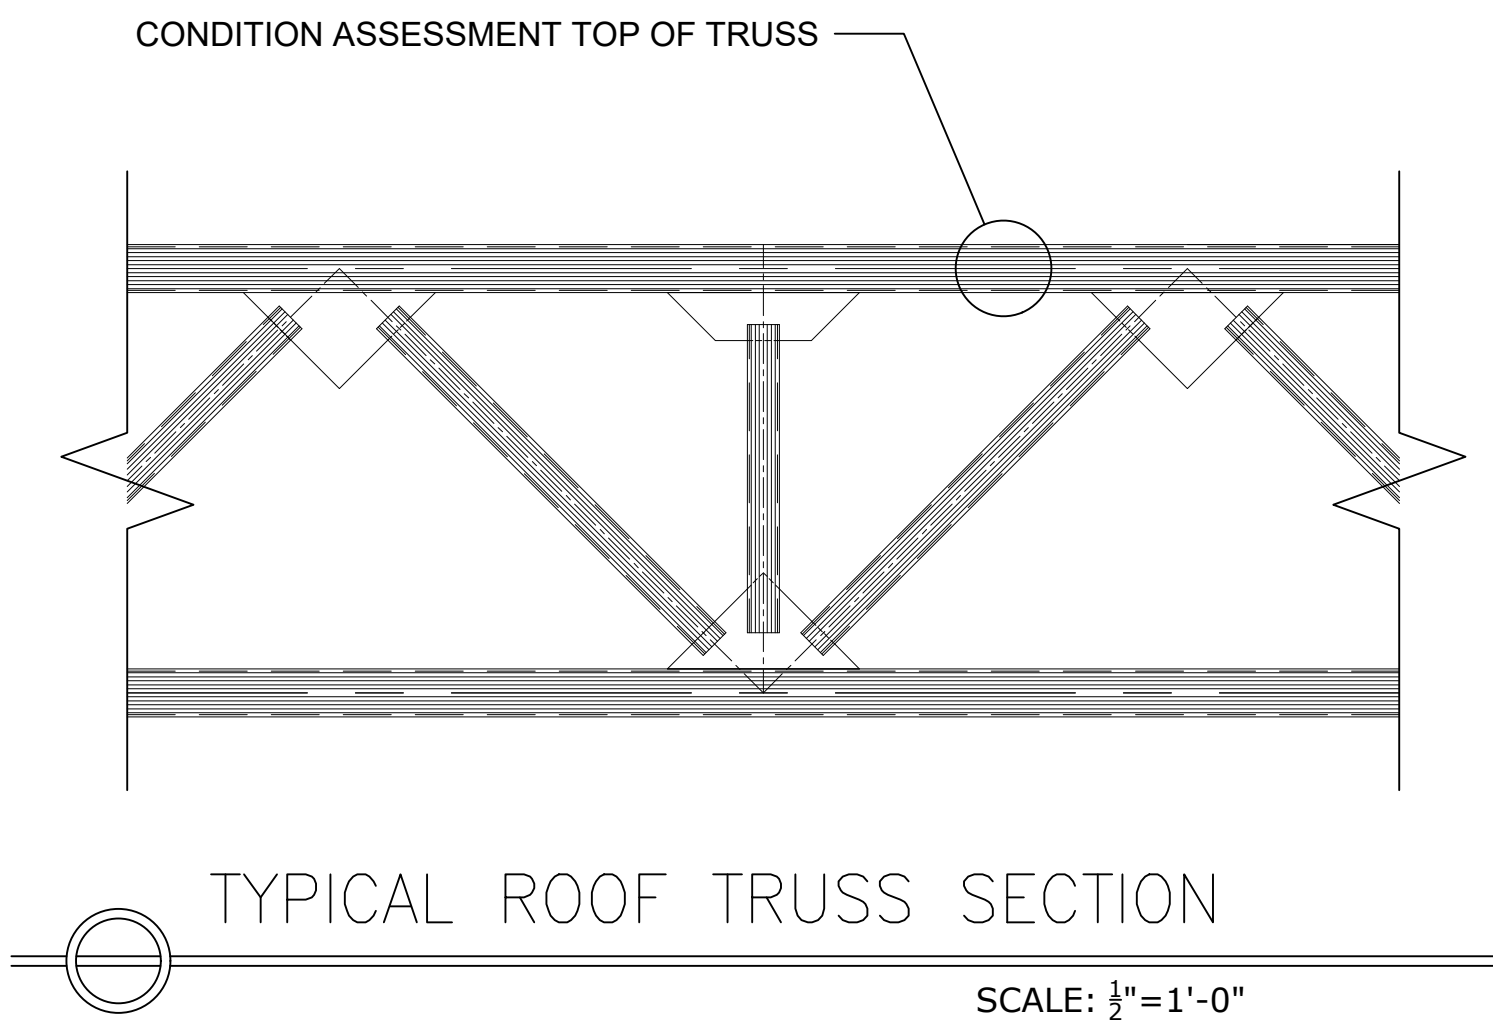
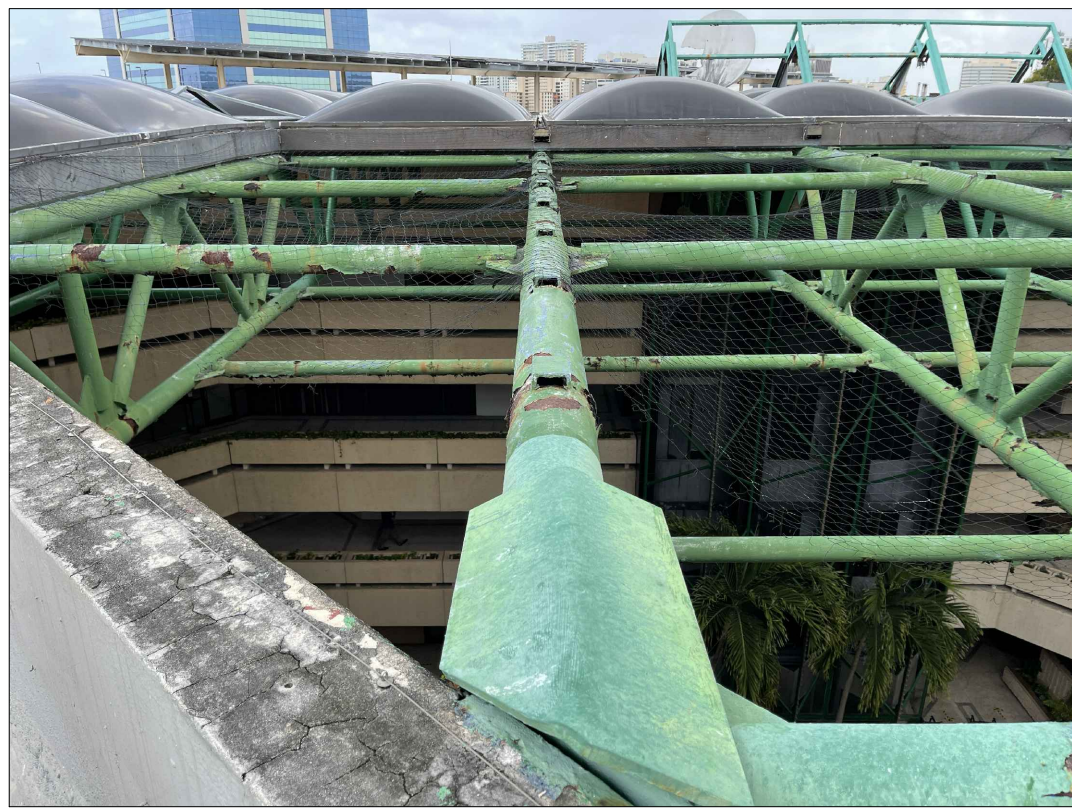
TYPICAL EXAMPLE OF FINDING ON TOP OF TRUSS.

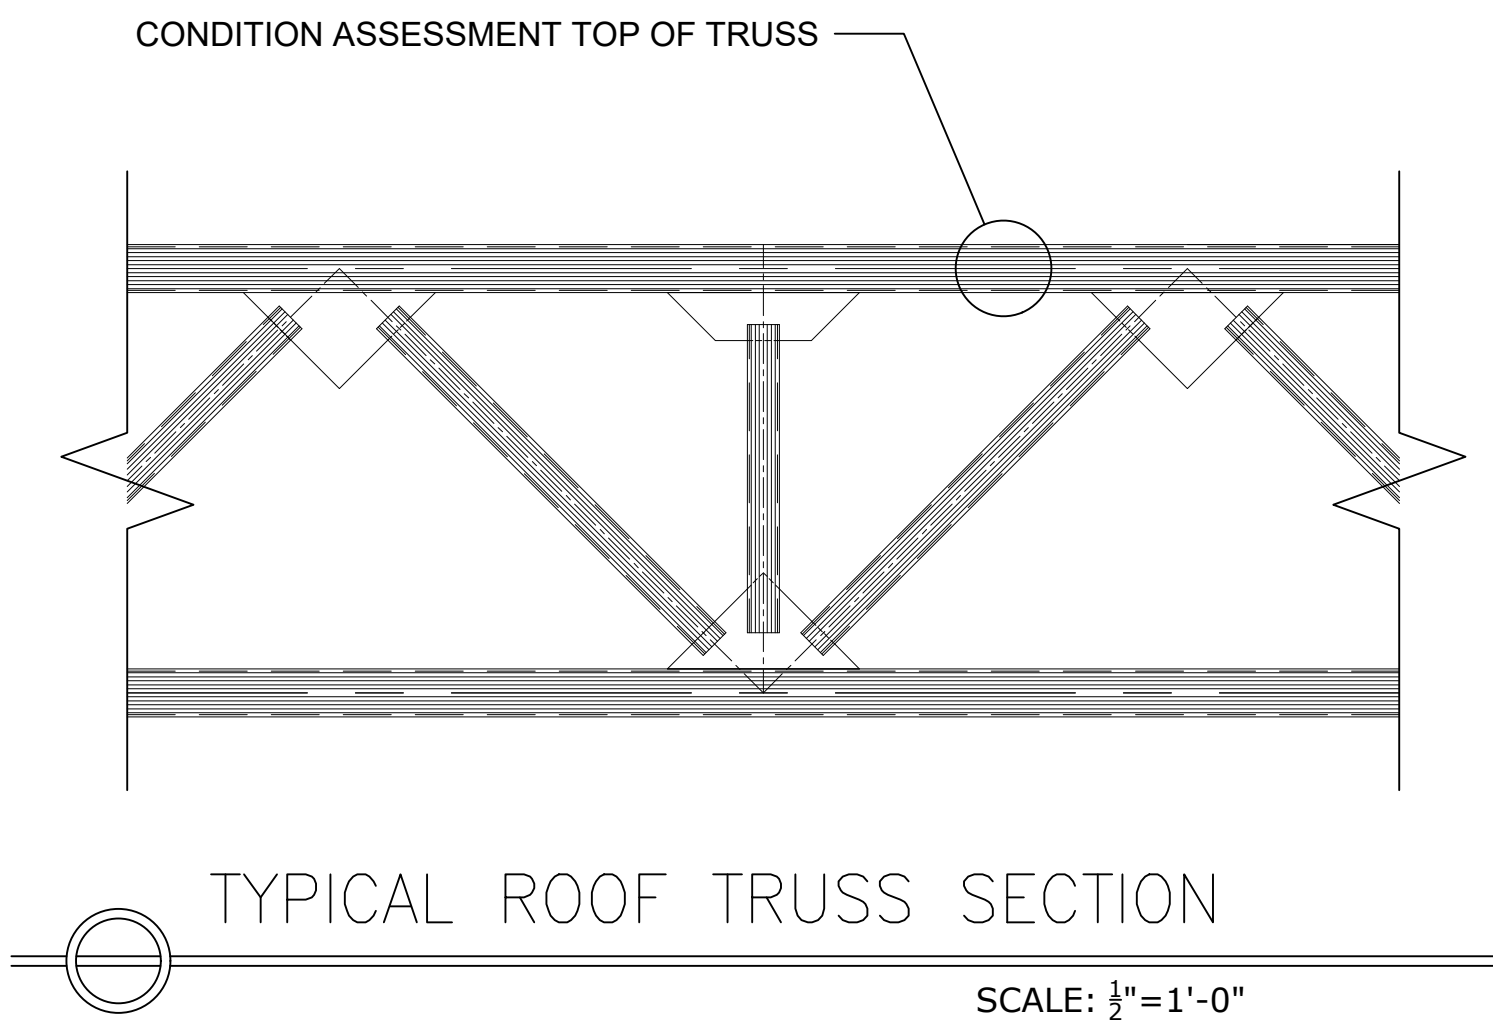
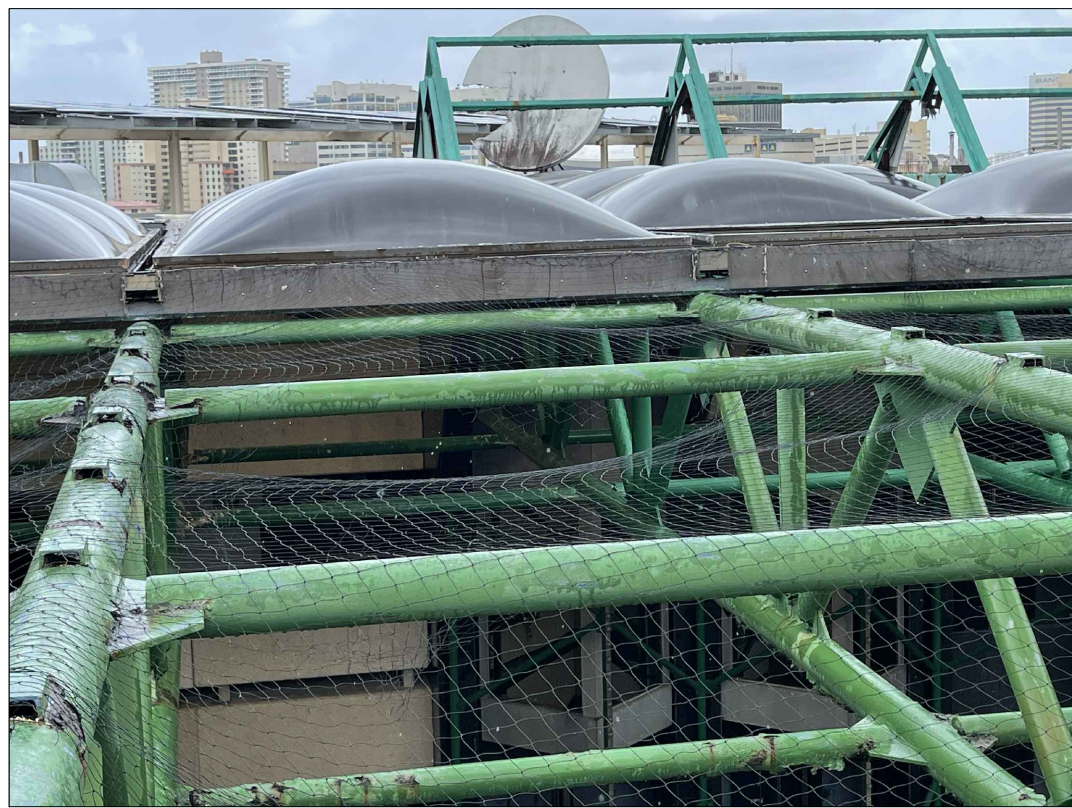
TYPICAL EXAMPLE OF FINDING  
ON TOP OF TRUSS.

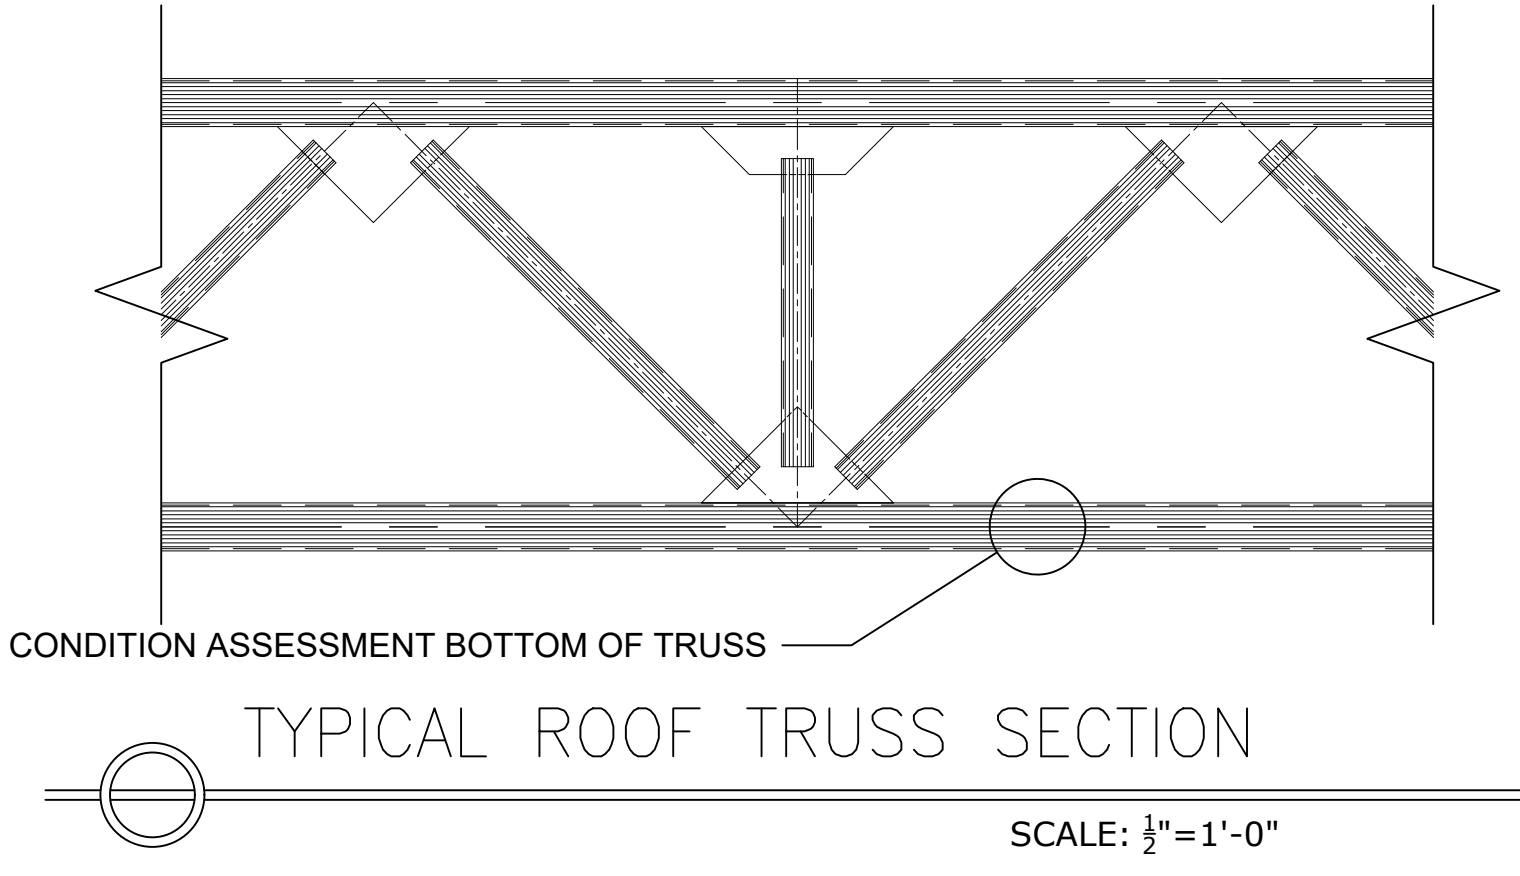
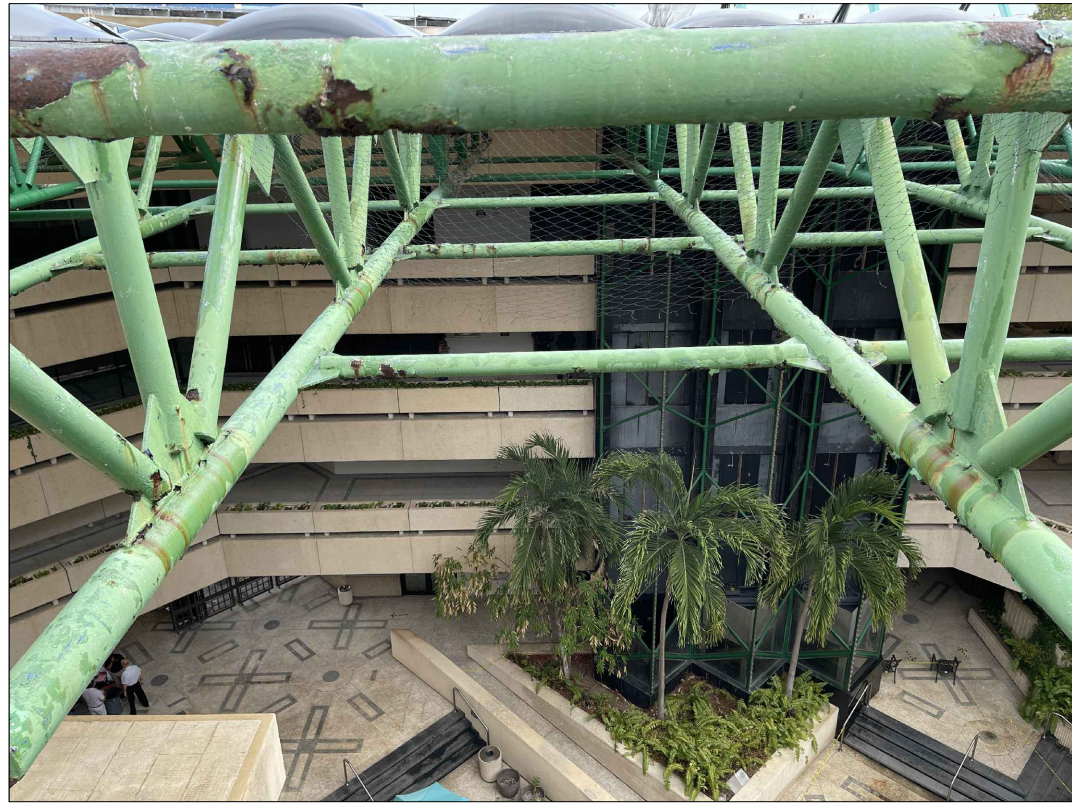
TYPICAL EXAMPLE OF FINDING ON BOTTOM OF TRUSS.

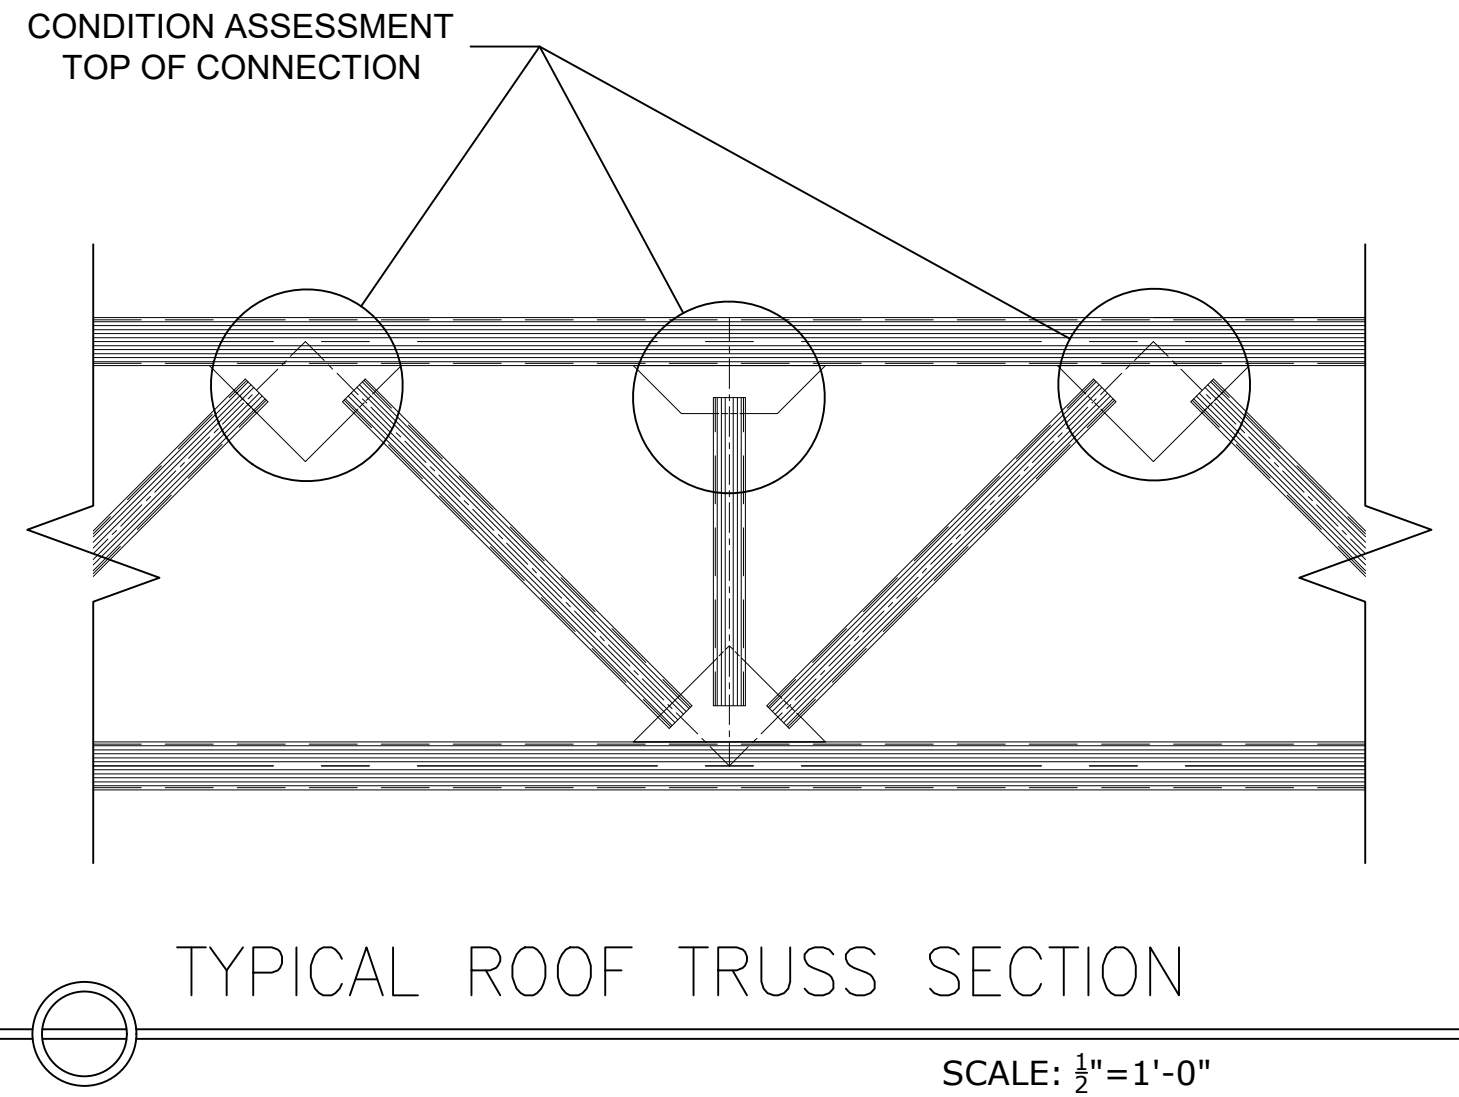
TYPICAL EXAMPLE OF FINDING  
ON TOP OF CONNECTION.

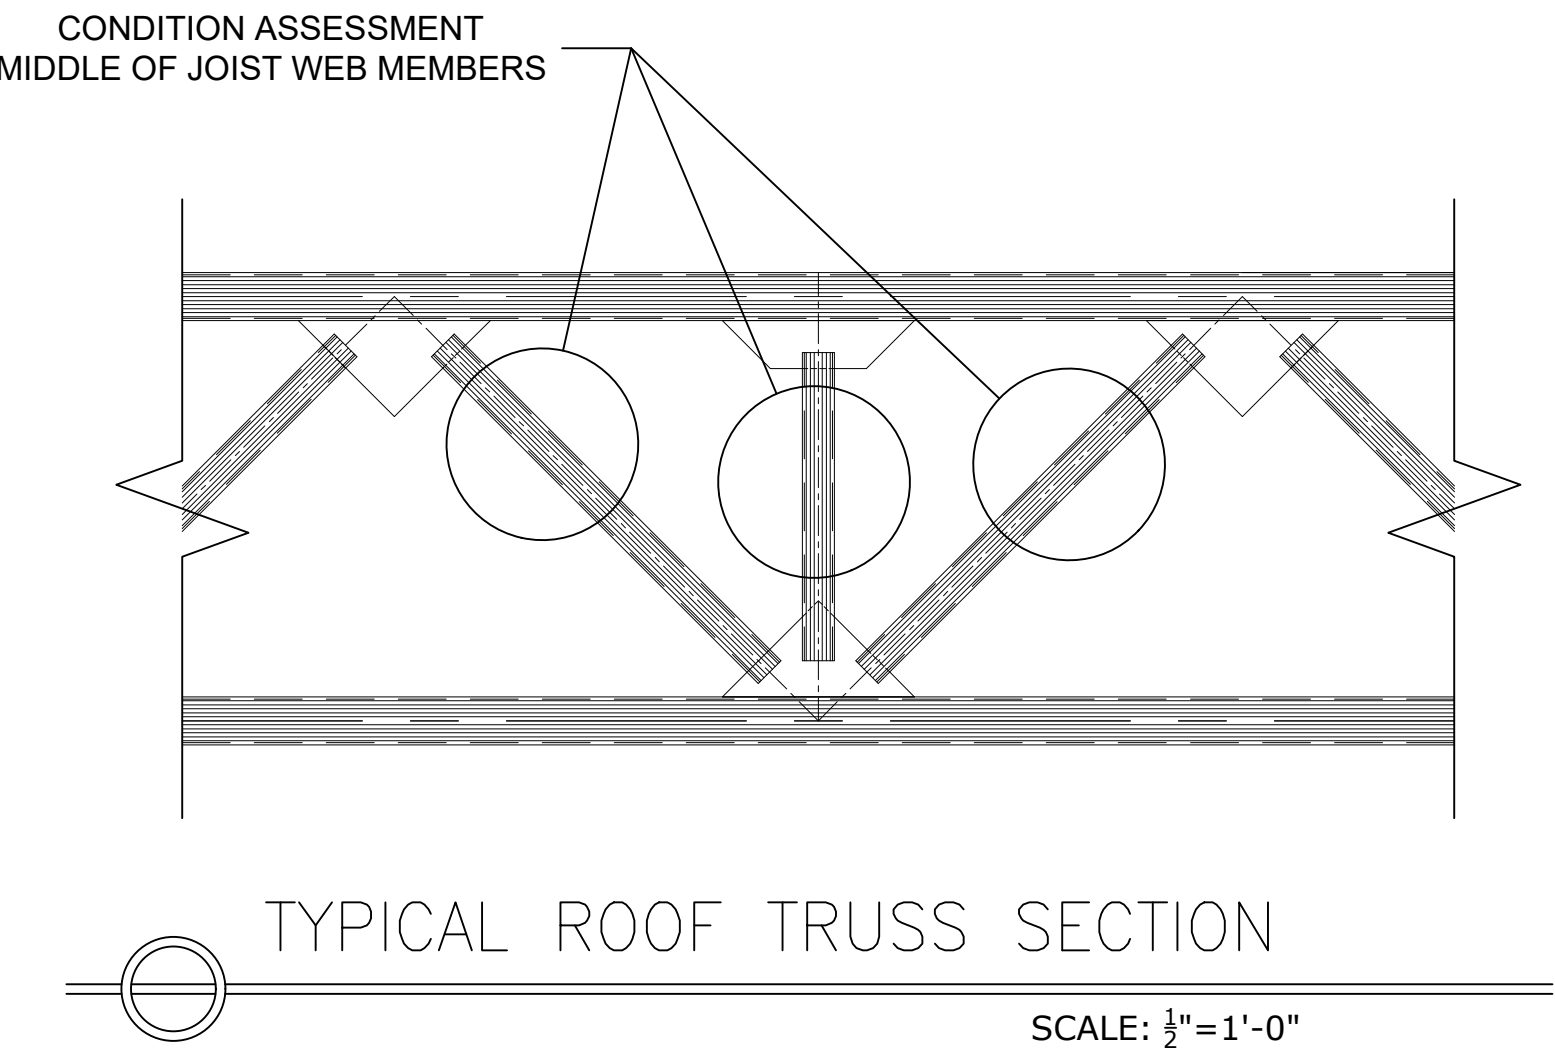
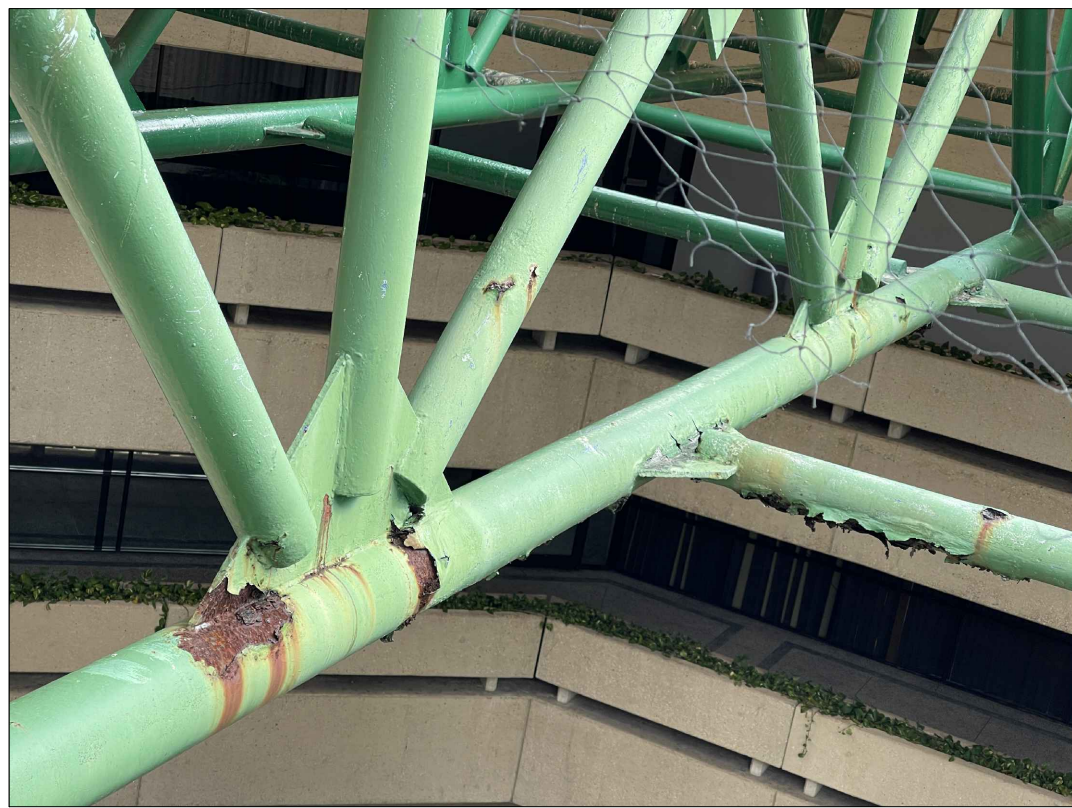
TYPICAL EXAMPLE OF FINDING  
ON JOIST WEB MEMBERS.
