Urb. Maria del Carmen Facility Damages Repair

Damage Repairs – Urb. Maria del Carmen, Corozal Scope of Work Reference

Bid Documentsfor ethod of Repair (MOR)

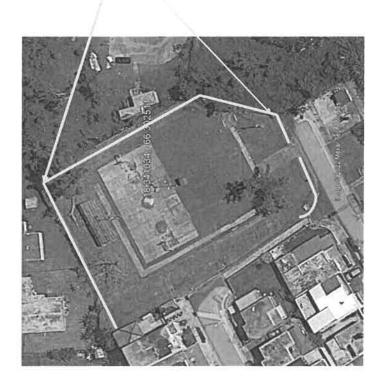
Existing chain link repairs:

Replace existing chain link fence sections 480 Lf aprox.

* See Scope of work attached
