## ENMIENDA NÚMERO 1

### SUBASTA INFORMAL NÚMERO 22J-08406-R2

**PARA LA ADQUISICIÓN DE SERVICIOS DE REPARACIÓN GENERAL DE LA  
INFRAESTRUCTURA DEL CTS PONCE DEL DEPARTAMENTO DE SALUD DEL  
GOBIERNO DE PUERTO RICO  
(FEMA REF. NO. 90019 P/W #6515 & REF. NO. 158747 P/W 281)**

**SCOPE OF WORK AMENDED I**

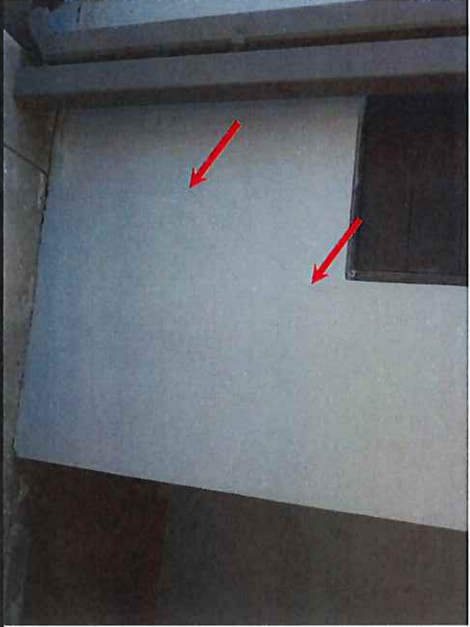
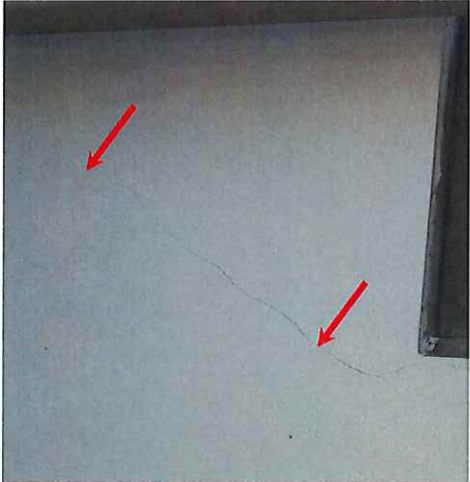
<b>Photo #</b> 9		<b>Photo #</b> 10

<b>Applicant:</b> PR Department of Health		<b>Damage Inventory #</b> 403796		<b>Category:</b> E
<b>Work Order #</b> 65036		<b>FIPS #</b> 000-U40VB-00		<b>Date:</b> 12/15/2020
<b>Site Inspector:</b> Montalvo, Hernandez, Peeva, Davila, Barrios		<b>GPS:</b> 18.03499, -66.59630		
<b>Damage Description:</b>		<b>Damage Facility:</b> Center for Transitional Services (CTS)		
Exterior wall, Apartment and Conference room.		Exterior wall, Apartment and Conference room.

- a. Repair cracks in 460 SF of CMU wall

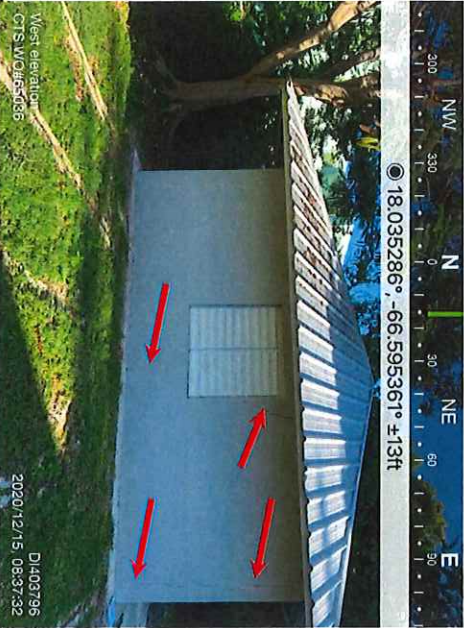
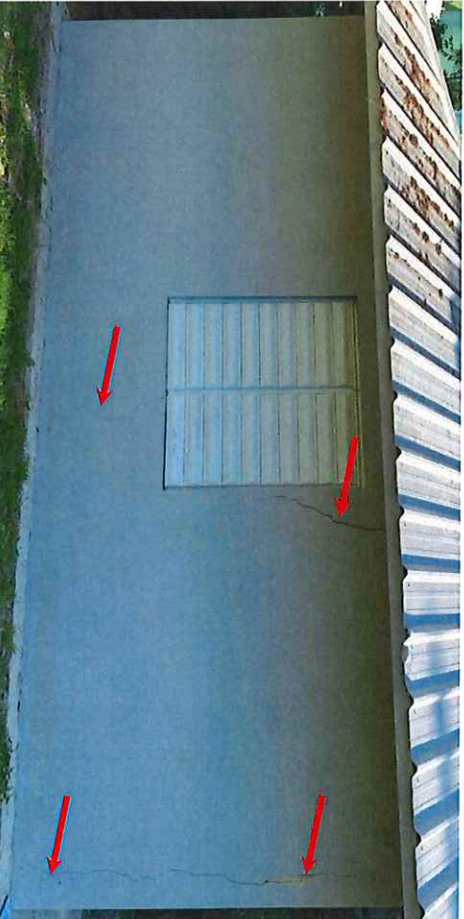
<b>Damage Description:</b>		<b>Photo #</b> 11		<b>Damage Description:</b>		<b>Photo #</b> 12	
Gazebo Storage, West side CMU wall affected by cracks.				Gazebo Storage, West side CMU wall affected by cracks.

- a. Repair cracks in 152.72 SF of CMU wall
- b. Repair cracks in 151.38 SF of CMU wall
- c. Repair cracks in 151.38 SF of CMU wall

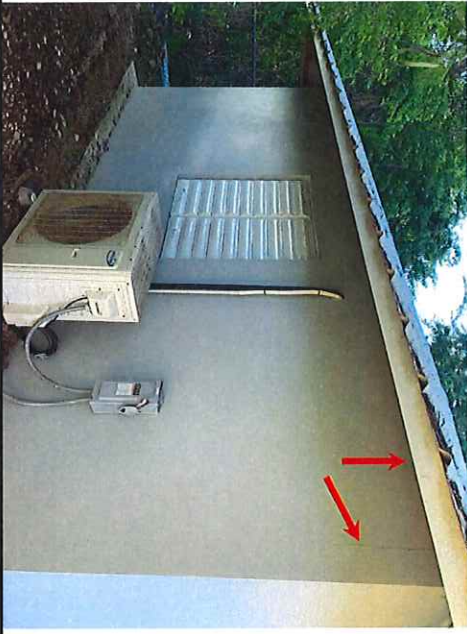
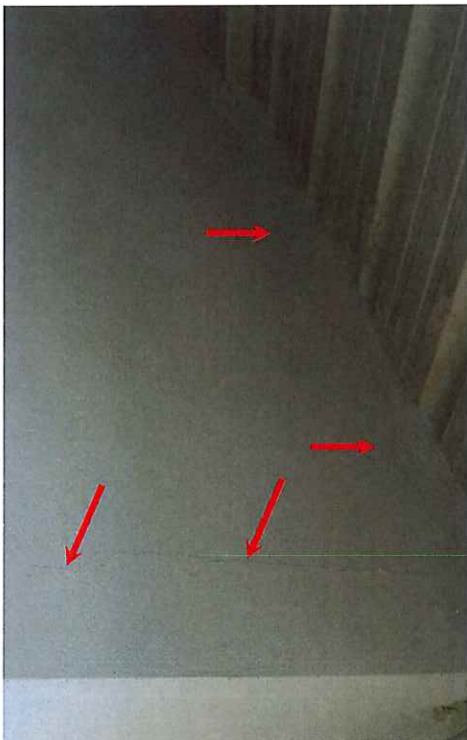
<b>Damage Description:</b>	<b>Photo #</b>	<b>Damage Description:</b>	<b>Photo #</b>
Gazebo Storage, Northwest side CMU wall affected by cracks.	13	Gazebo Storage, Northwest side CMU wall affected by cracks.	14

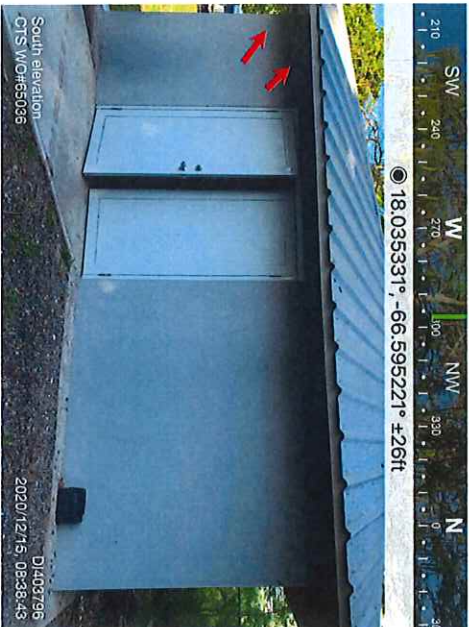
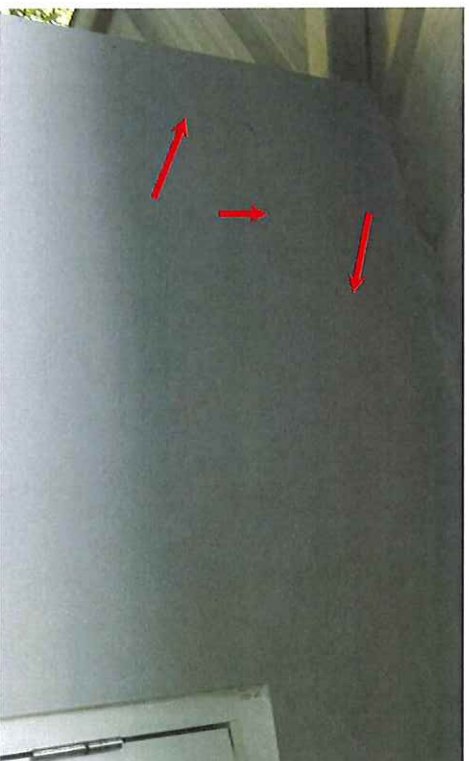
<b>Damage Description:</b>	<b>Photo #</b>	<b>Damage Description:</b>	<b>Photo #</b>
Gazebo Storage, Southwest side CMU wall affected by cracks.	15	Gazebo Storage, Southwest side CMU wall affected by cracks.	16

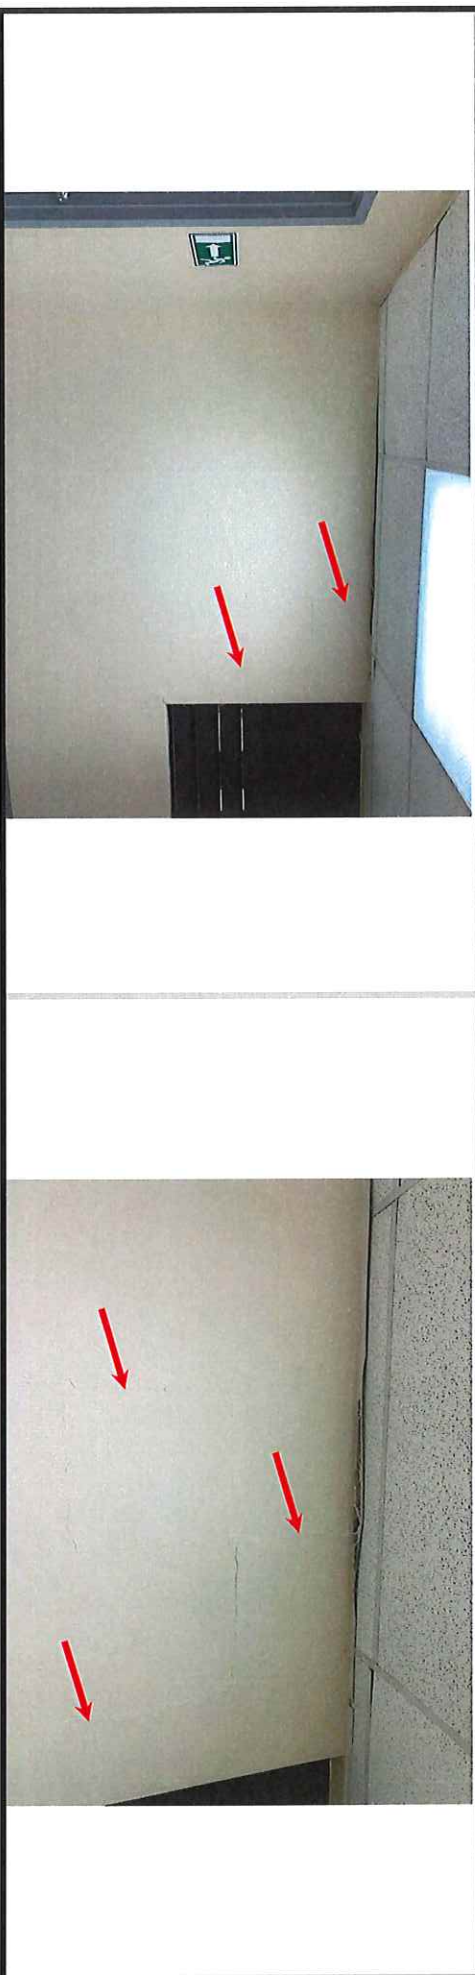
<b>Damage Description:</b>	<b>Photo #</b>	<b>Damage Description:</b>	<b>Photo #</b>
Hallway, Exterior wall of Dining Hall, South side CMU wall affected by cracks.	17	Hallway, Exterior wall of Dining Hall, South side CMU wall affected by cracks.	18

- a. Repair cracks in 64 SF of CMU wall

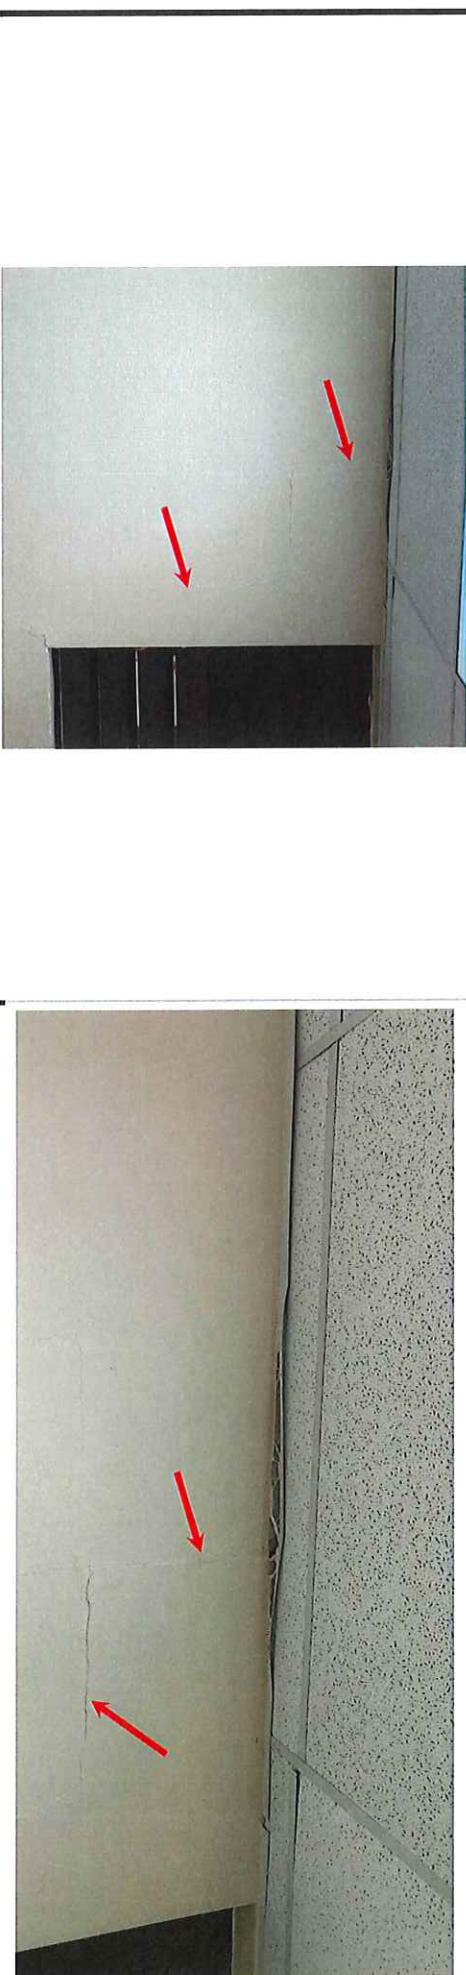
<b>Damage Description:</b>	<b>Photo #</b>	<b>Damage Description:</b>	<b>Photo #</b>
Hallway, Exterior wall of Dining Hall, South side CMU wall affected by cracks.	19	Hallway, Exterior wall of Dining Hall, South side CMU wall affected by cracks.	20

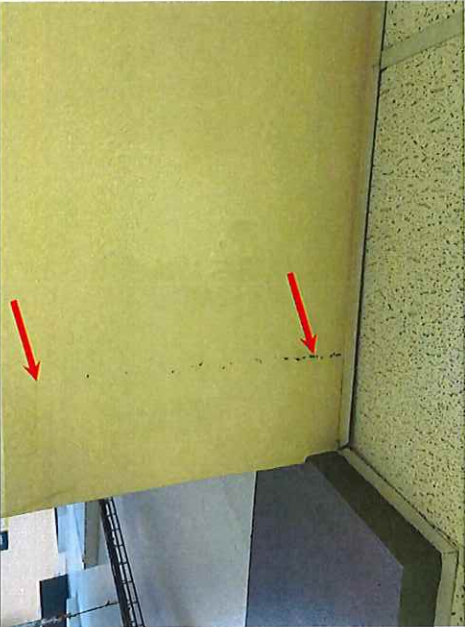
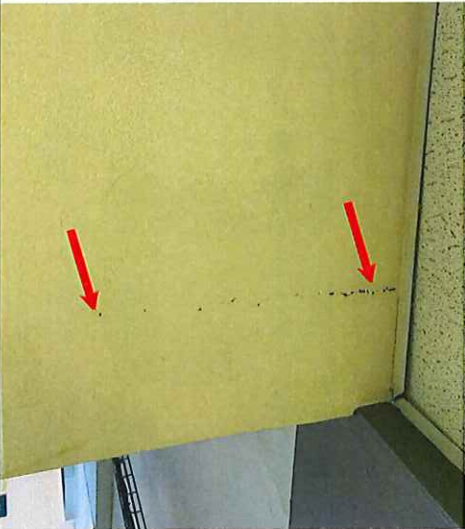
<b>Applicant:</b> PR Department of Health		<b>Damage Inventory #</b> 403796		<b>Category:</b> E	
<b>Work Order #</b> 65036		<b>FIPS #</b> 000-U4OVB-00		<b>Date:</b> 12/15/2020	
<b>Site Inspector:</b> Montalvo, Hernandez, Peeva, Davila, Barrios		<b>GPS:</b> 18.03499, -66.59530		<b>Damage Facility:</b> Center for Transitional Services (CTS)	
<b>Damage Description:</b> Hallway, front of Adjustment office, CMU walls affected by cracks.		<b>Photo #</b> 21		<b>Damage Description:</b> Hallway, front of Adjustment office, CMU walls affected by cracks.

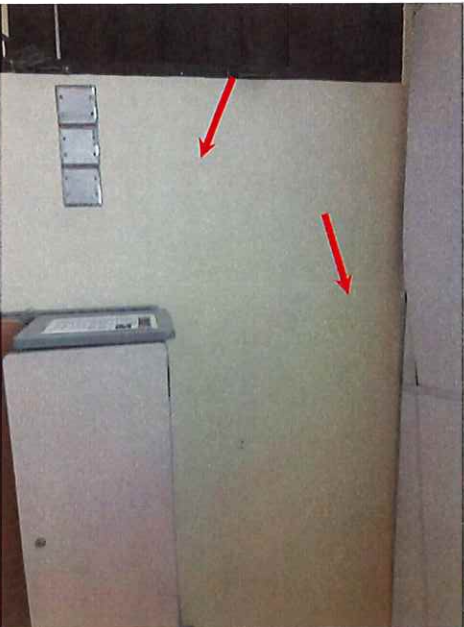
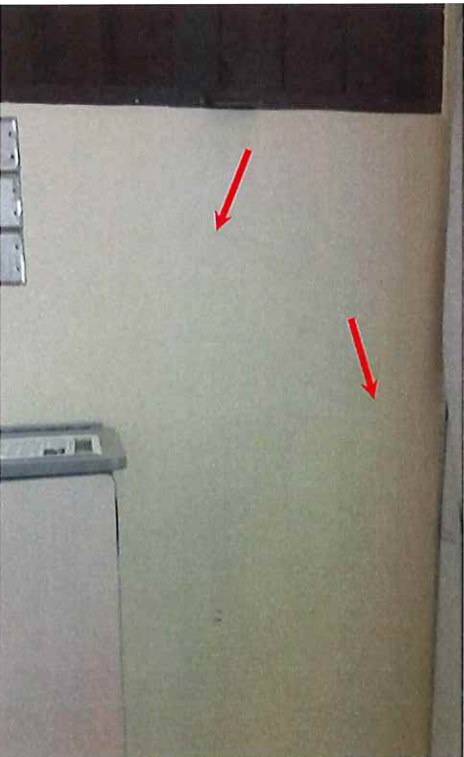
<b>Damage Description:</b> Hallway, pantry exterior wall, affected by cracks.		<b>Photo #</b> 23		<b>Damage Description:</b> Hallway, pantry exterior wall, affected by cracks.

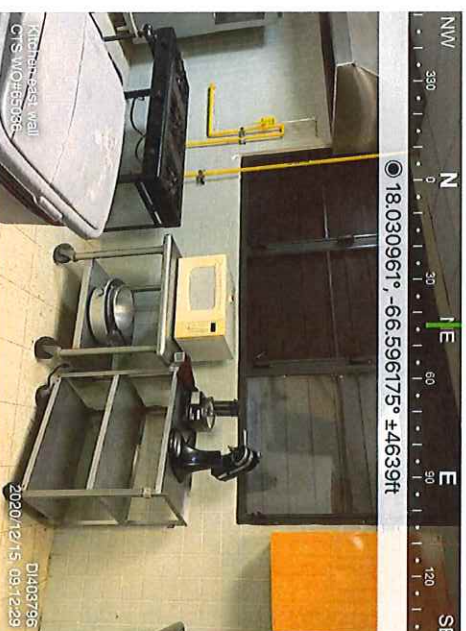
<b>Damage Description:</b>	<b>Photo #</b> 27	<b>Damage Description:</b>	<b>Photo #</b> 28
Hallway and Dining Hall, floor affected by cracks.		Kitchen, CMU wall and tiles affected by cracks.

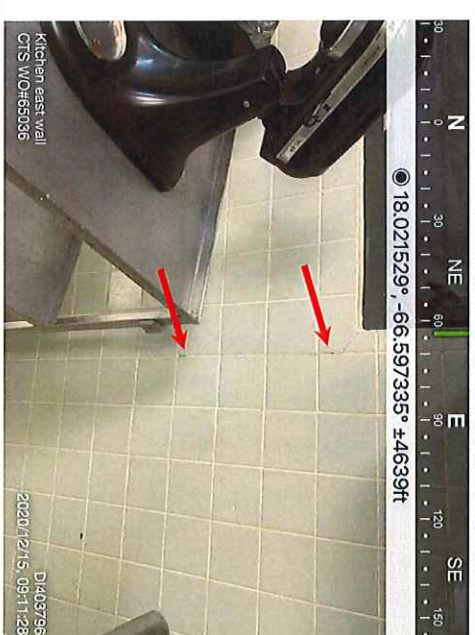
<b>Damage Description:</b>	<b>Photo #</b>	<b>Damage Description:</b>	<b>Photo #</b>
Kitchen, CMU wall and tiles affected by cracks.	29	Kitchen, CMU wall and tiles affected by cracks.	30

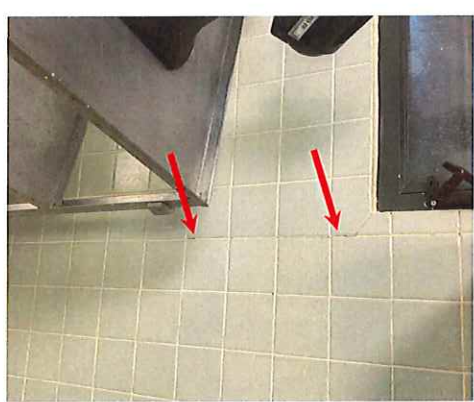
<b>Damage Description:</b>	<b>Photo #</b>	<b>Damage Description:</b>	<b>Photo #</b>
Kitchen, CMU wall and tiles affected by cracks.	31	Kitchen, CMU wall and tiles affected by cracks.	32

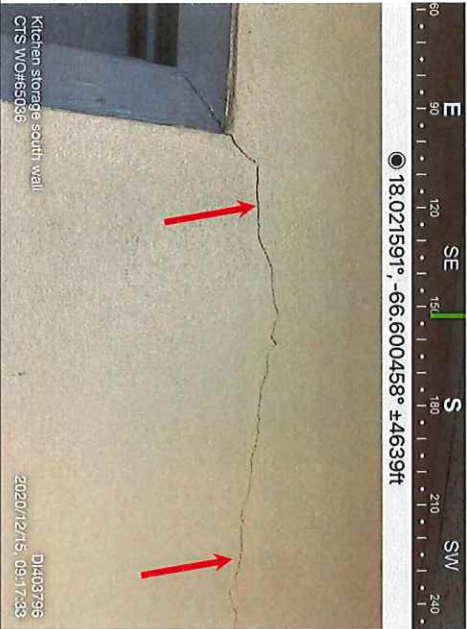
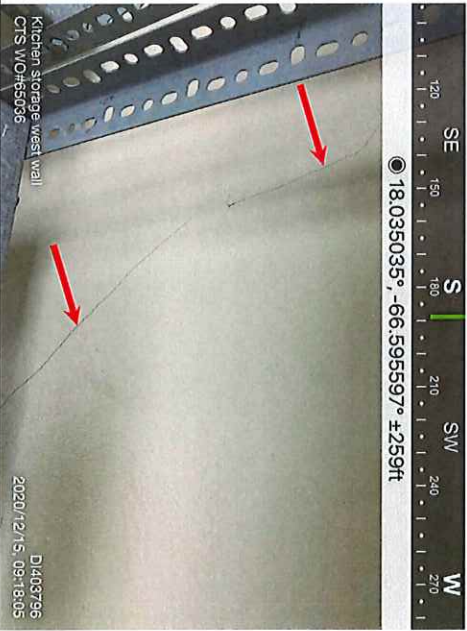
Damage Description:		Damage Description:		Photo # 36
Kitchen Storage, CMU wall affected by cracks.		Kitchen Storage, CMU wall affected by cracks.

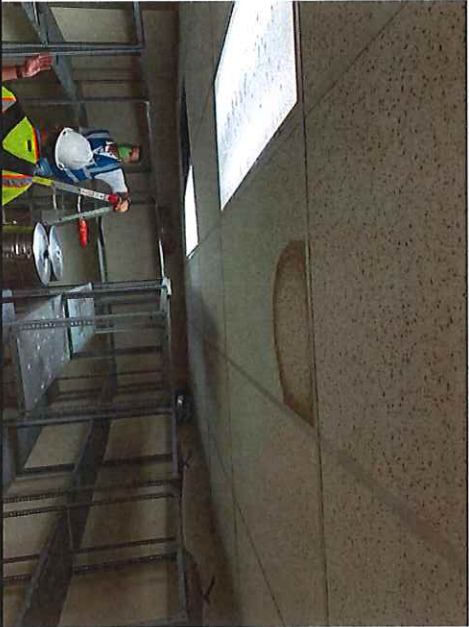
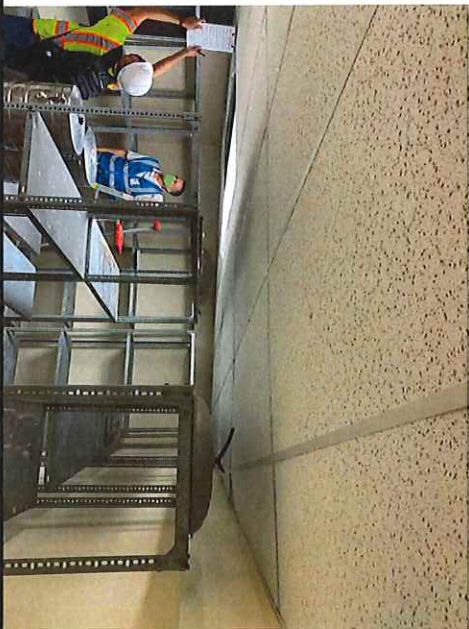
<b>Applicant:</b> PR Department of Health			<b>Damage Inventory #</b> 403796			<b>Category:</b> E
<b>Work Order #</b> 65036			<b>FIPS #</b> 000-U40VB-00			<b>Date:</b> 12/15/2020
<b>Site Inspector:</b> Montalvo, Hernandez, Peeva, Davila, Barrios			<b>GPS:</b> 18.03499, -66.59530			<b>Damage Facility:</b> Center for Transitional Services (CTS)
<b>Damage Description:</b>			<b>Damage Description:</b>			<b>Photo #</b> 38
Kitchen Storage, hung ceiling affected by seismic movement.			Kitchen Storage, hung ceiling affected by seismic movement.

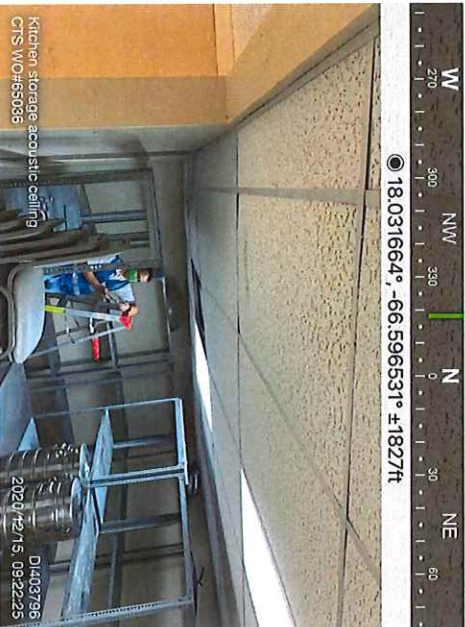
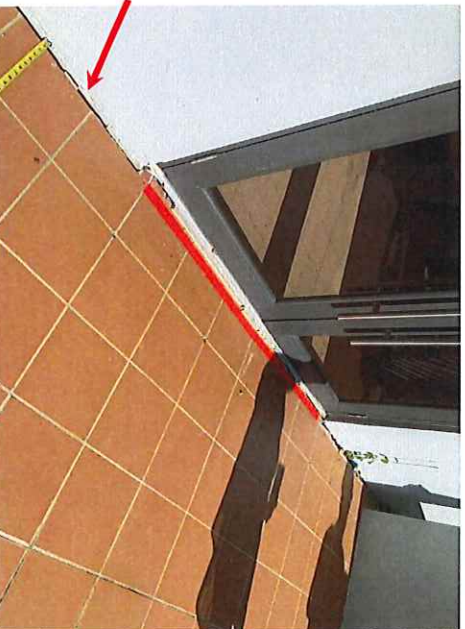
<b>Damage Description:</b>			<b>Damage Description:</b>			<b>Photo #</b> 40
Kitchen Storage, hung ceiling affected by seismic movement.			Main entrance (Front Side), separation at joint.

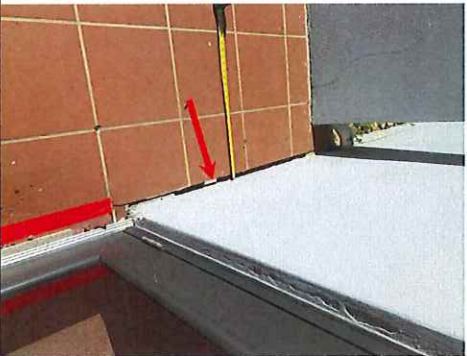
<b>Applicant:</b> PR Department of Health		<b>Damage Inventory #</b> 403796		<b>Category:</b> E	
<b>Work Order #</b> 65036		<b>FIPS #</b> 000-U40VB-00		<b>Date:</b> 12/15/2020	
<b>Site Inspector:</b> Montalvo, Hernandez, Peeva, Davila, Barrios		<b>Damage Facility:</b> Center for Transitional Services (CTS)		<b>GPS:</b> 18.03499, -66.59630	
<b>Damage Description:</b> Main entrance (Front Side), separation at joint.		<b>Photo #</b> 41		<b>Damage Description:</b> Main entrance (Front Side), separation at joint.

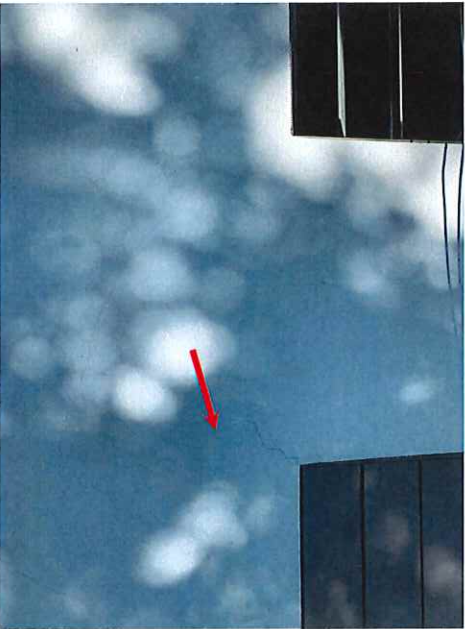
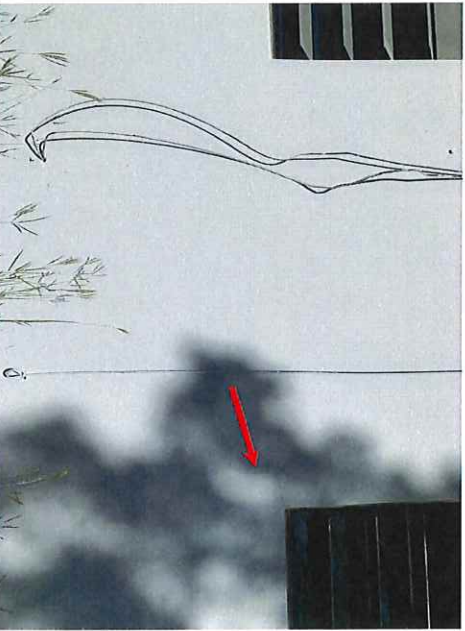
<b>Damage Description:</b> Main entrance (Front Side), CMU wall affected by cracks.		<b>Photo #</b> 43		<b>Damage Description:</b> Main entrance (Front Side), CMU wall affected by cracks.

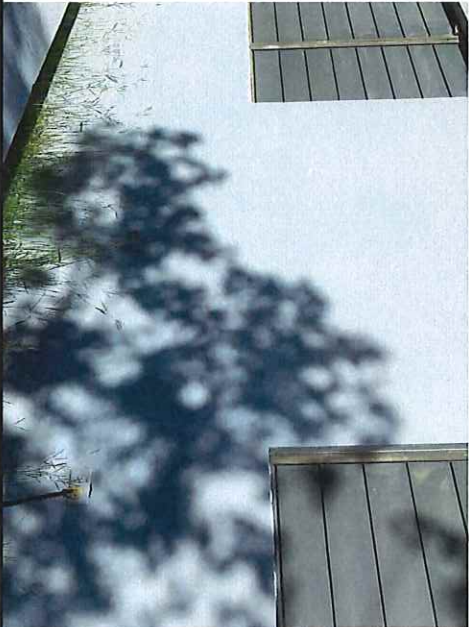
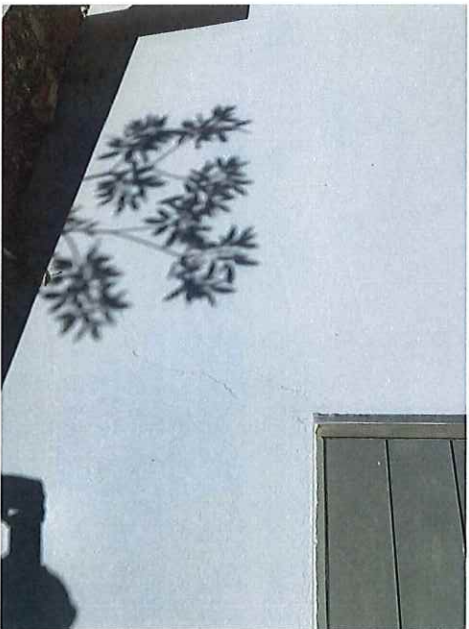
<b>Applicant:</b> PR Department of Health		<b>Damage Inventory #</b> 403796		<b>Category:</b> E	
<b>Work Order #</b> 65036		<b>FIPS #</b> 000-U40VB-00		<b>Date:</b> 12/15/2020	
<b>Site Inspector:</b> Montalvo, Hernandez, Peeva, Davila, Barrios		<b>GPS:</b> 18.03499, -66.59630		<b>Damage Facility:</b> Center for Transitional Services (CTS)	
<b>Damage Description:</b> Main entrance (Front Side), CMU wall affected by cracks.		<b>Photo #</b> 45		<b>Damage Description:</b> Main entrance (Front Side), CMU wall affected by cracks.

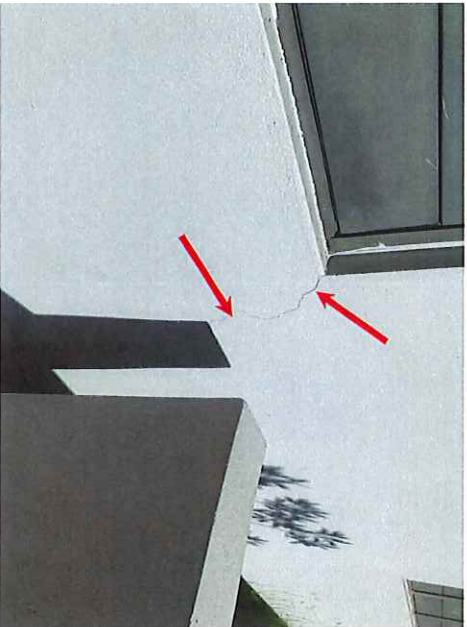
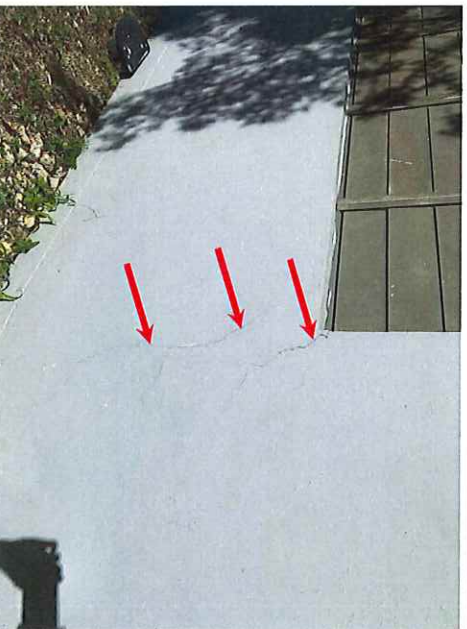
<b>Damage Description:</b> Main entrance (Front Side), CMU wall affected by cracks.		<b>Photo #</b> 47		<b>Damage Description:</b> Main entrance (Front Side), CMU wall affected by cracks.

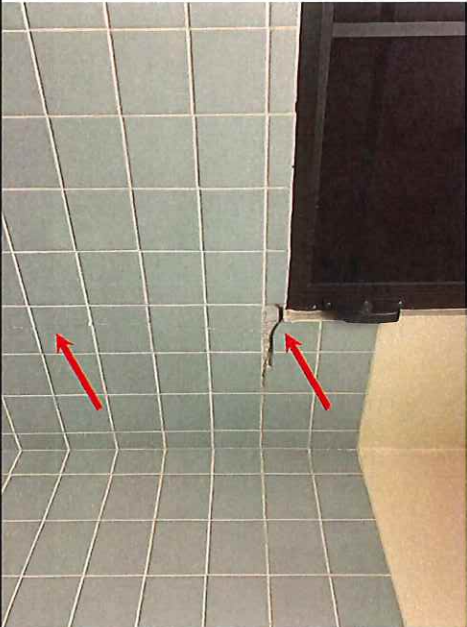
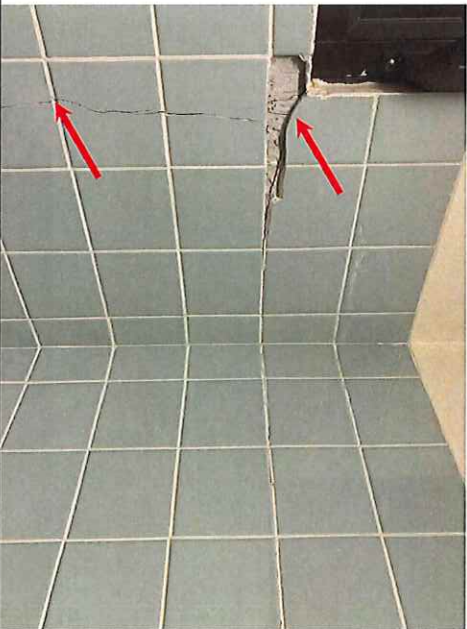
<b>Damage Description:</b> Men's Restroom, CMU wall and tile affected by cracks.		<b>Photo #</b> 51	<b>Damage Description:</b> Men's Restroom, CMU wall and tile affected by cracks.	
		<b>Photo #</b> 52

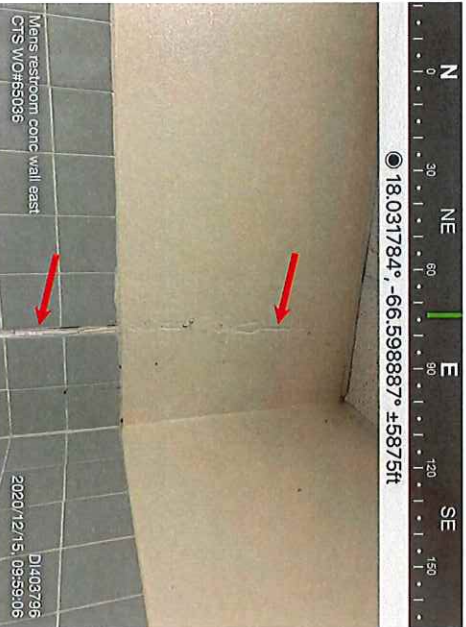
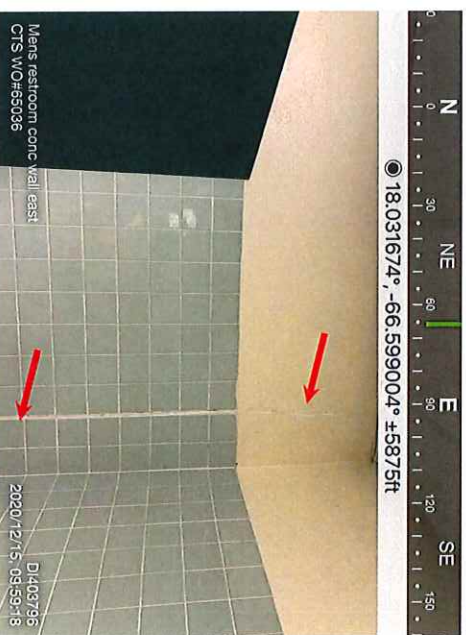
<b>Damage Description:</b>	<b>Photo #</b> 55	<b>Damage Description:</b>	<b>Photo #</b> 56
Participants Men's restroom, CMU wall crack worsened by seismic movement.		Participants Men's restroom, CMU wall crack worsened by seismic movement.

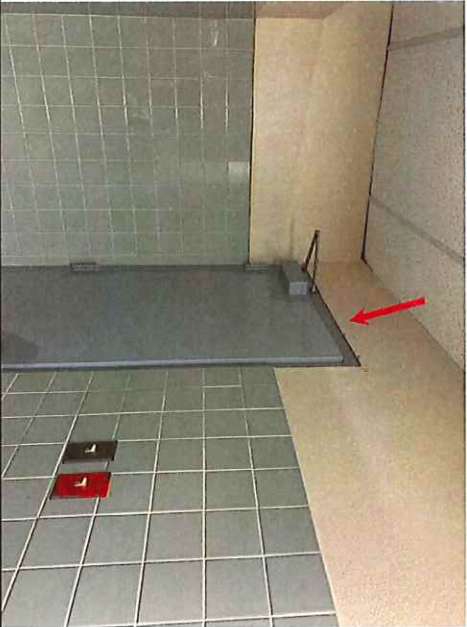
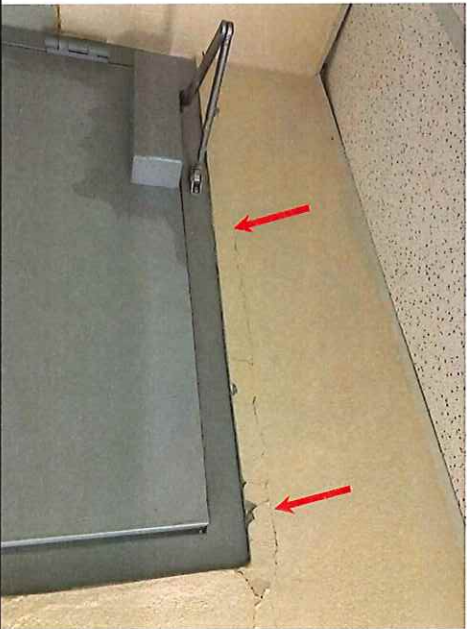
<b>Damage Description:</b> Rear entrance, CMU wall affected by cracks.		<b>Photo #</b> 59	<b>Damage Description:</b> Rear entrance, CMU wall affected by cracks.	<b>Photo #</b> 60

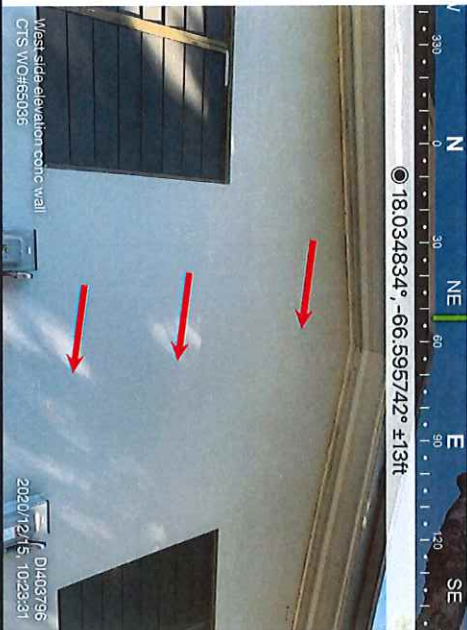
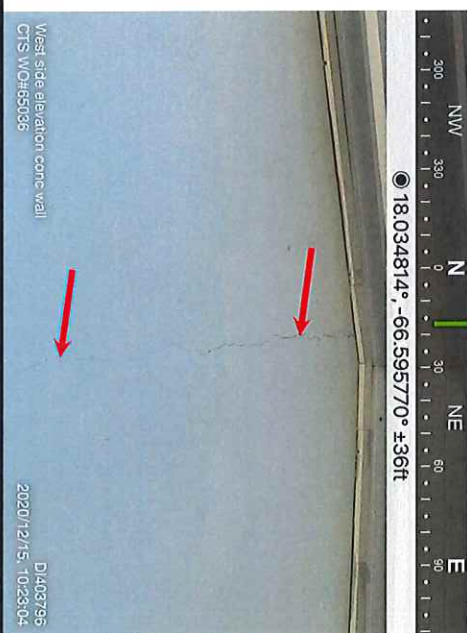
<b>Damage Description:</b>  Side wall exterior, CMU wall affected by cracks.		<b>Photo #</b>	63	<b>Damage Description:</b>  Intentionally Left in Blank

- D. Hallway (Front adjustment office):
  - a. Repair cracks in 112 SF of CMU wall
- E. Hallway (Pantry exterior wall):
  - a. Repair cracks in 44 SF of CMU wall
- F. Kitchen:
  - a. Repair cracks in 156 SF of CMU wall and 20 4 IN x 4 IN ceramic wall tiles
- G. Kitchen Storage:
  - a. Repair cracks in 124 SF of CMU wall
  - b. Repair cracks in 92.64 SF of CMU wall
- H. Main Entrance (FRONT SIDE):
  - a. Repair 14 LF of joint separation
  - b. Repair 2,185 SF of concrete wall cracks
- I. Men's Restroom:
  - a. Repair cracks in 64 SF of CMU wall
- J. Pantry Exterior Wall:
  - a. Repair cracks in 451 SF of CMU wall
- K. Participants Men's Restrooms:
  - a. Repair cracks in 128 SF of CMU wall
  - b. Repair cracks in 128 SF of CMU wall
- L. Rear Entrance:
  - a. Repair cracks in 1,083 SF of CMU wall
- M. Side Wall Exterior:
  - a. Repair cracks in 460 SF of CMU wall

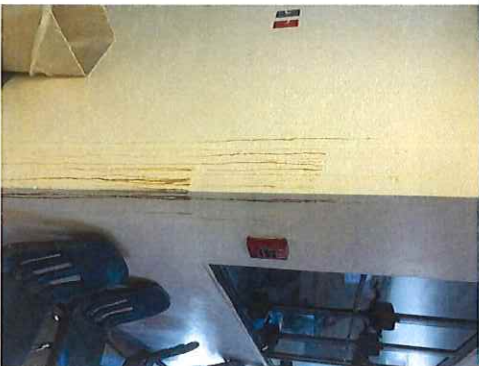
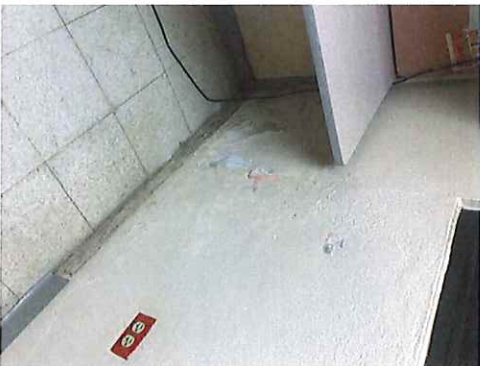
Interior Building, 75 SF of painted concrete walls, seal and paint separation caused by water infiltration, 0% work completed.

- a. Prepare and paint, 75 SF of concrete walls
- b. Prepare and paint, 75 SF of concrete ceiling
- c. Remove and replace, 105 LF of 4 in vinyl baseboard
- d. Remove and replace, 650 SF of vinyl floor tiles, 1 ft long x 1 ft wide

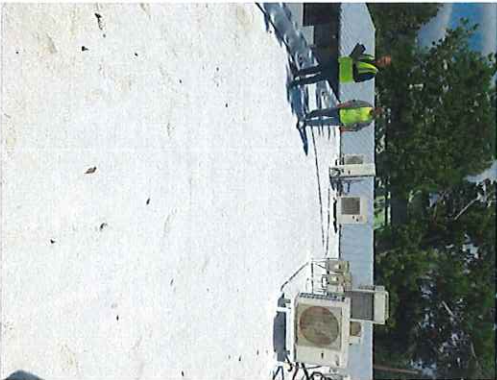
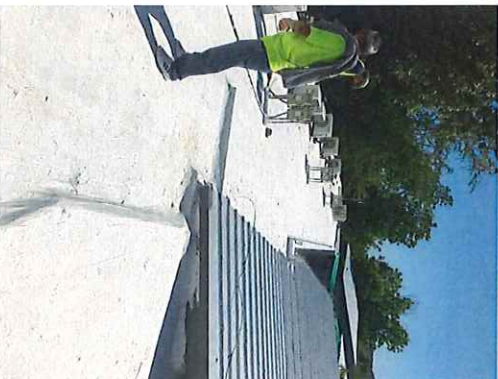
<b>Photo#</b> 7	<b>Damage Description</b>	
Exterior Building, 3,270 SF of complete roof elastomeric membrane, temporary elastomeric sealant placed on roof because to previous sealant was stripped, 0% work completed.

Exterior Building, 3,270 SF of complete roof elastomeric membrane, temporary elastomeric sealant placed on roof because to previous sealant was stripped, 0% work completed.

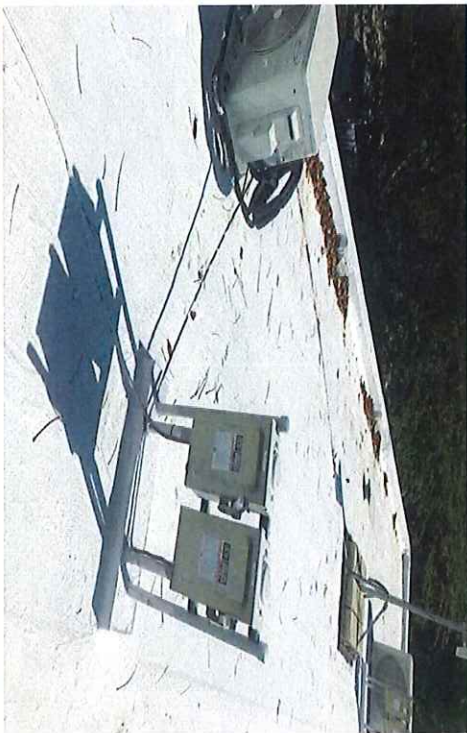
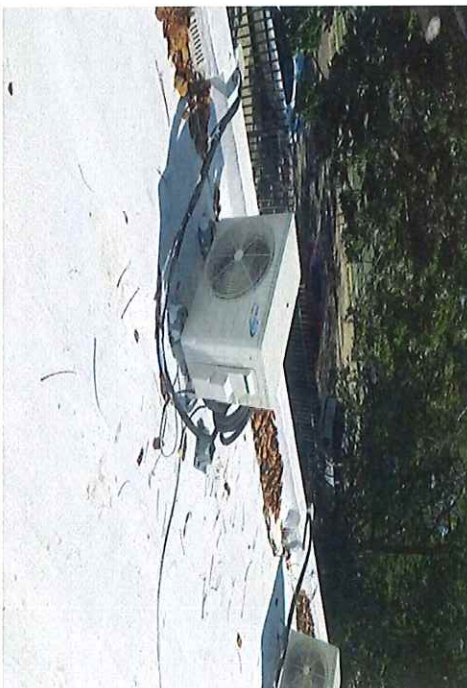
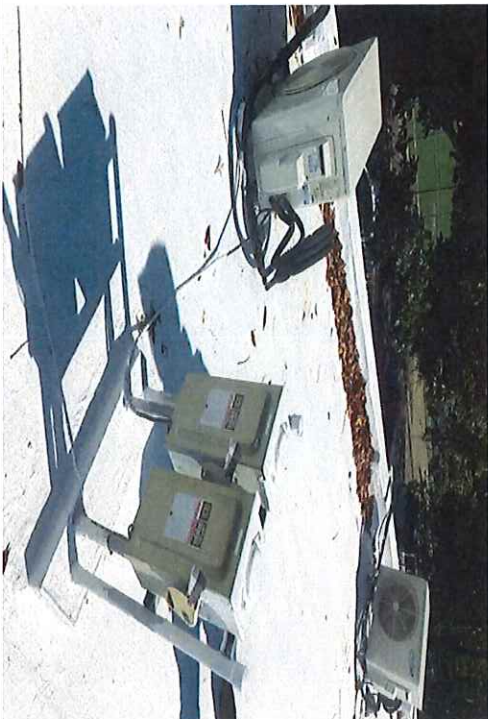
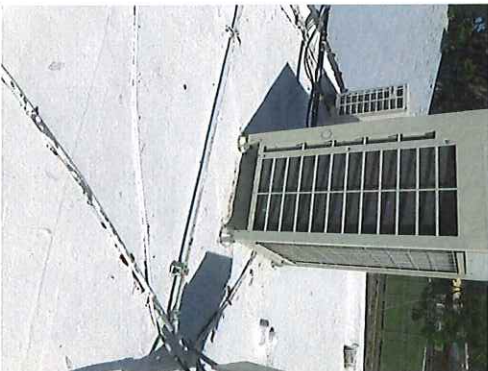
<b>Damage Description:</b> Contents, 4 each of AIR-CON ACZC14C4R12 12k BTU A/C split unit condensers, 3.5 kW, toppled over due to straight line wind, 100% work completed.		<b>Photo#</b> 15		<b>Damage Description</b> Contents, 4 each of AIR-CON ACZC14C4R12 12k BTU A/C split unit condensers, 3.5 kW, toppled over due to straight line wind, 100% work completed.

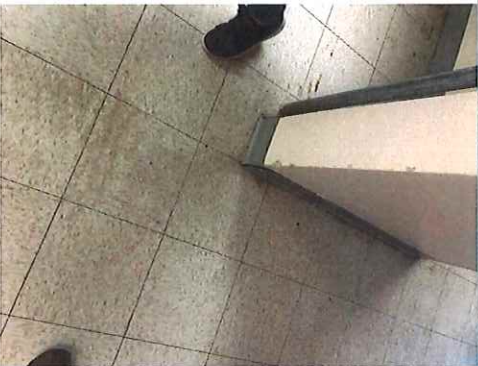
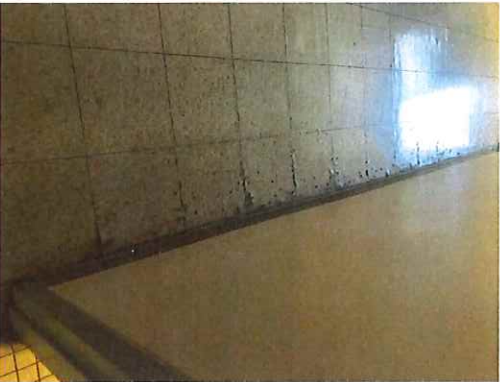
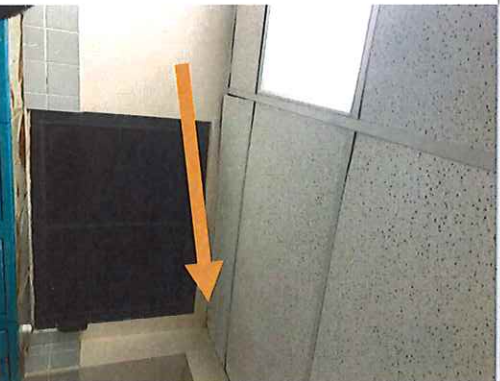
<b>Photo#</b> 19 Interior		<b>Photo#</b> 20

<b>Damage Description</b> Interior Building, 35 SF of 4 IN vinyl baseboard, 105 LF long x 4 IN high, deterioration and separation caused by water infiltration, 0% work completed.		
<b>Photo#</b> 17		<b>Photo#</b> 18		
<b>Damage Description:</b> Building, 650 SF of 650 each of vinyl floor tile , 1 FT long x 1 FT wide, staining and separation caused by water infiltration, 0% work completed.		<b>Damage Description</b> Interior Building, 60 each of acoustic ceiling tile, 4 FT long x 2 FT wide, stained due to water infiltration, 0% work completed

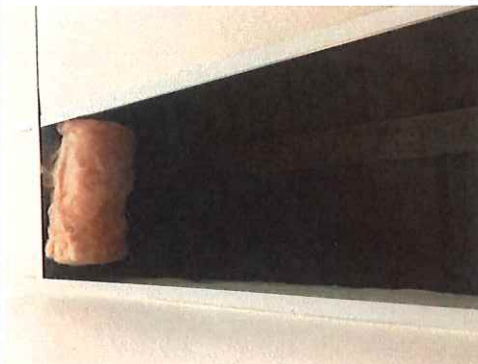
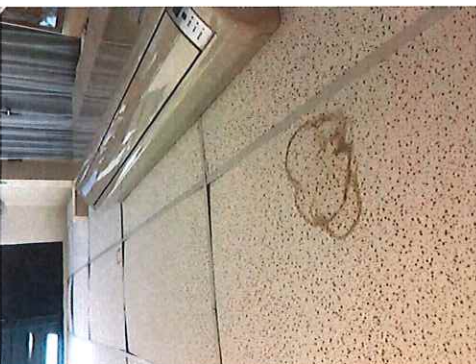
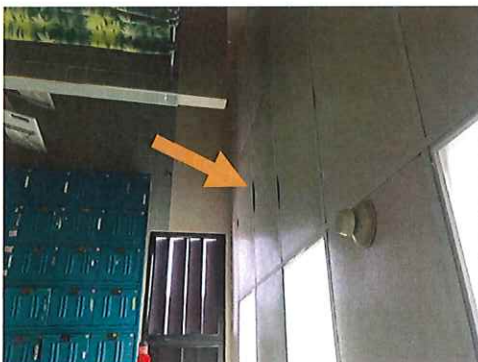
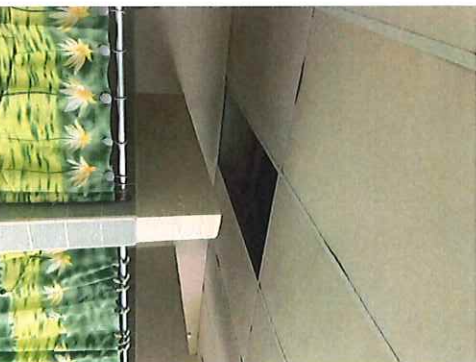
Interior Building, 60 each of acoustic ceiling tile, 4 FT long x 2 FT wide, stained due to water infiltration, 0% work completed		
Damage Description:		Photo# 23	Damage Description	
Interior Building, 60 each of acoustic ceiling tile, 4 FT long x 2 FT wide, stained due to water infiltration, 0% work completed		Interior Building, 60 each of acoustic ceiling tile, 4 FT long x 2 FT wide, stained due to water infiltration, 0% work completed

Photo# 24	Damage Description	
Interior Building, 60 each of acoustic ceiling tile, 4 FT long x 2 FT wide, stained due to water infiltration, 0% work completed		Interior Building, 60 each of acoustic ceiling tile, 4 FT long x 2 FT wide, stained due to water infiltration, 0% work completed

Interior Building, 60 each of acoustic ceiling tile, 4 FT long x 2 FT wide, stained due to water infiltration, 0% work completed

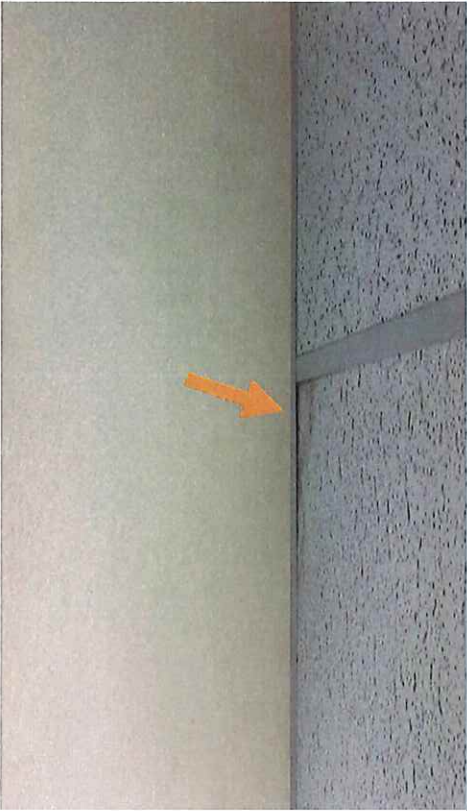
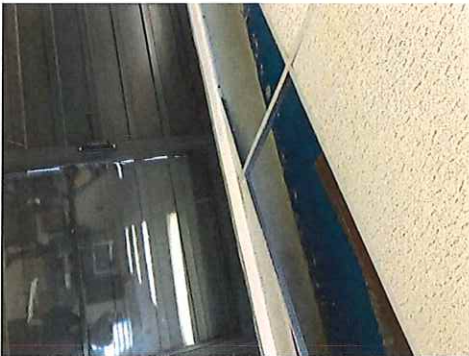
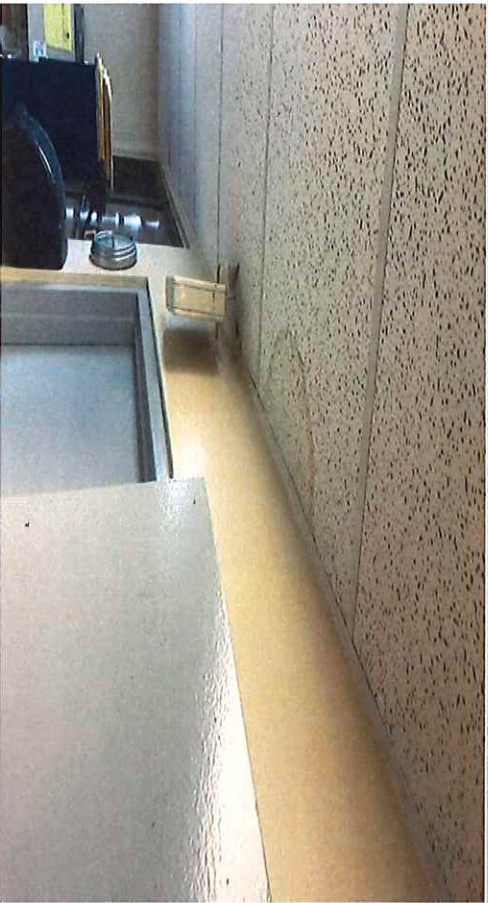
<b>Damage Description:</b> Interior Building, 60 each of acoustic ceiling tile, 4 FT long x 2 FT wide, stained due to water infiltration, 0% work completed		<b>Photo#</b> 27		<b>Damage Description:</b> Interior Building, 60 each of acoustic ceiling tile, 4 FT long x 2 FT wide, stained due to water infiltration, 0% work completed

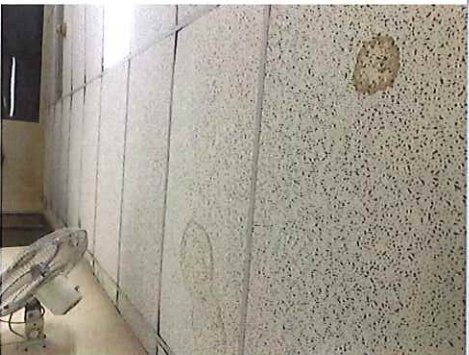
<b>Damage Description:</b>		<b>Photo#</b> 31	<b>Damage Description</b>	
Interior Building, 60 each of acoustic ceiling tile, 4 FT long x 2 FT wide, stained due to water infiltration, 0% work completed
