ENMIENDA NÚM. 3

SUBASTA FORMAL 23J-16945 PARA REALIZAR MEJORAS EN EL PRIMER PISO DE LA UNIDAD DE SALUD PÚBLICA (USP) DE RÍO PIEDRAS, ADSCRITA AL DEPARTAMENTO DE SALUD DEL GOBIERNO DE PUERTO RICO

Damage Description and Dimensions

Damage #151656; USP Rio Piedras

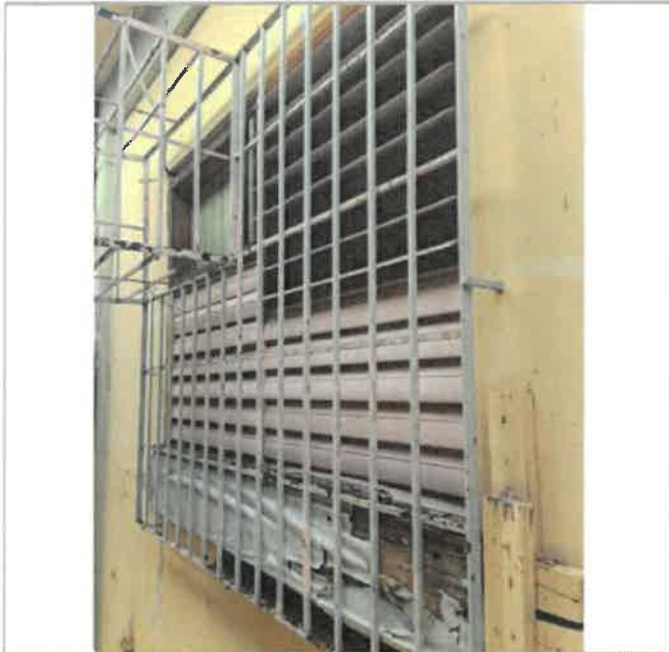
South Side Wall Exterior, 6 each of aluminum jalousie window, 5 FT long x 3 FT wide, high winds and wind blown debris broke and/or bent the windows, should be verified for Historic characteristics, 0% work completed (photo 1 of 2)

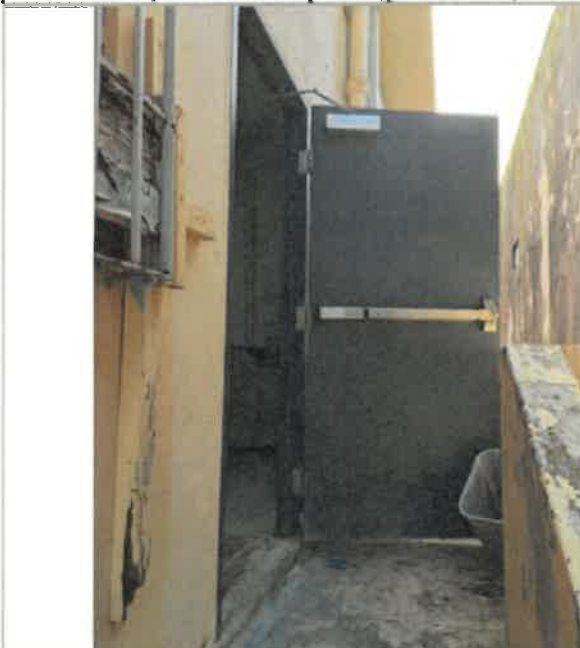
South Side Wall Exterior, 1 each of wooden security door, 3 FT wide x 7 FT high, high winds and wind blown debris broke the door, was replaced with a metal security door, 100% work completed

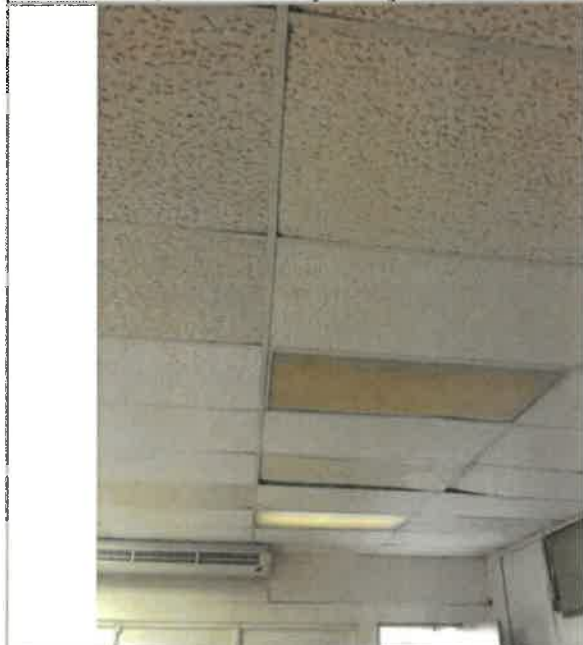
2nd Floor Administration, 1,829 SF of suspended lay-in acoustic 2 x 4 ceiling tile, 59 FT long x 31 FT wide, water intrusion through roof failure damage the tile, 0% work completed (photo 1 of 2)

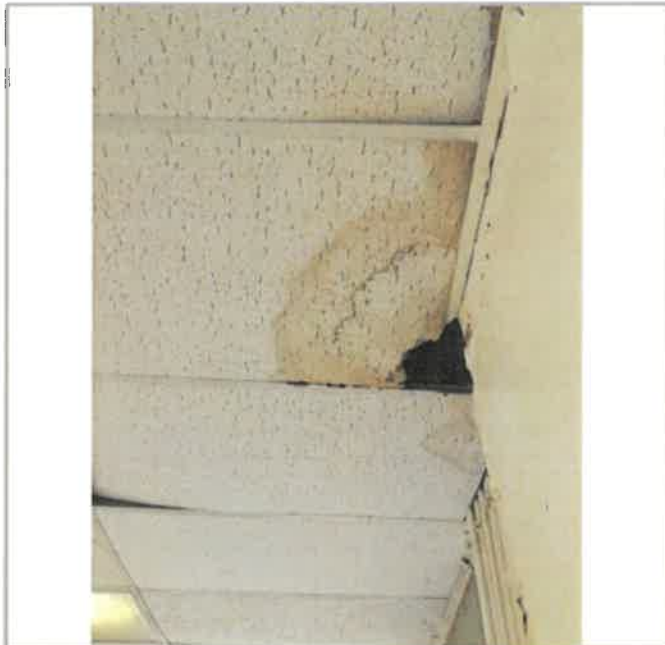
2nd Floor Administration, 1,829 SF of suspended lay-in acoustic 2 x 4 ceiling tile, 59 FT long x 31 FT wide, water intrusion through roof failure damage the tile, 0% work completed (photo 2 of 2)

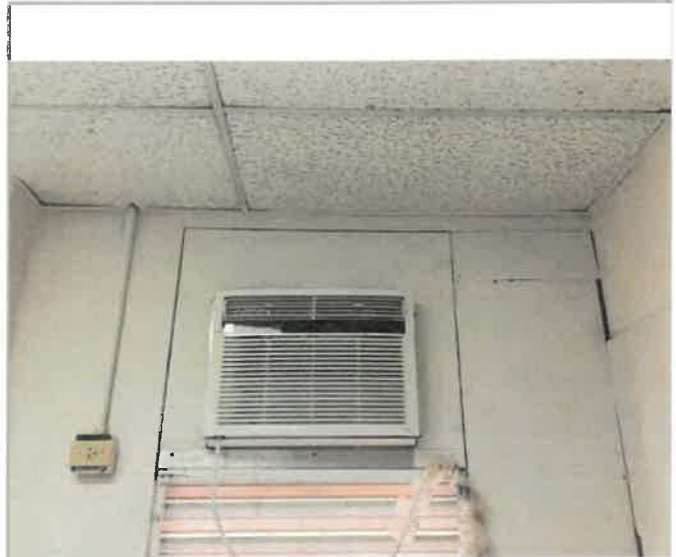
2nd Floor Administration, 1 each of window mounted 18,500 BTU A/C unit, Kenmore 253.70181, high winds, wind driven rain, wind blown debris, power surges, and water intrusion damage the unit, 0% work completed (photo 1 of 2)

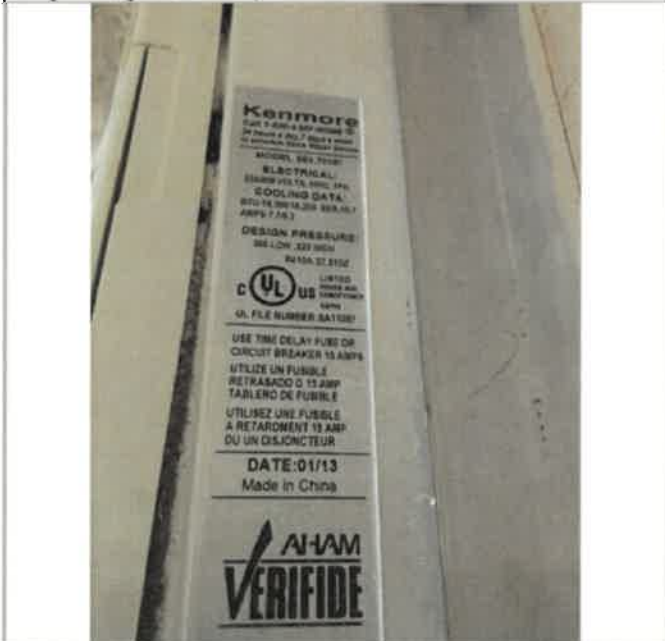
2nd Floor Administration, 1 each of window mounted 18,500 BTU A/C unit, Kenmore 253.70181, high winds, wind driven rain, wind blown debris, power surges, and water intrusion damage the unit, 0% work completed (photo 2 of 2)

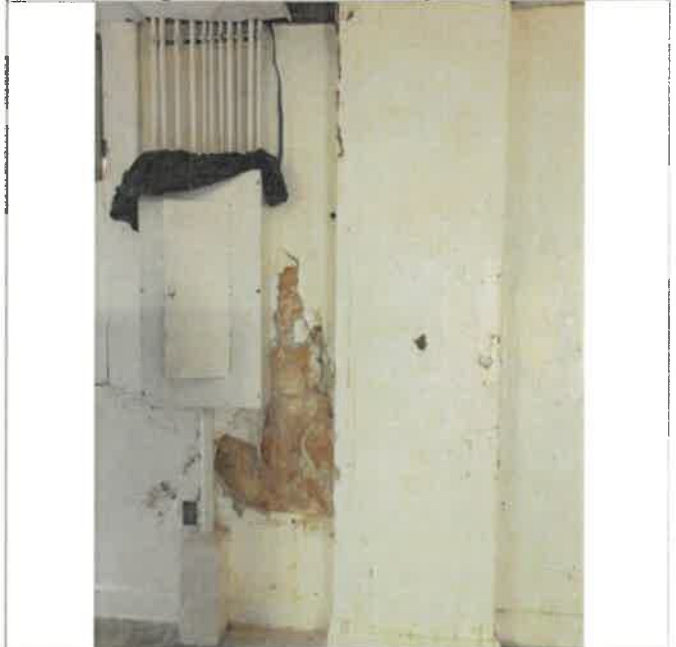
2nd Floor Administration, 160 SF of Historic concrete wall plaster and paint, 20 FT long x 8 FT high. water intrusion through roof and window failure, and water cascading down the outside side of the wall because of a missing downspout detached and scraped the plaster, 0% work completed

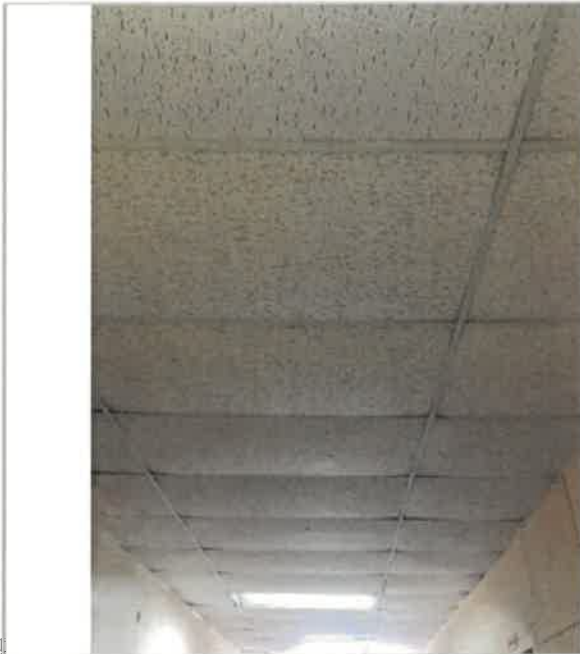
2nd Floor Main Hallway, 1,071 SF of suspended lay-in acoustic 2 x 4 ceiling tile, 119 FT long x 9 FT wide, water intrusion through roof failure damage the tile, temporarily replaced, 0% work completed

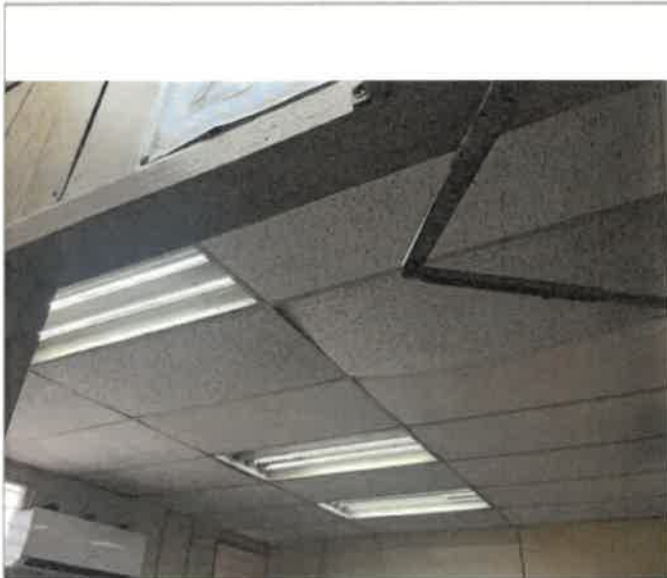
2nd Floor Doctor, Social Work and Mother & Child, 2 x 4 fluorescent drop-in ceiling light fixture, 4 tubes, and suspended acoustic ceiling tiles, water intrusion through roof and window failure damaged the fixtures, the tubes were replaced with LED types, (photo 2 of 3)

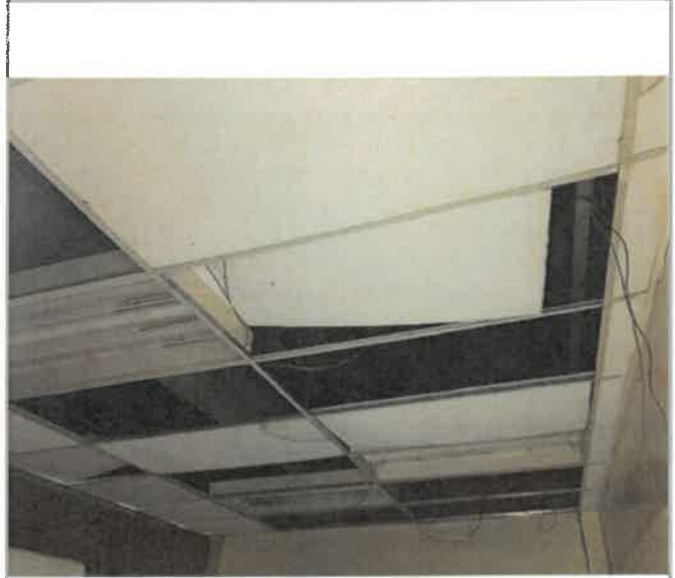
2nd Floor Doctor, Social Work and Mother & Child, 2 x 4 fluorescent drop-in ceiling light fixture, 4 tubes, and suspended acoustic ceiling tiles, water intrusion through roof and window failure damaged the fixtures, (photo 3 of 3)

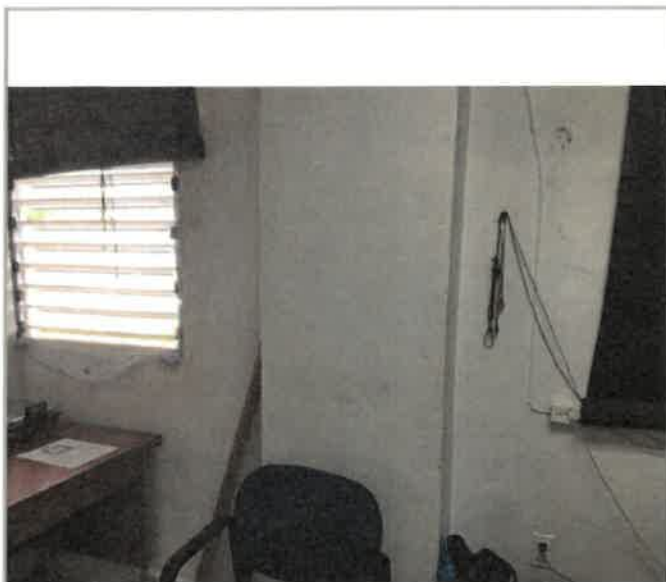
2nd Floor Health Certificate, 735 SF of Historic concrete wall paint, (17ft x 9ft high) + 2 walls of (17ft x 86in high) + (32ft x 86in high) + (15ft x 86in high), water intrusion through roof and window failure blistered and/or peeled off the paint, temporarily painted, 0% work completed (photo 1 of 2)

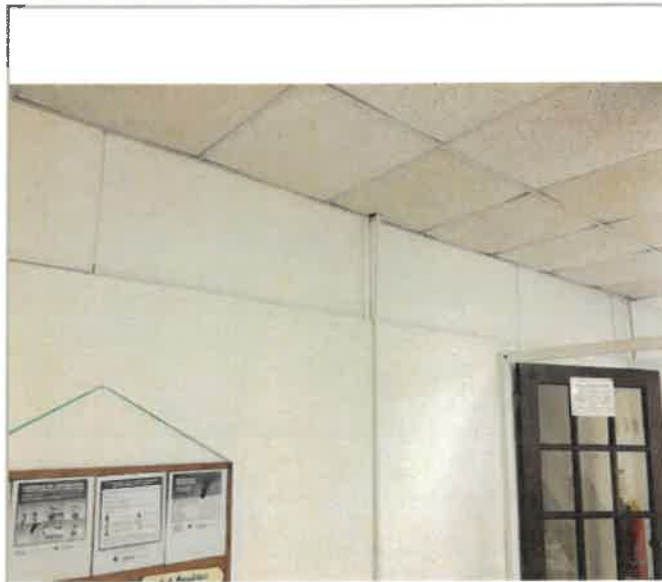
2nd Floor Health Certificate, 735 SF of Historic concrete wall paint and 112 SF of wooden panel wall paint, water intrusion through roof and window failure blistered and/or peeled off the paint, temporarily painted, 0% work completed (photo 2 of 2)

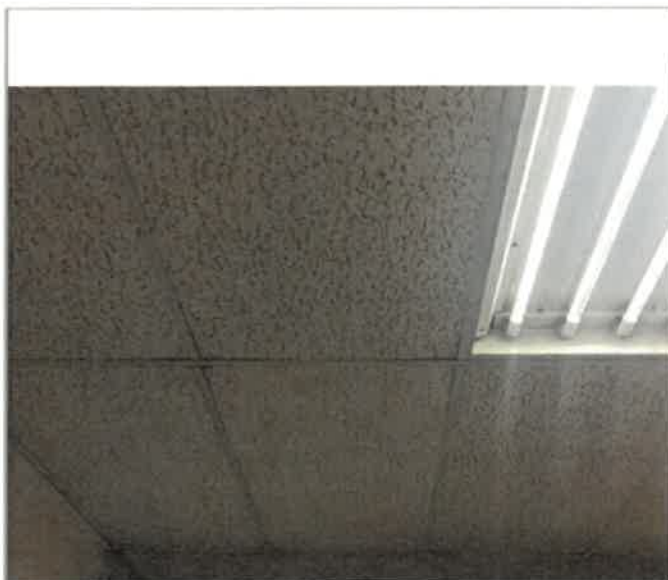
2nd Floor Vaccination, 12 each of fluorescent drop-in ceiling light fixture, 4 tubes, 2 FT long x 4 FT wide, and 720 SF of suspended lay-in acoustic 2 x 4 ceiling tile, 36 FT long x 20 FT wide, water intrusion through roof and window failure damage the tile and fixtures, temporarily replaced tiles and tubes

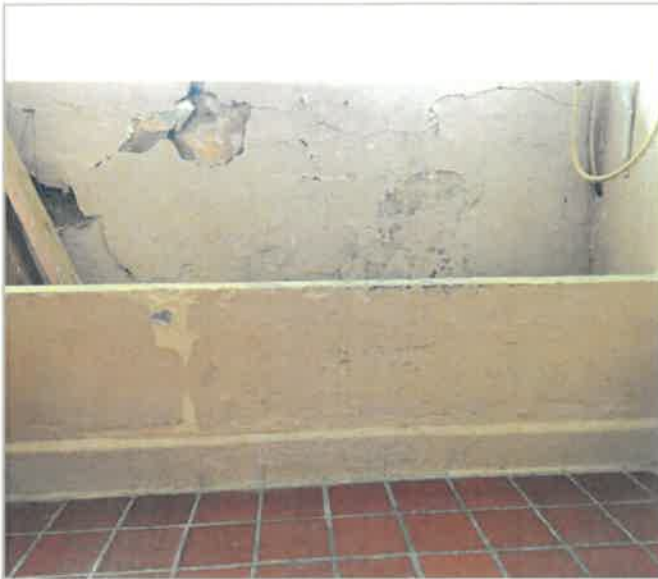
2nd Floor Restrooms Hallway, 32 SF of Historic concrete wall plaster, 8 FT long x 4 FT high, water intrusion through roof and window failure detached and/or scraped the plaster under the window opening, 0% work completed

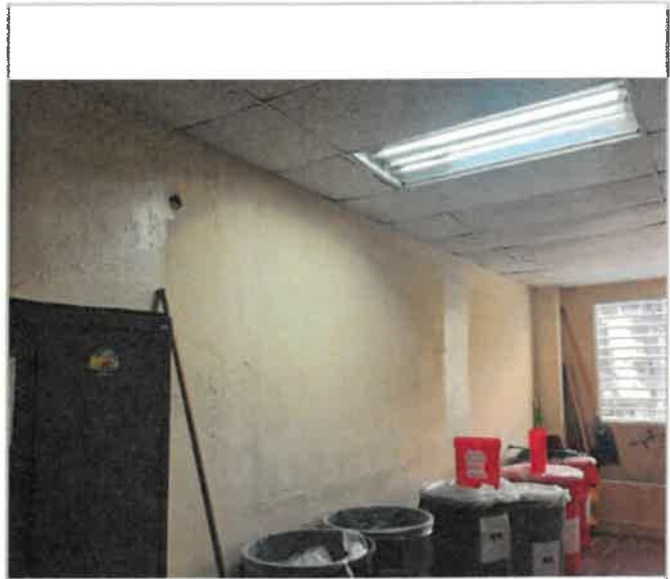
2nd Floor Restrooms Hallway, 720 SF of Historic concrete wall paint, 80 LF long x 9 FT high, water intrusion through roof and window failure blistered and/or peeled off the paint, temporarily painted, 0% work completed

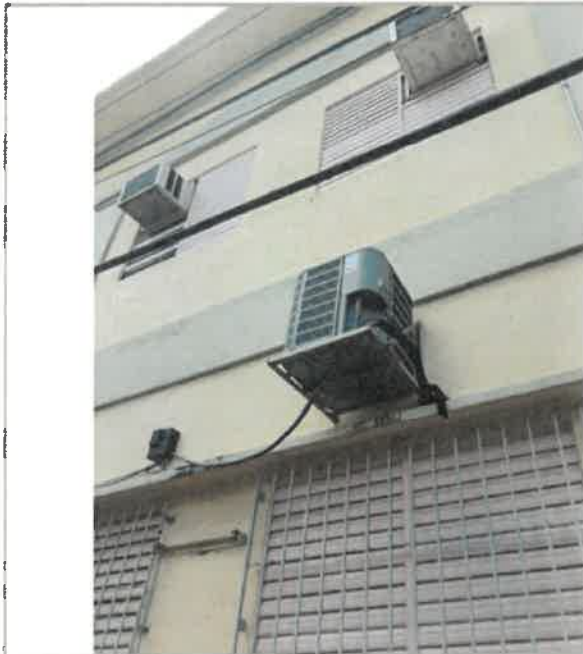
2nd Floor Health Certificate, 2 each of wall mounted 3 ton split A/C unit (view of the compressor), high winds, wind driven rain, wind blown debris and water intrusion damage the unit, 100% work completed (photo 2 of 3)

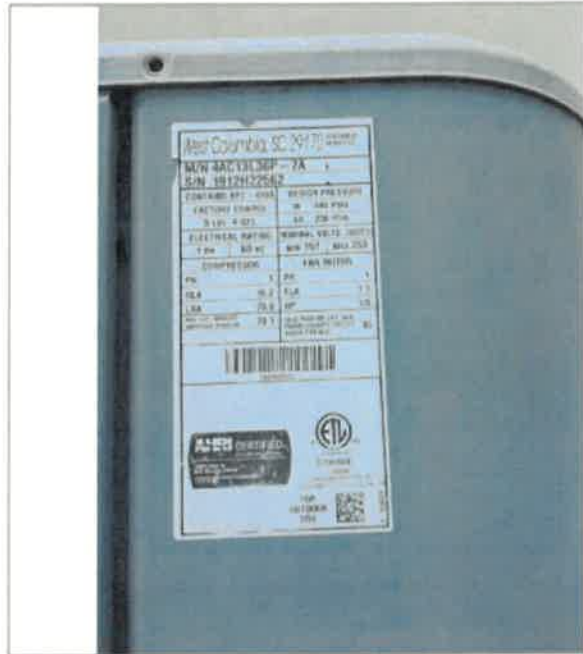
2nd Floor Health Certificate, 2 each of wall mounted 3 ton split A/C unit (compressor specifications), high winds, wind driven rain, wind blown debris and water intrusion damage the unit, 100% work completed (photo 3 of 3)

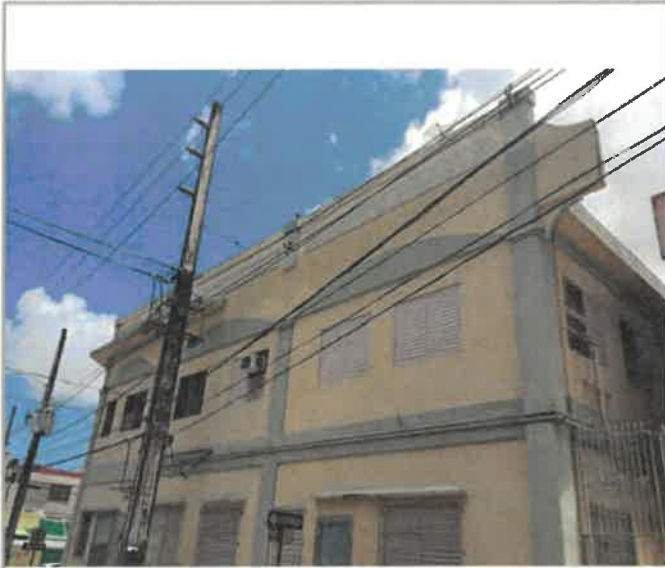
West Side Wall Building Exterior, 3 CY of Historic concrete cornice and paint, 40 FT long x 30 IN wide x 8 IN high, high winds, wind driven rain, and wind blown debris broke and/or loosened the cornice, it was demolished by Applicant, 0% work completed (photo 1 of 2)

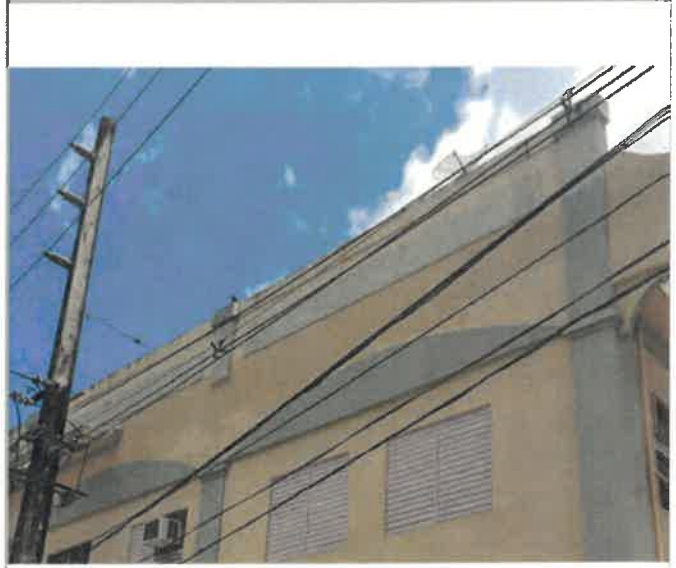
West Side Wall Building Exterior, 3 CY of Historic concrete cornice and paint, 40 FT long x 30 IN wide x 8 IN high, high winds, wind driven rain, and wind blown debris broke and/or loosened the cornice, it was demolished by Applicant, 0% work completed (photo 2 of 2)

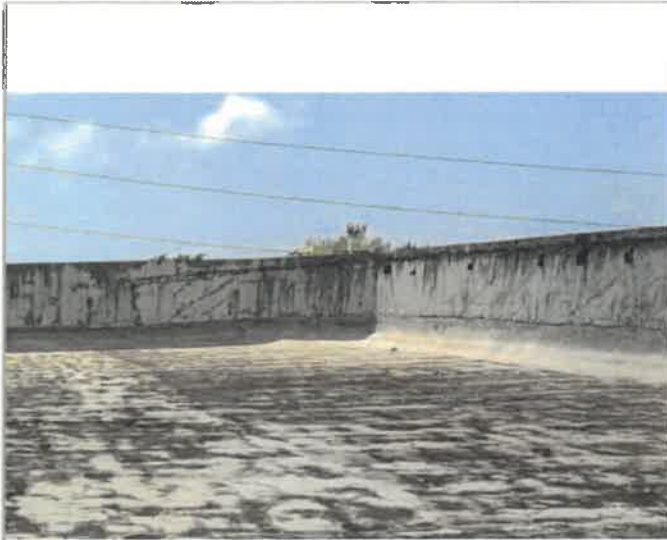
Roof Parapet, 1,960 SF of parapet wall paint, 280 LF long x 7 FT high, high winds, wind driven rain, and wind blown debris blistered and peeled off the paint, 0% work completed

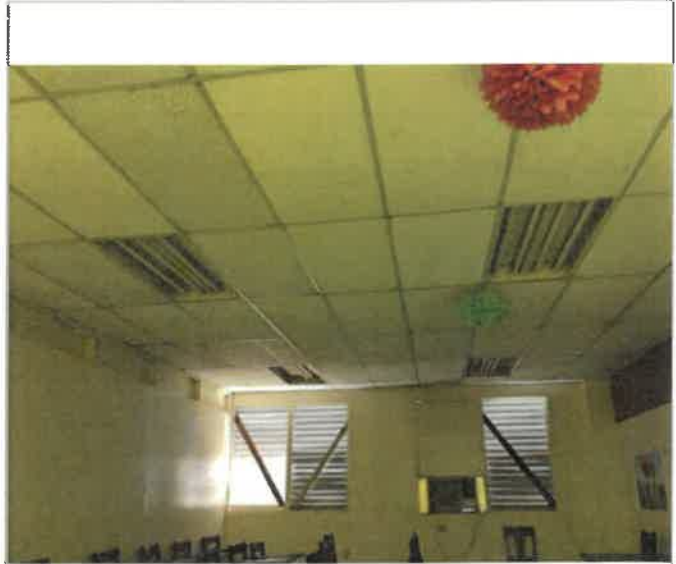
2nd Floor Conference Room 1, suspended lay-in acoustic 2 x 4 ceiling tile; fluorescent 2 x 4 drop-in ceiling light fixture, 4 tubes; and wall paint, water intrusion through roof and window failure damaged the area, 0% work completed

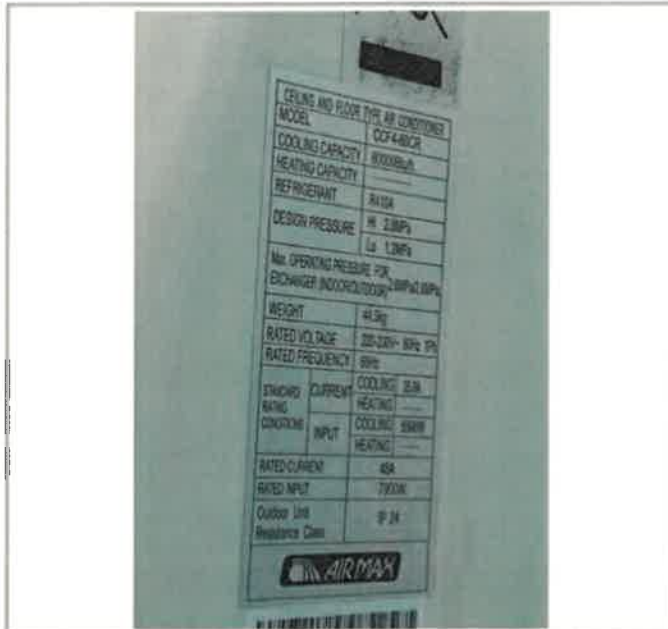
1st Floor Clinical Laboratory, 1 each of wall mounted AirMax CCF4-60CR 5 ton split A/C unit repairs, high winds, wind driven rain, wind blown debris and water intrusion damage the unit, 100% work completed (photo 2 of 2)

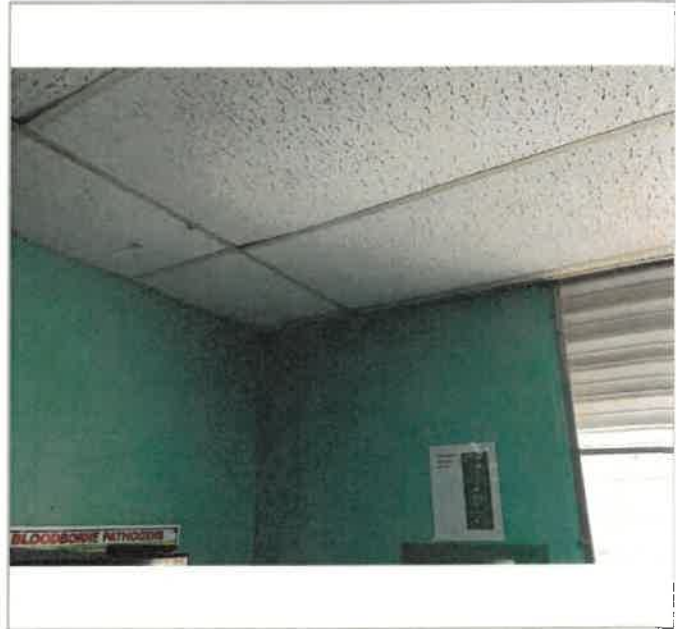
1st Floor Clinical Laboratory, 256 SF of suspended lay-in acoustic 2 x 4 ceiling tile, the first two rows next to the outside wall (this is a corner area) (8ft x 20ft) + (4ft x 24ft), water intrusion through window failure damage the tile, temporarily replaced, 0% work completed

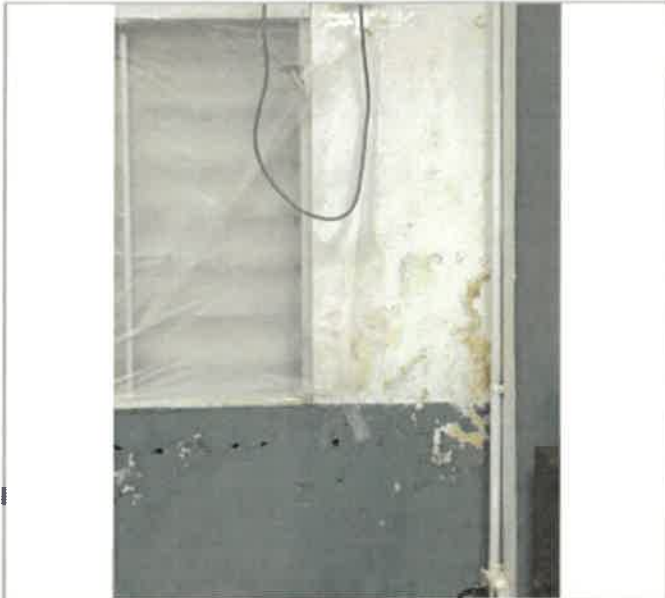
1st Floor Serology, 219 SF of Historic concrete wall paint, 24.25 FT long x 9 FT high, water intrusion through window failure and surface water flooding from water accumulated between the affected and the adjacent buildings blistered and/or peeled off the paint, ongoing problem, temporarily painted, 0% work completed (photo 1 of 2)

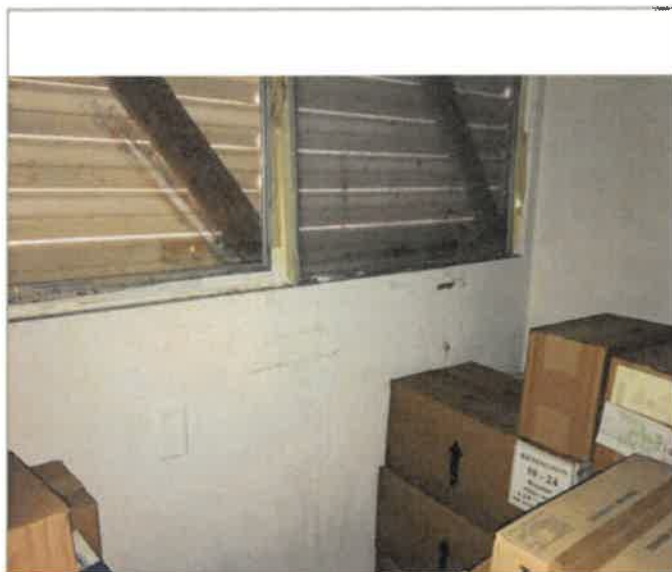
1st Floor Storage Room, 405 SF of Historic concrete wall paint, 45 FT long x 9 FT high, water intrusion through window failure and surface water flooding blistered and/or peeled off the paint, 0% work completed (photo 2 of 3)

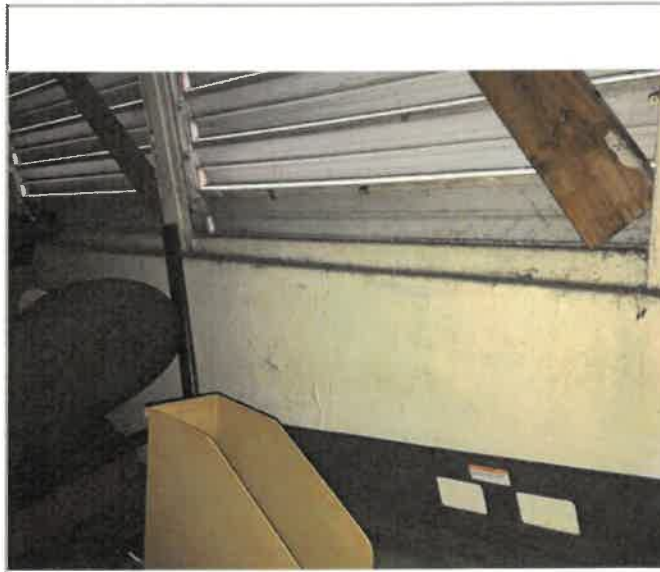
1st Floor Storage Room, 405 SF of Historic concrete wall paint, 45 FT long x 9 FT high, water intrusion through window failure and surface water flooding blistered and/or peeled off the paint, 0% work completed (photo 3 of 3)

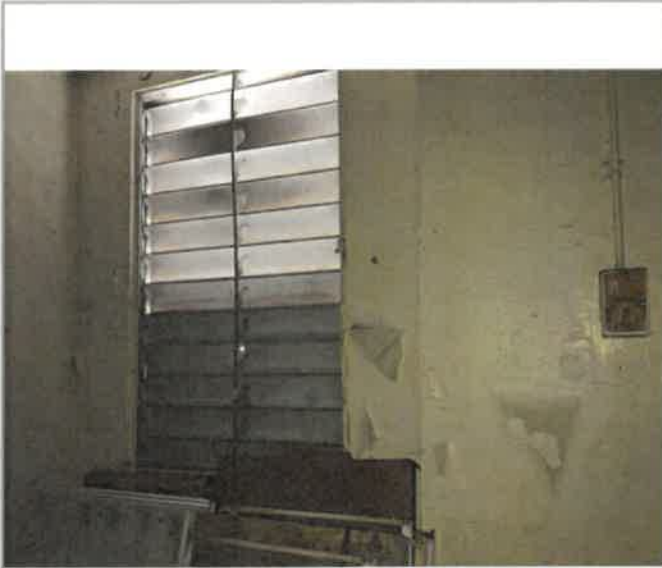
1st Floor Maintenance Storage Area, 815 SF of Historic concrete wall paint, 90.5 LF long x 9 FT high, water intrusion through window failure blistered and/or peeled off the paint, 0% work completed

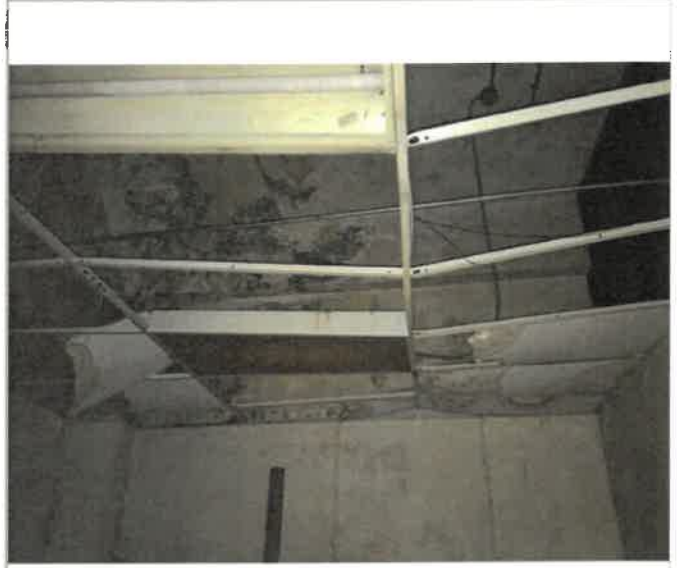
1st Floor Maintenance Storage Area, 544 SF of suspended lay-in acoustic 2 x 4 ceiling tile, the first three rows next to the outside wall (this is a corner area) (64ft x 6ft) + (20ft x 8ft), water intrusion through window failure damage the tile, 0% work completed

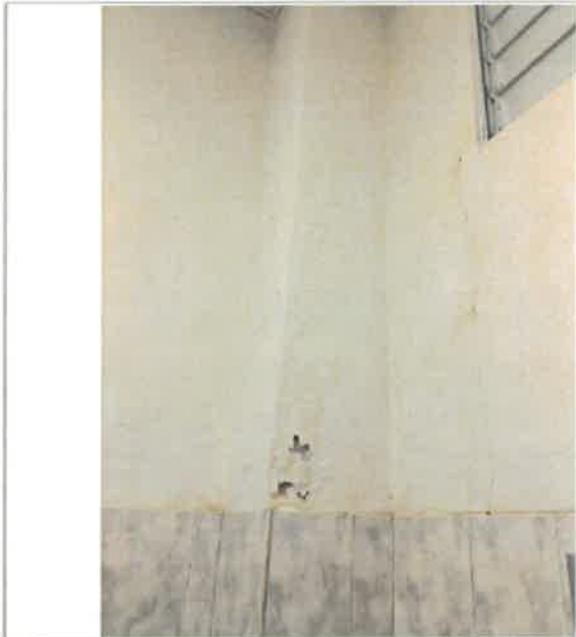
1st Floor Men's Restroom, 54 SF of Historic concrete wall paint, 9.5 FT long x 5.67 FT high, there are glazed tiles on the lower part of the wall, water intrusion through window failure blistered and/or peeled off the paint, ongoing problem, 0% work completed

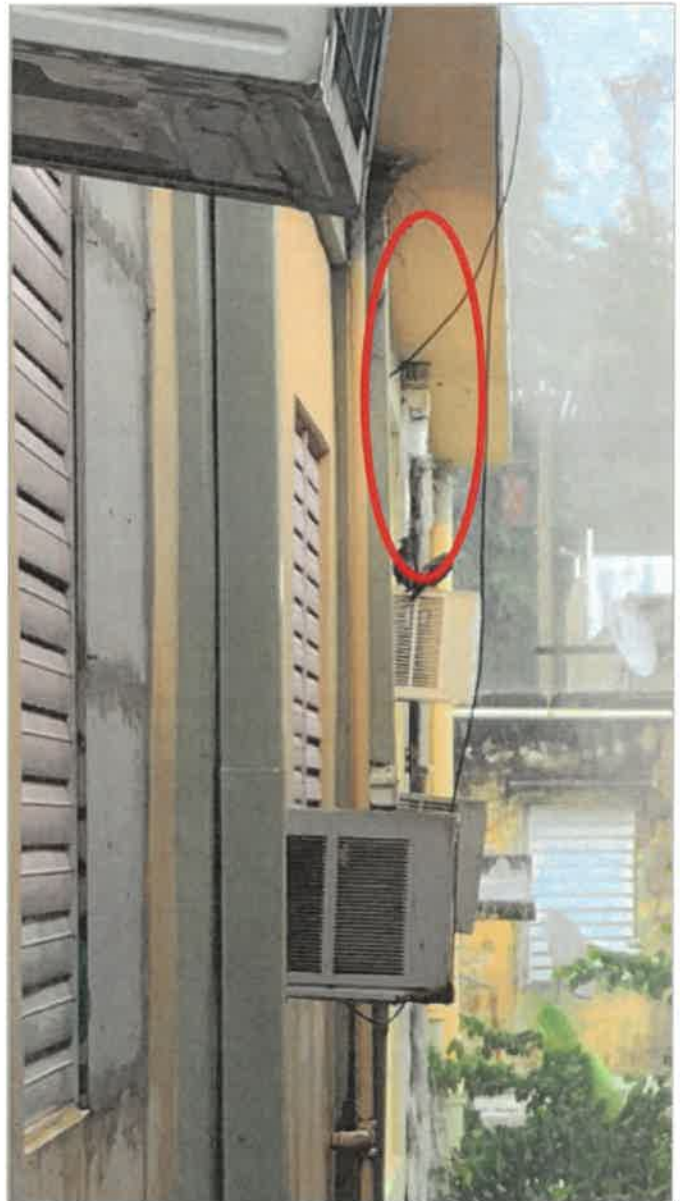
South Side Wall Exterior, metal 4in x 6in downspout, 90 LF long (view of another missing downspout and water falling profusely), high winds, wind driven rain, and wind blown debris blew off three 30ft long pieces, possible mitigation to effectively drain the south side of the building because all the roof drainage is on that side (where another building structure is erected just 5 ft apart) plus the emergency concrete stairs are on that side of the building, closing more that drainage area, 0% work completed (photo 3 of 3)

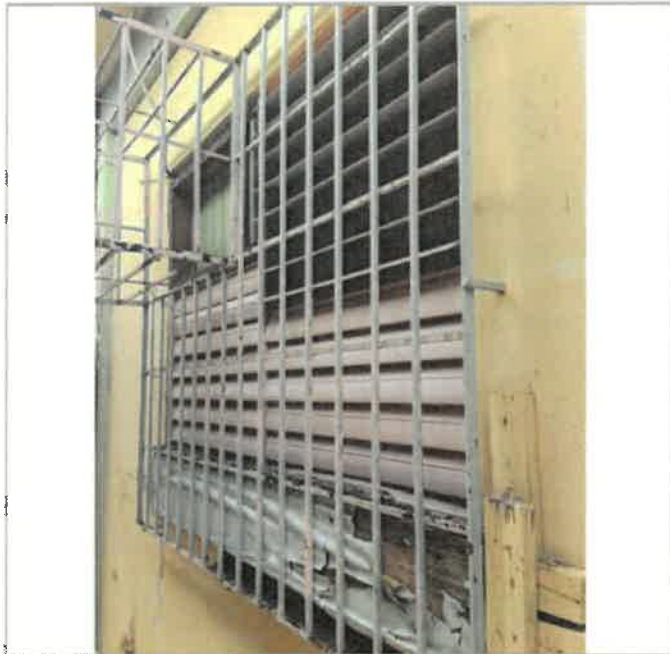
South Side Wall Exterior, 6 each of aluminum jalousie window, 5 FT long x 3 FT wide, high winds and wind blown debris broke and/or bent the windows, should be verified for Historic characteristics. 0% work completed (photo 1 of 2)

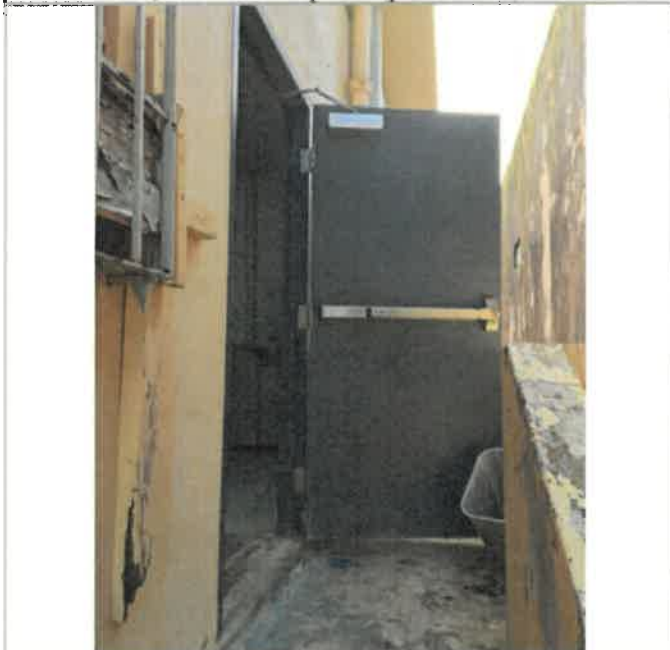
South Side Wall Exterior, 1 each of wooden security door. 3 FT wide x 7 FT high, high winds and wind blown debris broke the door, was replaced with a metal security door, 100% work completed

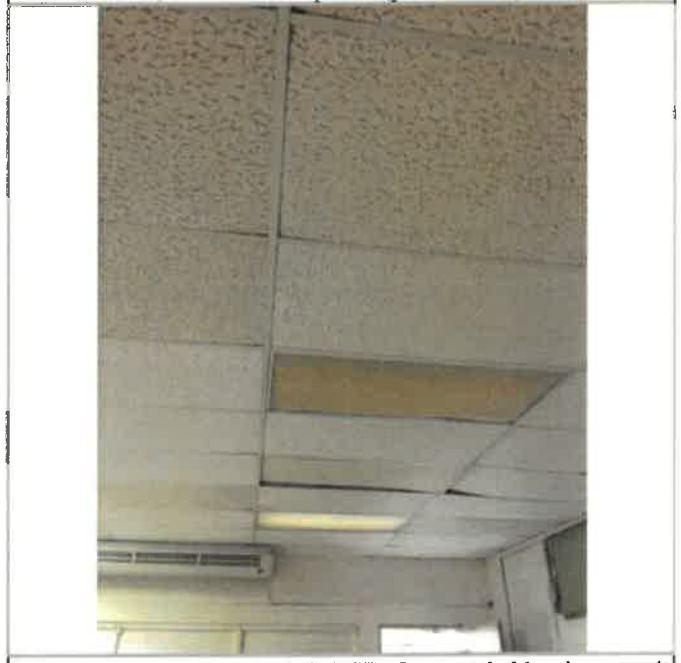
2nd Floor Administration, 1,829 SF of suspended lay-in acoustic 2 x 4 ceiling tile, 59 FT long x 31 FT wide, water intrusion through roof failure damage the tile. 0% work completed (photo 1 of 2)

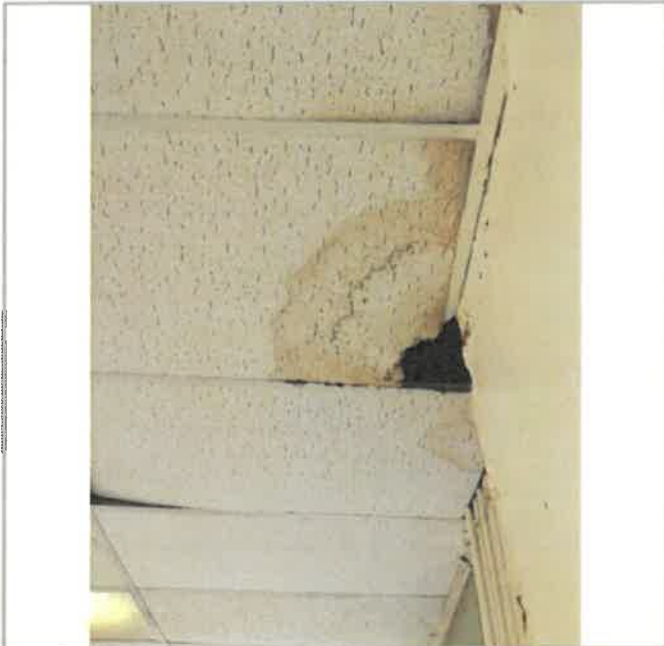
2nd Floor Administration, 1,829 SF of suspended lay-in acoustic 2 x 4 ceiling tile, 59 FT long x 31 FT wide, water intrusion through roof failure damage the tile, 0% work completed (photo 2 of 2)

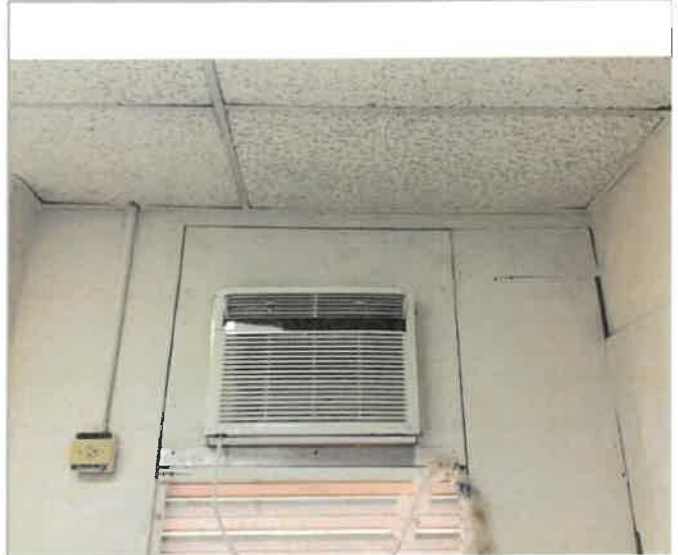
2nd Floor Administration, 1 each of window mounted 18,500 BTU A/C unit, Kenmore 253.70181, high winds, wind driven rain, wind blown debris, power surges, and water intrusion damage the unit, 0% work completed (photo 1 of 2)

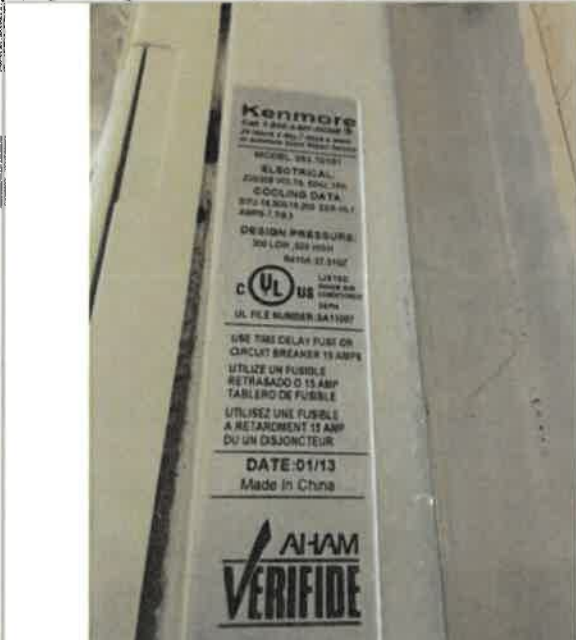
2nd Floor Administration, 1 each of window mounted 18,500 BTU A/C unit, Kenmore 253.70181, high winds, wind driven rain, wind blown debris, power surges, and water intrusion damage the unit, 0% work completed (photo 2 of 2)

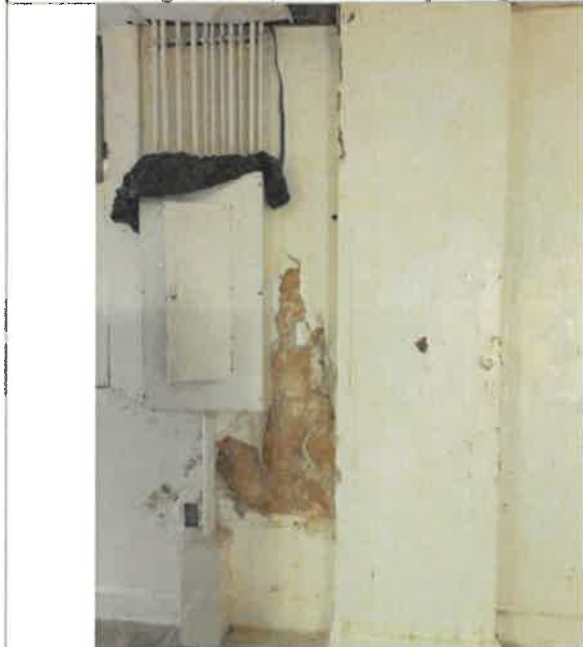
2nd Floor Administration, 160 SF of Historic concrete wall plaster and paint, 20 FT long x 8 FT high, water intrusion through roof and window failure, and water cascading down the outside side of the wall because of a missing downspout detached and scraped the plaster, 0% work completed

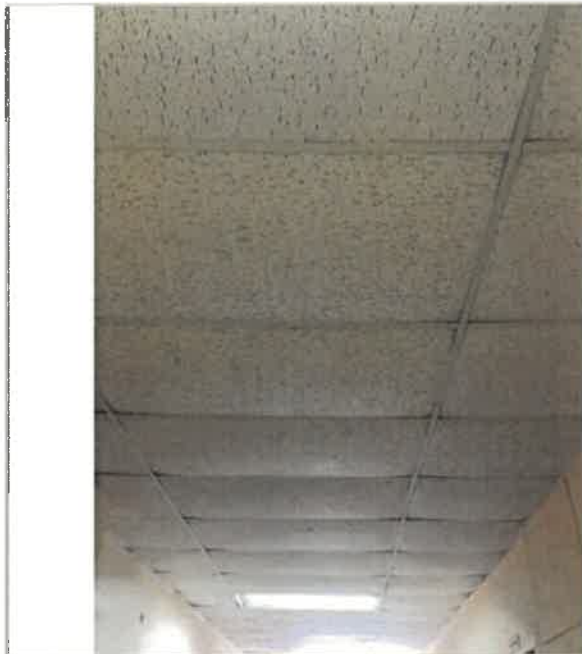
2nd Floor Main Hallway, 1,071 SF of suspended lay-in acoustic 2 x 4 ceiling tile, 119 FT long x 9 FT wide, water intrusion through roof failure damage the tile, temporarily replaced, 0% work completed

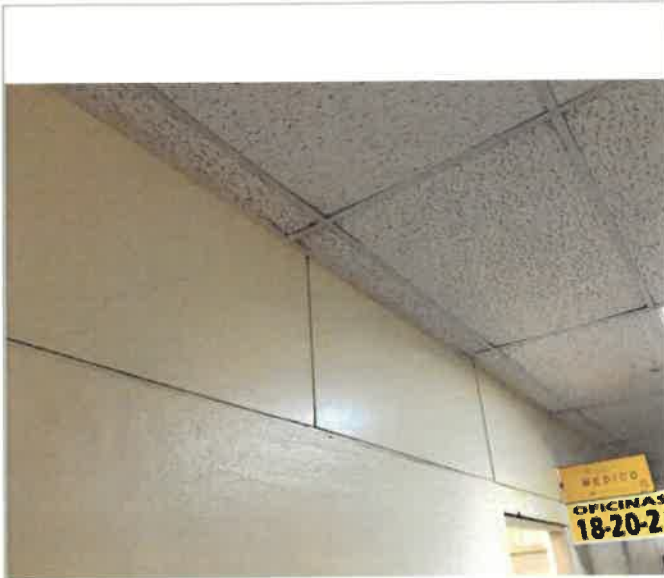
2nd Floor Main Hallway, 455 SF of wooden panel wall paint, 260 LF long x 21 IN high, water intrusion through roof and window failure blistered and/or peeled off the paint, temporarily painted, 0% work completed (photo 1 of 2)

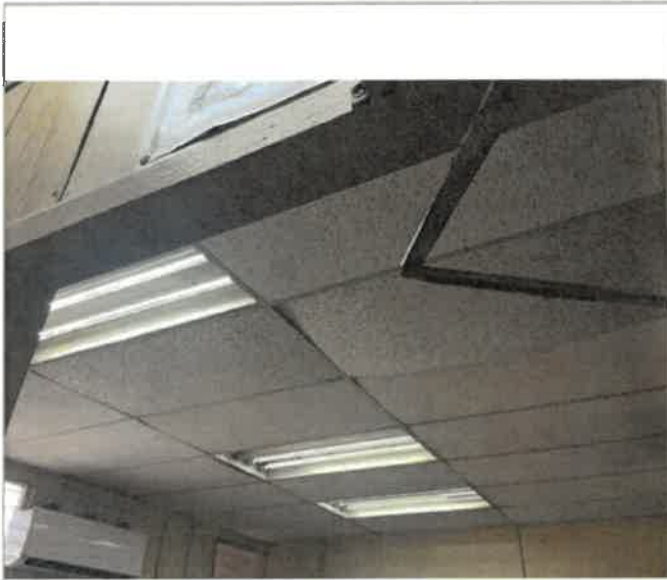
2nd Floor Doctor, Social Work and Mother & Child, 2 x 4 fluorescent drop-in ceiling light fixture, 4 tubes, and suspended acoustic ceiling tiles, water intrusion through roof and window failure damaged the fixtures, the tubes were replaced with LED types, (photo 2 of 3)

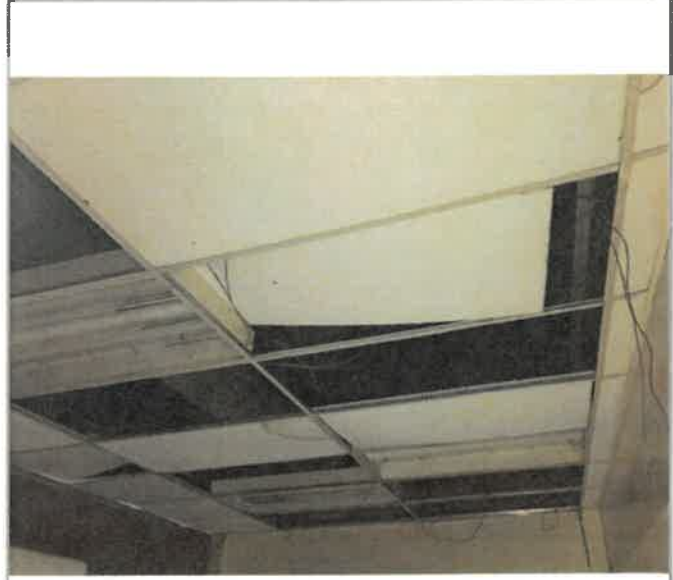
2nd Floor Doctor, Social Work and Mother & Child, 2 x 4 fluorescent drop-in ceiling light fixture, 4 tubes, and suspended acoustic ceiling tiles, water intrusion through roof and window failure damaged the fixtures, (photo 3 of 3)

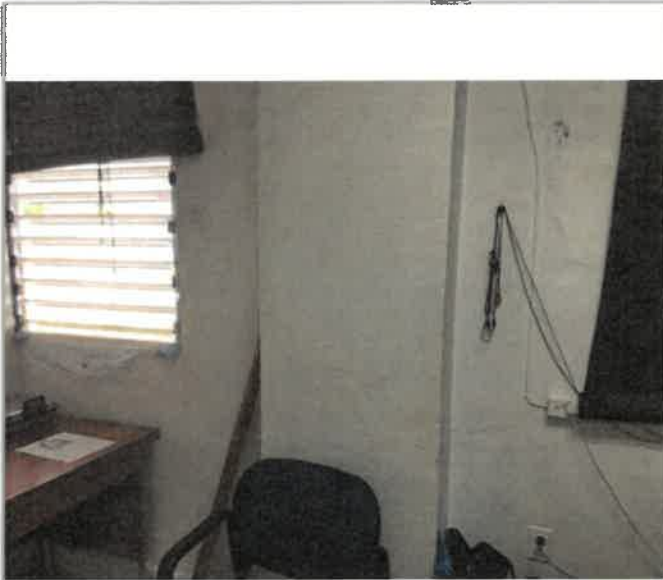
2nd Floor Health Certificate, 735 SF of Historic concrete wall paint, (17ft x 9ft high) + 2 walls of (17ft x 86in high) + (32ft x 86in high) + (15ft x 86in high), water intrusion through roof and window failure blistered and/or peeled off the paint, temporarily painted, 0% work completed (photo 1 of 2)

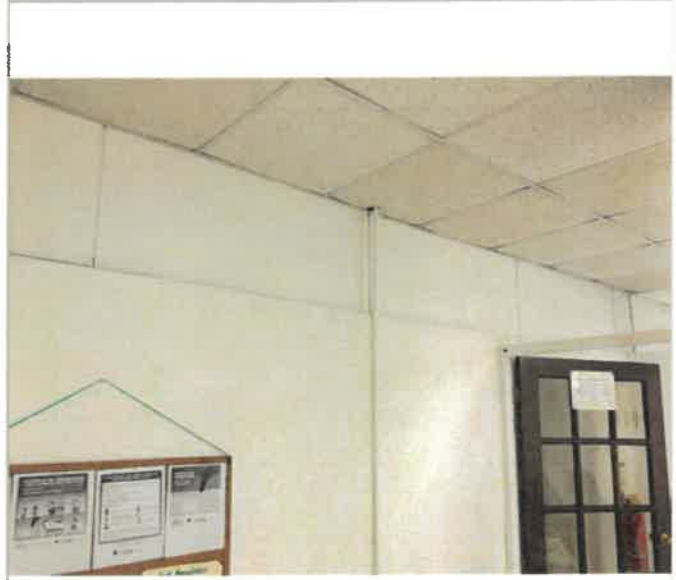
2nd Floor Health Certificate, 735 SF of Historic concrete wall paint and 112 SF of wooden panel wall paint, water intrusion through roof and window failure blistered and/or peeled off the paint, temporarily painted, 0% work completed (photo 2 of 2)

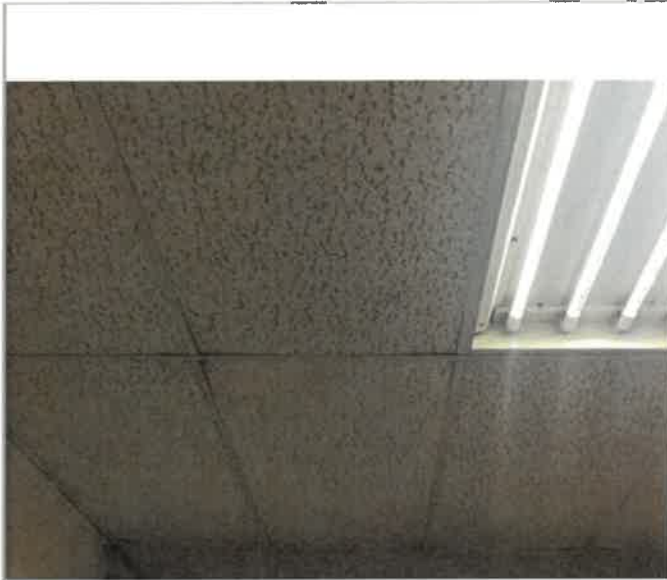
2nd Floor Vaccination, 12 each of fluorescent drop-in ceiling light fixture, 4 tubes, 2 FT long x 4 FT wide, and 720 SF of suspended lay-in acoustic 2 x 4 ceiling tile, 36 FT long x 20 FT wide, water intrusion through roof and window failure damage the tile and fixtures, temporarily replaced tiles and tubes

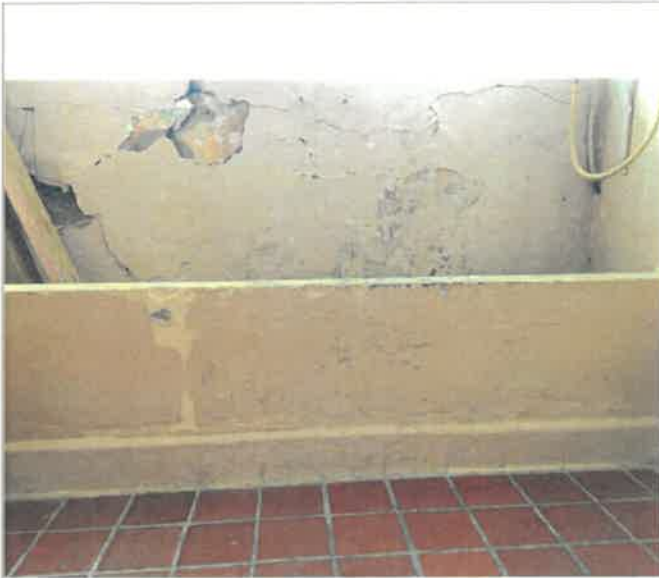
2nd Floor Restrooms Hallway, 32 SF of Historic concrete wall plaster, 8 FT long x 4 FT high, water intrusion through roof and window failure detached and/or scraped the plaster under the window opening, 0% work completed

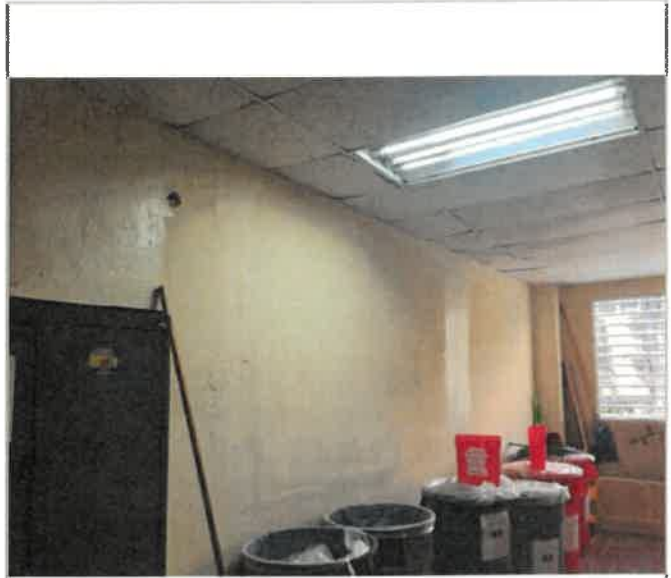
2nd Floor Restrooms Hallway, 720 SF of Historic concrete wall paint, 80 LF long x 9 FT high, water intrusion through roof and window failure blistered and/or peeled off the paint, temporarily painted, 0% work completed

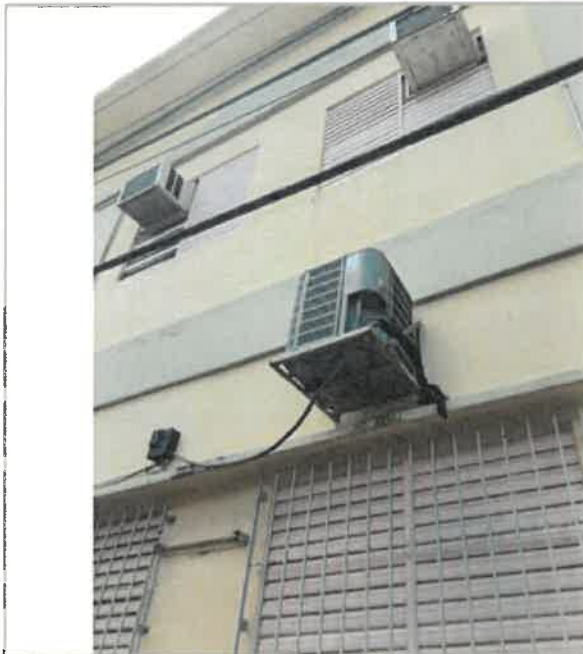
2nd Floor Health Certificate, 2 each of wall mounted 3 ton split A/C unit (view of the compressor), high winds, wind driven rain, wind blown debris and water intrusion damage the unit, 100% work completed (photo 2 of 3)

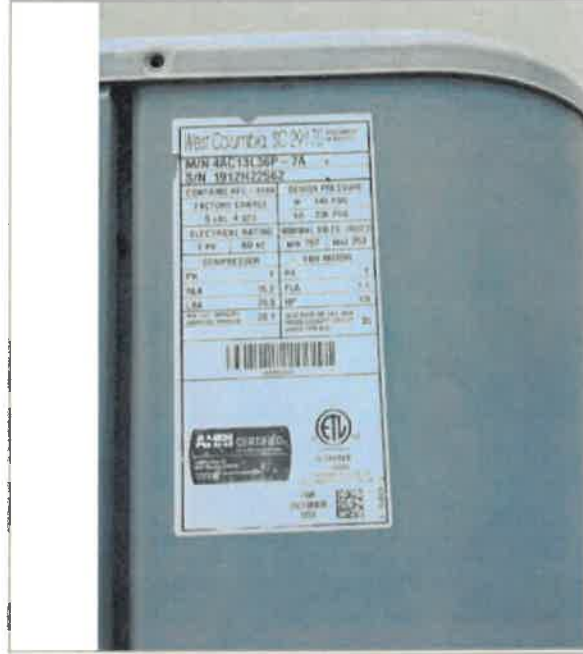
2nd Floor Health Certificate, 2 each of wall mounted 3 ton split A/C unit (compressor specifications), high winds, wind driven rain, wind blown debris and water intrusion damage the unit, 100% work completed (photo 3 of 3)

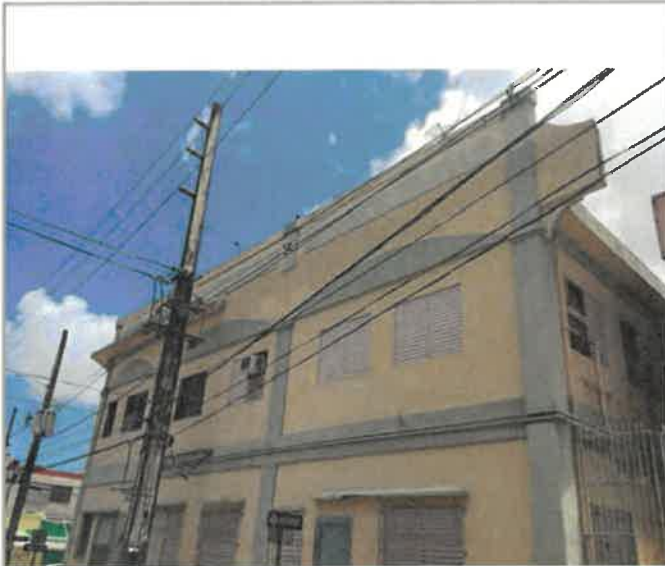
West Side Wall Building Exterior, 3 CY of Historic concrete cornice and paint, 40 FT long x 30 IN wide x 8 IN high, high winds, wind driven rain, and wind blown debris broke and/or loosened the cornice, it was demolished by Applicant, 0% work completed (photo 1 of 2)
