**LIMITED ENVIRONMENTAL SURVEY  
FOR  
LEAD BASED PAINT (LBP)  
AND  
ASBESTOS CONTAINING MATERIALS (ACM)  
FOR  
OFICINAS REGIONALES/HAFI/  
ANTIGUA RESIDENCIA DE ENFERMERAS  
AGUADILLA, PUERTO RICO**

Prepared For:  
Department of Health

Prepared By:

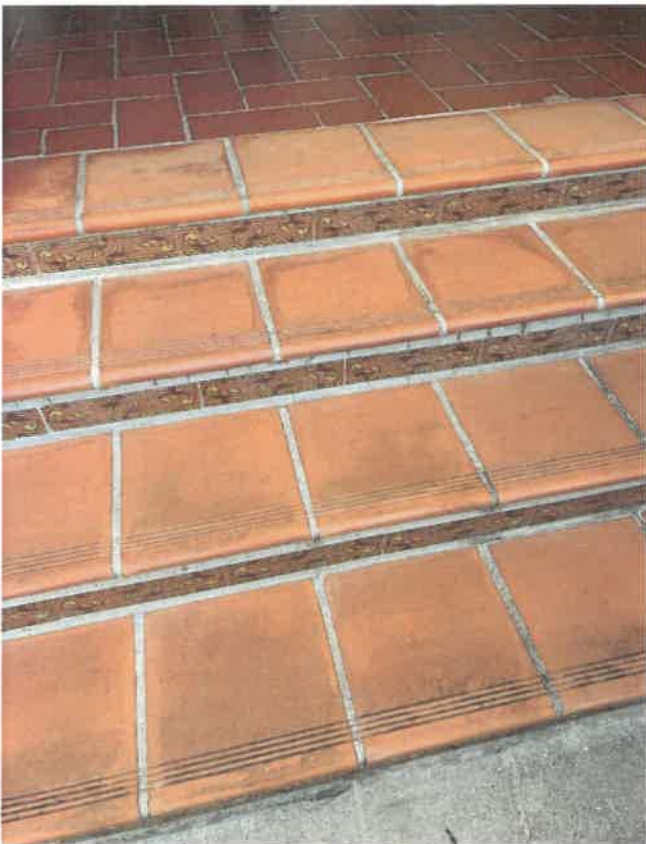
Entrance Riser	Ceramic	Brown	68 ln.ft
----------------	---------	-------	----------

**Brown Ceramic Entrance Riser  
Painted with LBP  
Exterior, Stairs**

If remodeling activities will be conducted in the nearest future, it is required to remove all LBP materials prior to performance of said activities.

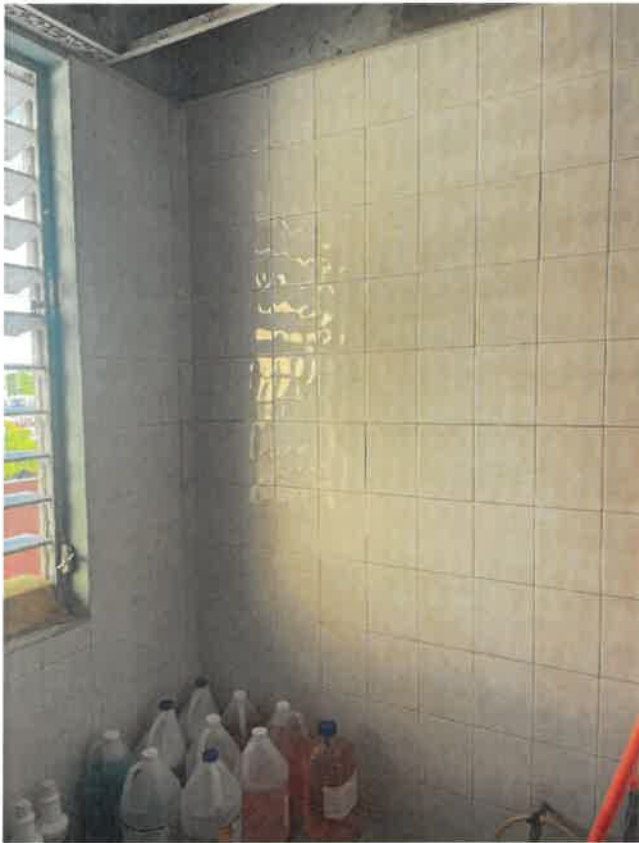
Wall B	Ceramic	White	} 60 sq.ft
Wall C	Ceramic	White	
Wall D	Ceramic	White	
Dike Side	Ceramic	White	20 sq.ft

**White Ceramic Wall Tiles  
Painted with LBP  
Adjacent Mech Room- Janitor Room**

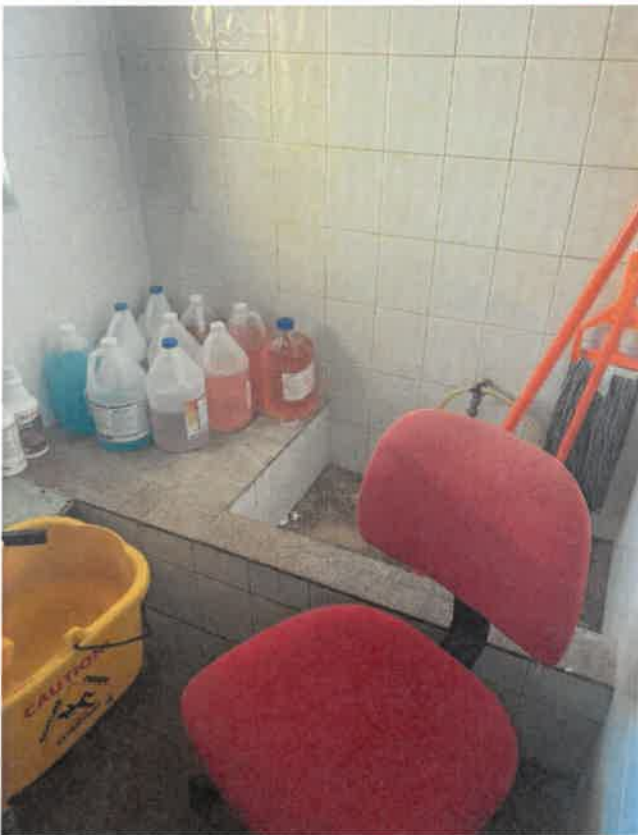
**White Ceramic Dike Side  
Painted with LBP  
Adjacent Mech Room- Janitor Room**
