LEAD BASED PAINT INSPECTION REPORT

CDT Maunabo

DEPARTAMENTO DE
SALUD

May 9, 2022

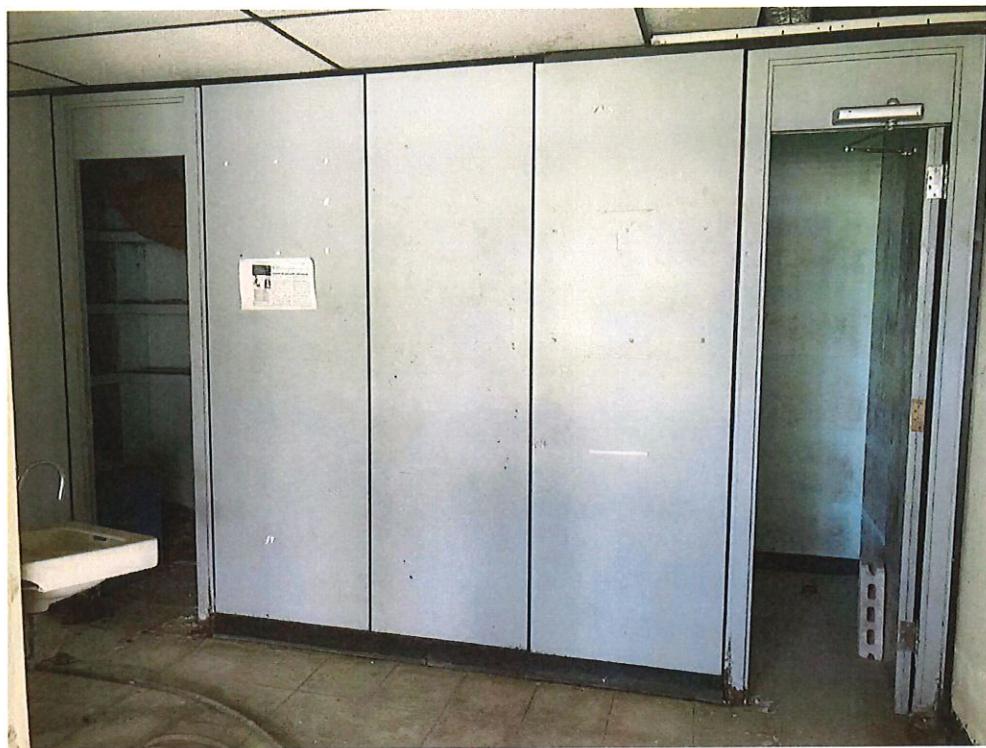
Photo Number 6 – X-Ray room Clinical Dental Wall

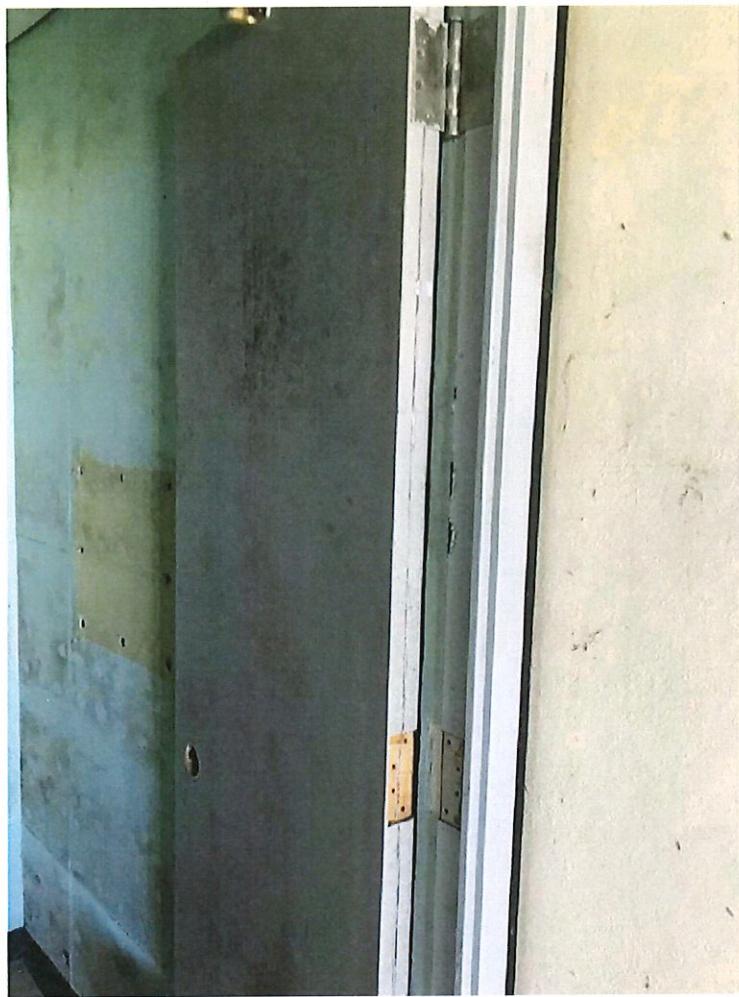
Photo Number 7 – Door X-Ray Room Clinical Dental

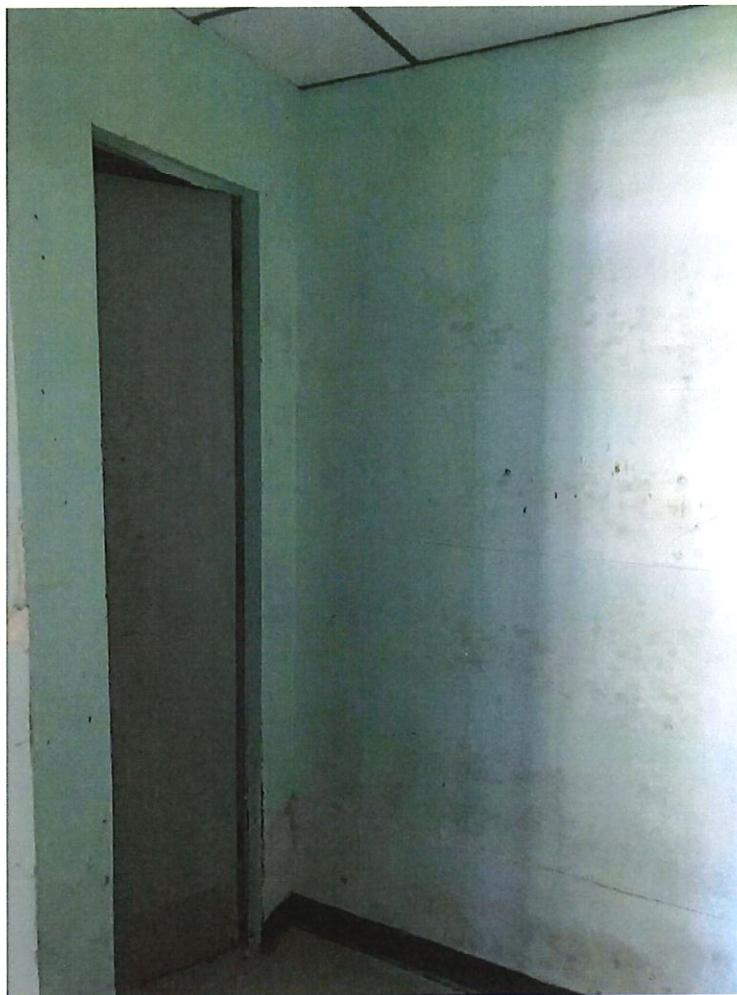
Photo Number 8 – Door X-Ray Room Clinical Dental

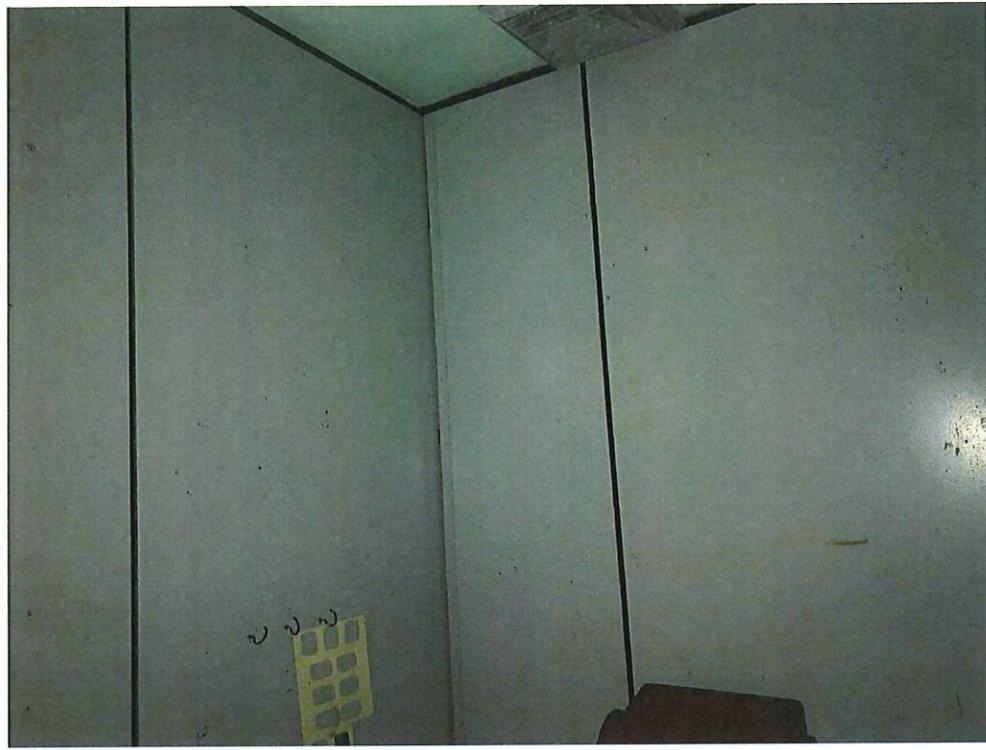
Photo Number 9 – Wall Interior "A" and "B" X-Ray Room Clinical Dental

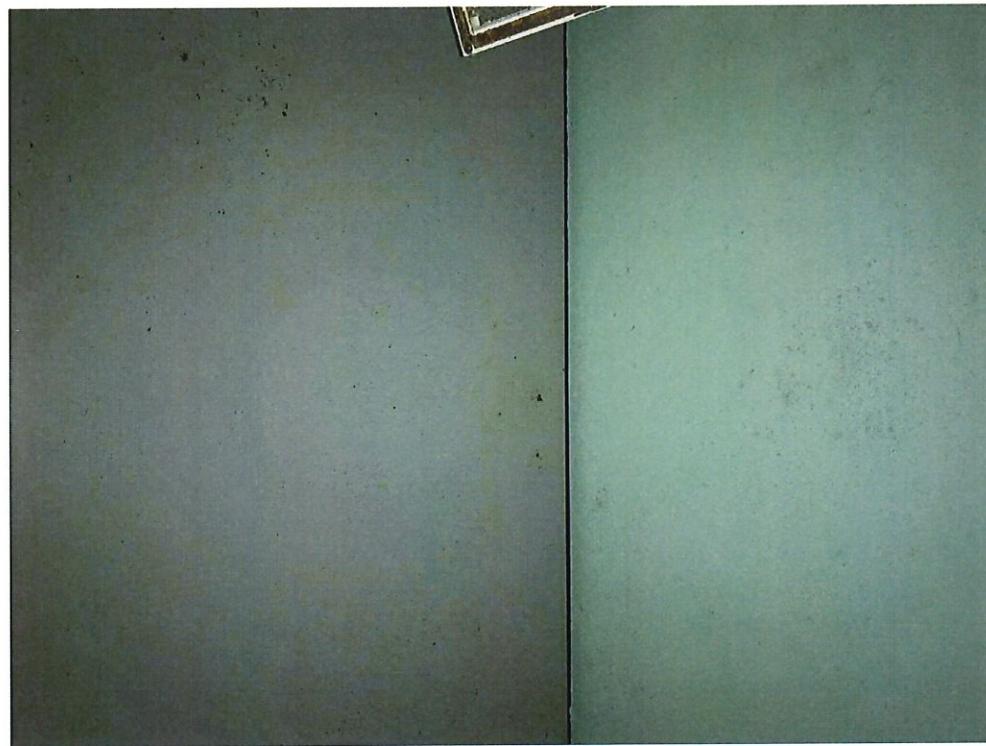
Photo Number 10 – Wall Interior "C" and "D" X-Ray Room Clinical Dental

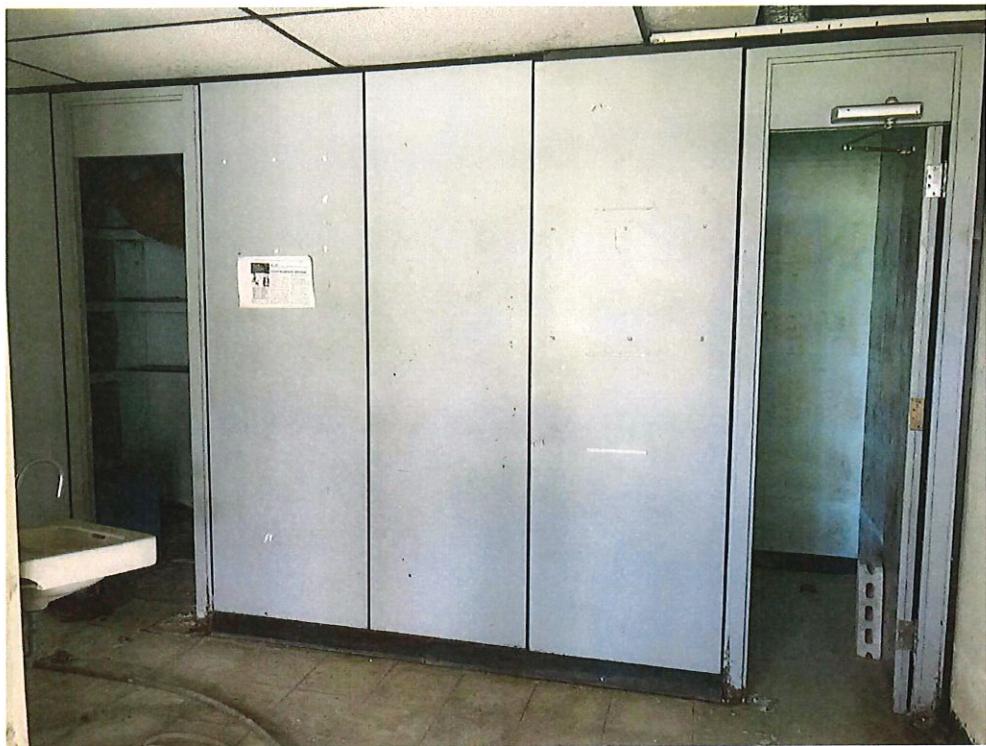
Photo Number 11 – Wall Interior "A" Clinical Dental

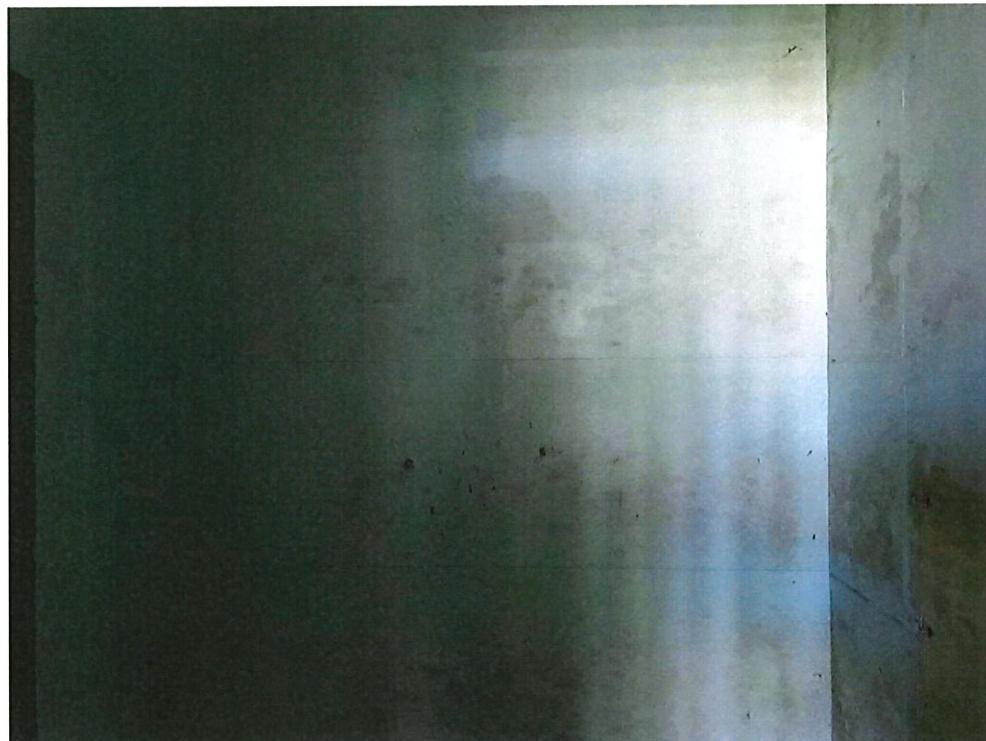
Photo Number 12 – Wall Interior "C" Dark Room at the X-Ray Room Area

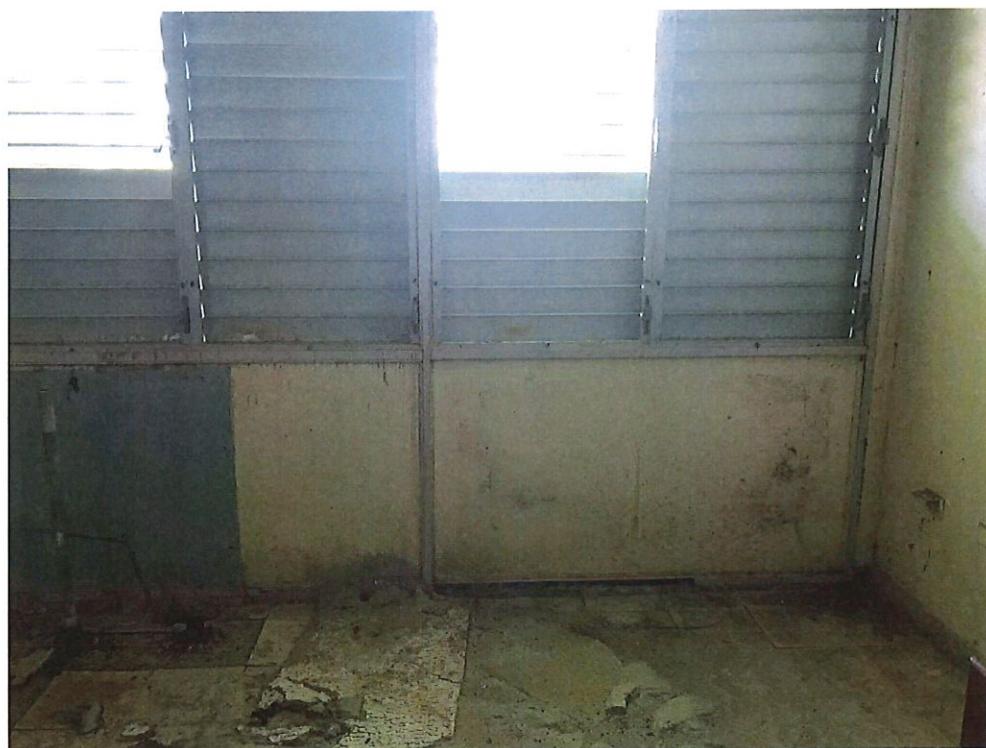
Photo Number 13 – Wall interior “D” Work Area

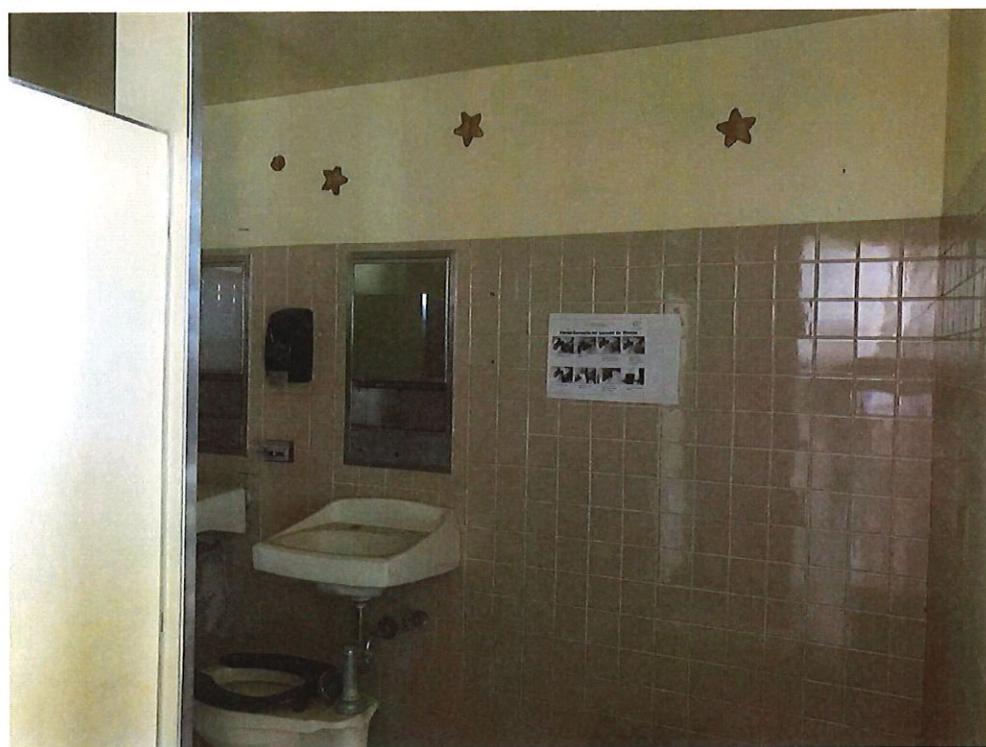
Photo Number 14 – Wall Interior Restrooms

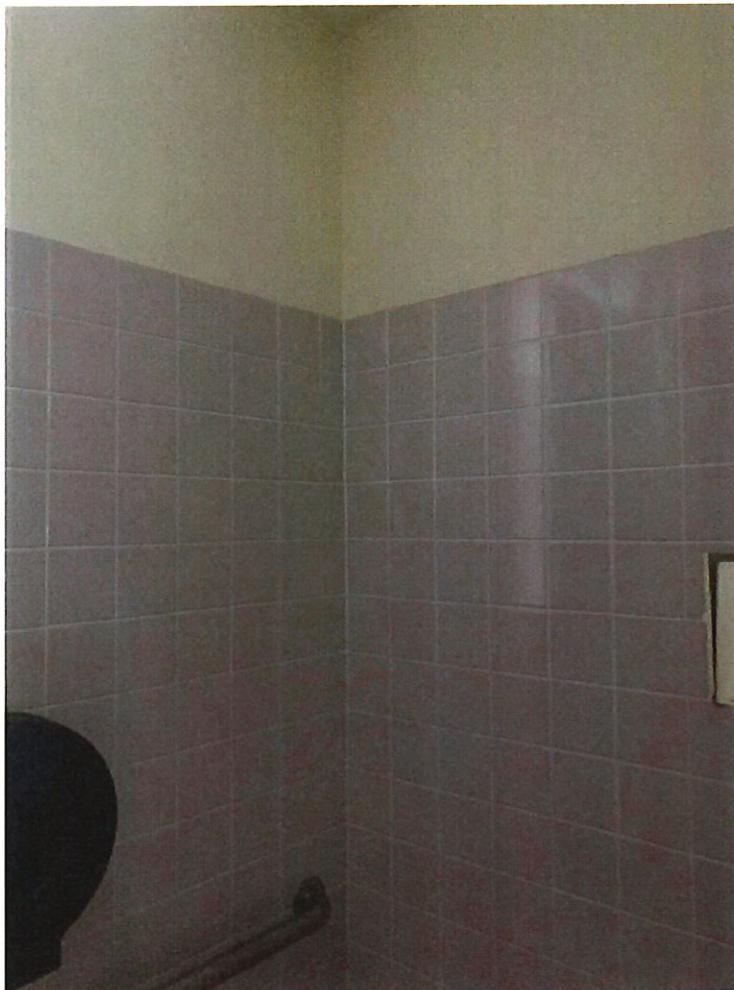
Photo Number 15 – Wall Interior Restrooms

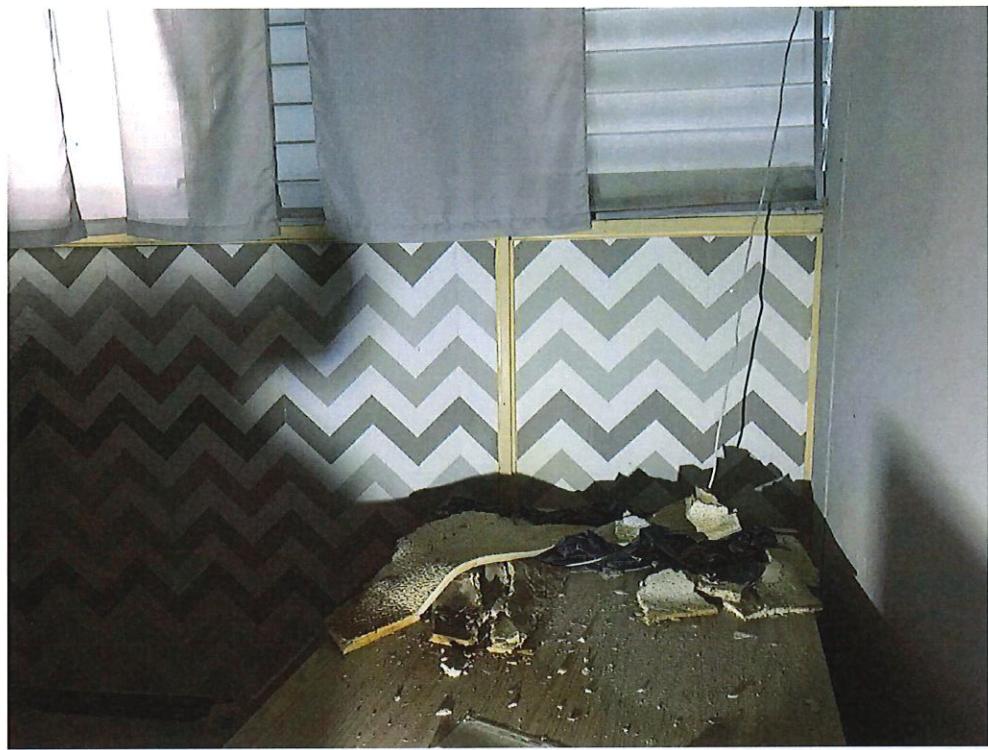
Photo Number 16 – Wall Interior “A” Exam & Treatment Room (83C)

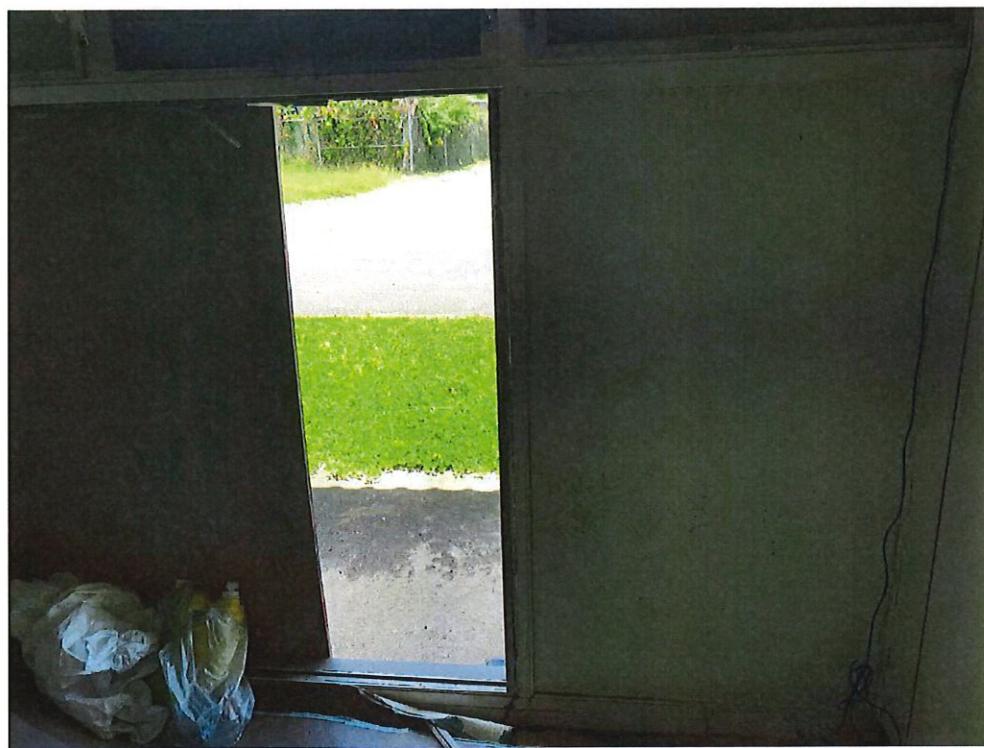
Photo Number 17 – Wall Interior “A” Exam & Treatment Room (71C)

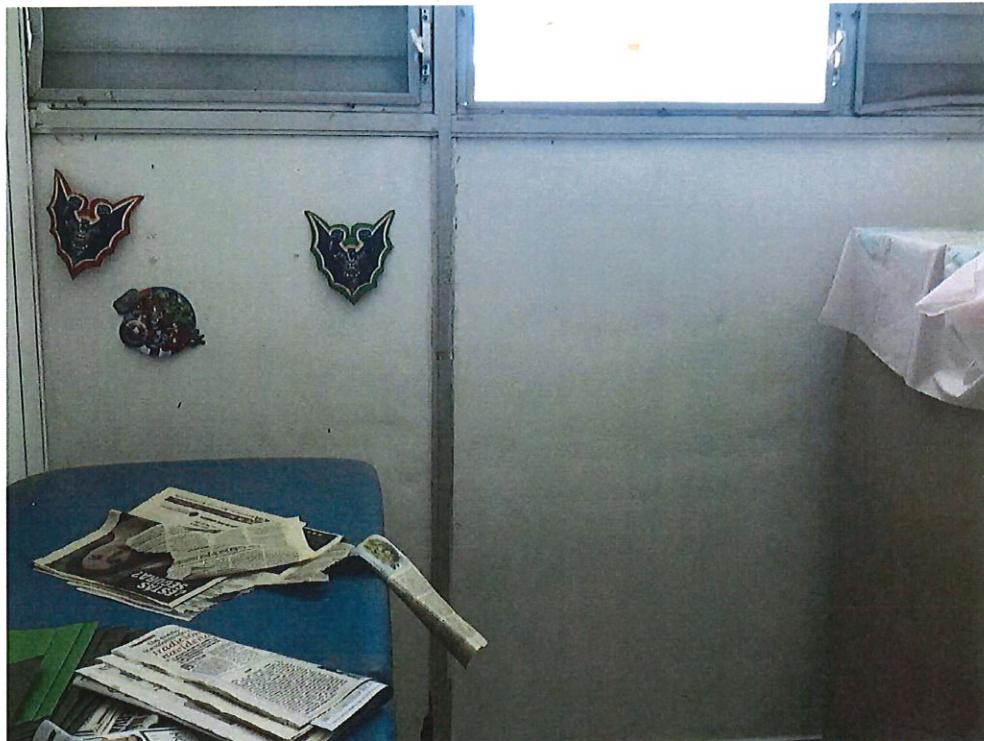
Photo Number 18 – Wall Interior “A” Exam & Treatment Room (70C)

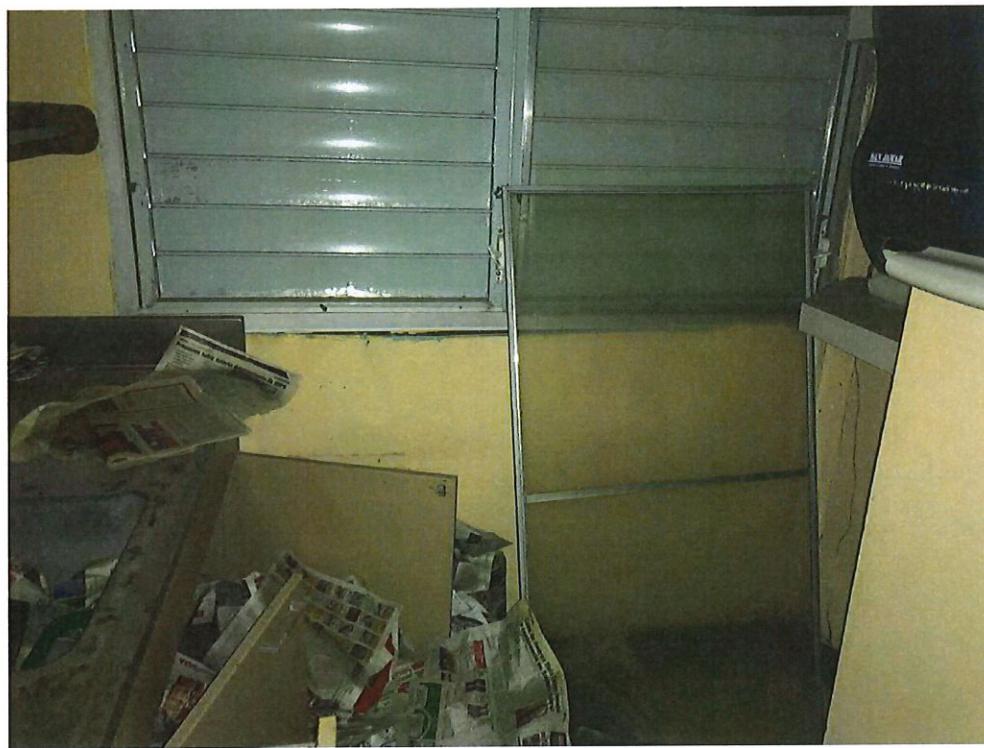
Photo Number 19 – Wall Interior “A” Clean Utility

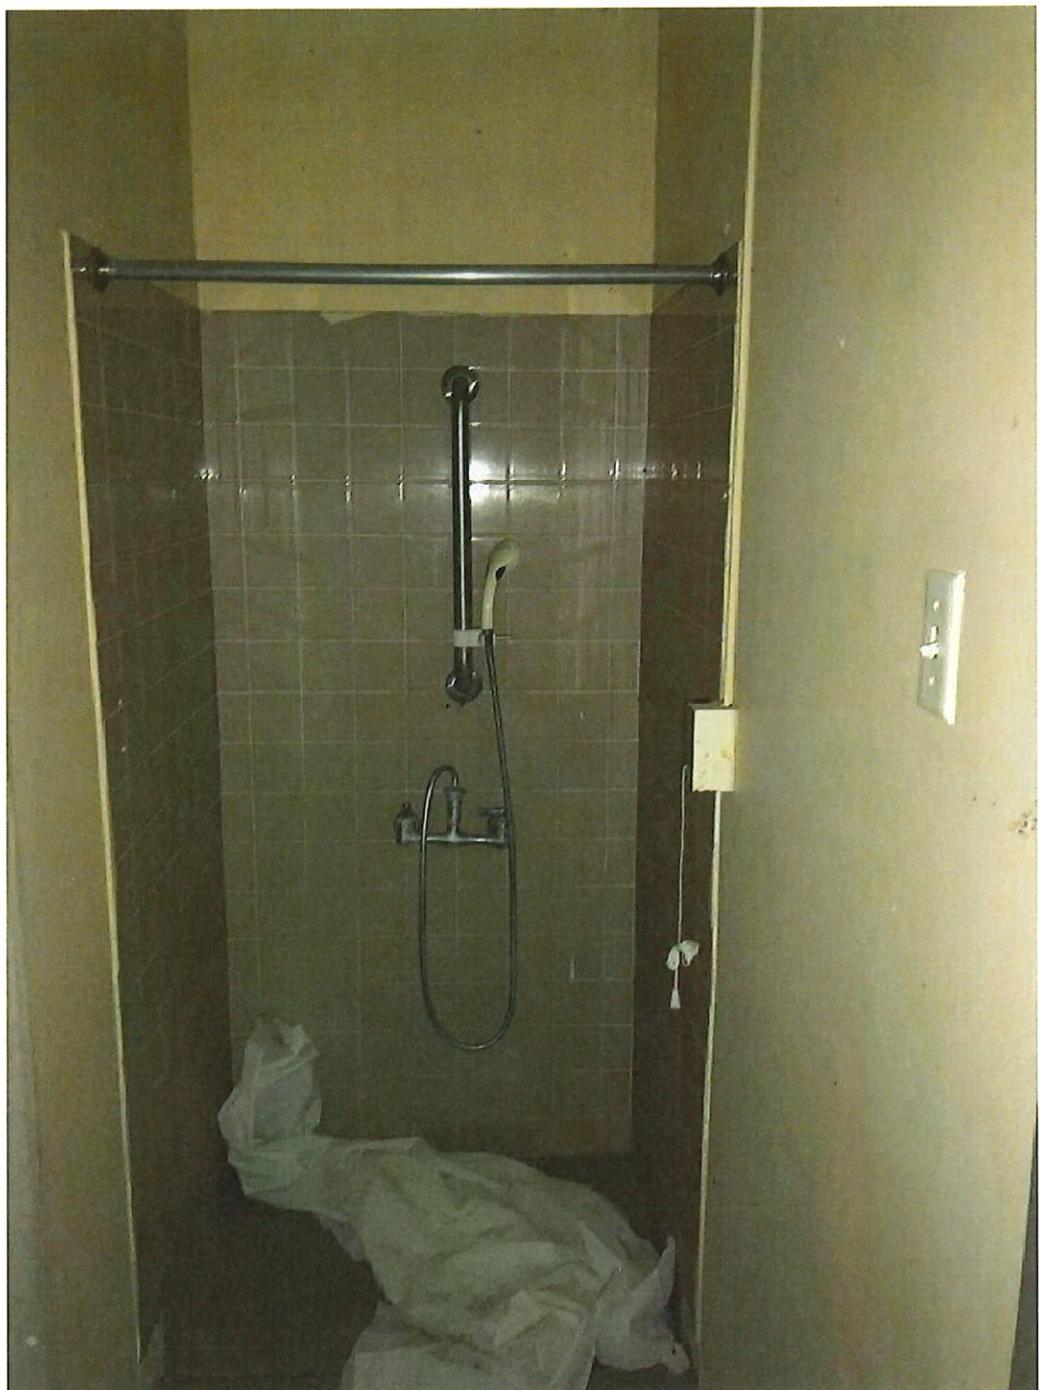
Photo Number 20 – Wall Interior Jan (Janitor) Room 58D

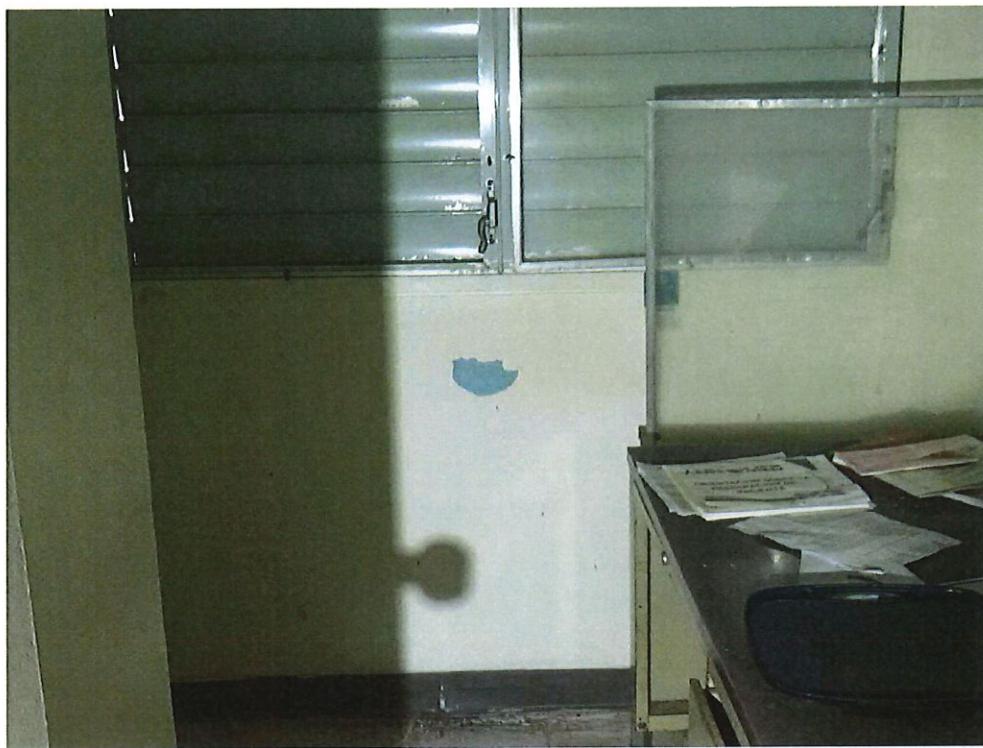
Photo Number 21 – Wall Interior “A” Soiled Utility

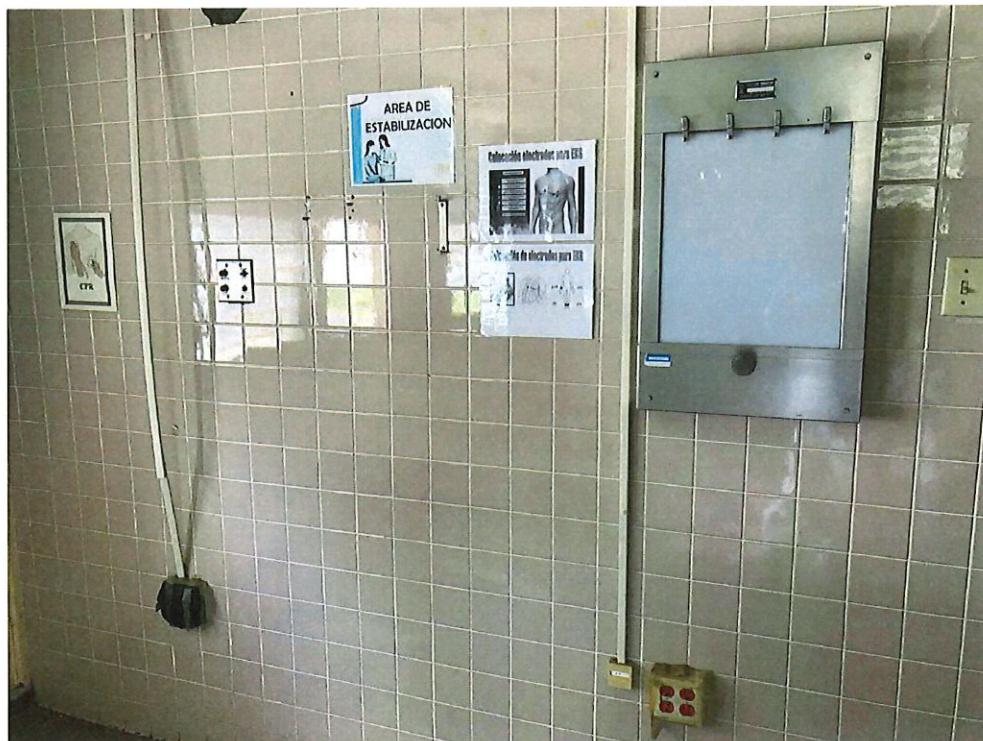
Photo Number 22 – Wall Interior Emergency Room

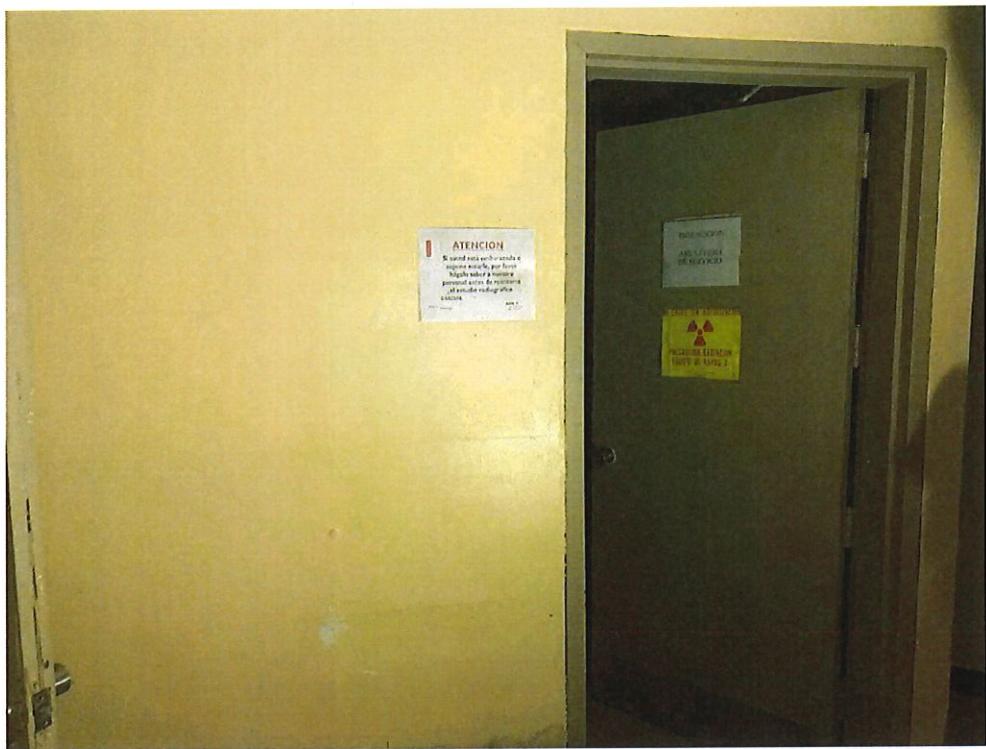
Photo Number 23 – Wall Interior “A” X-Ray Room

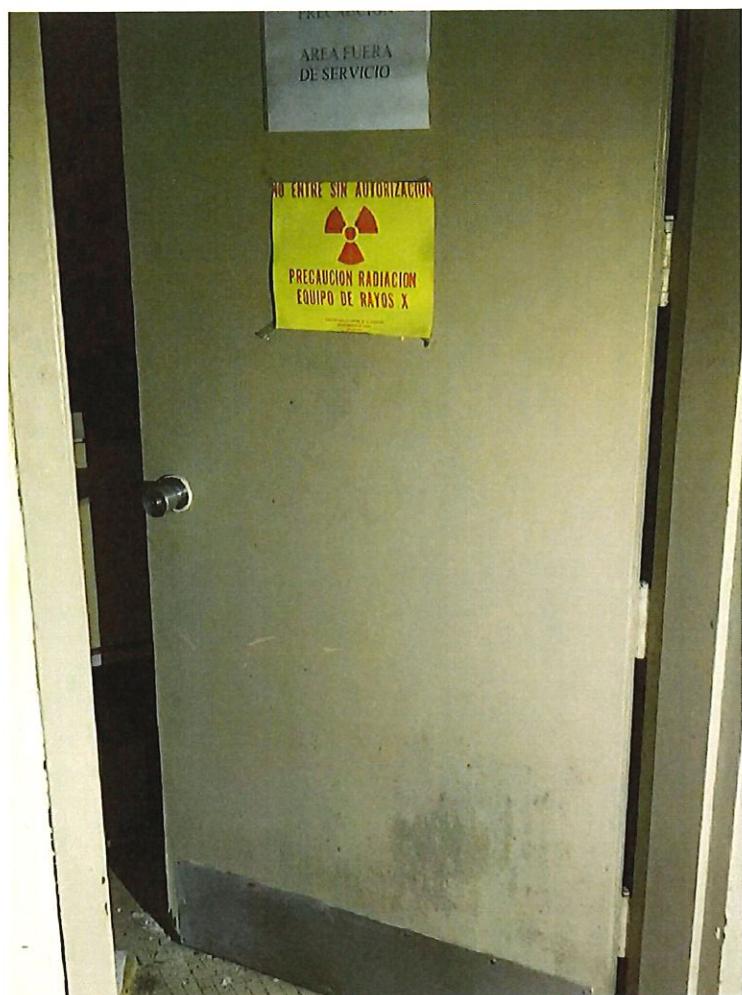
Photo Number 24 – Door Frame and Door Interior X-Ray Room

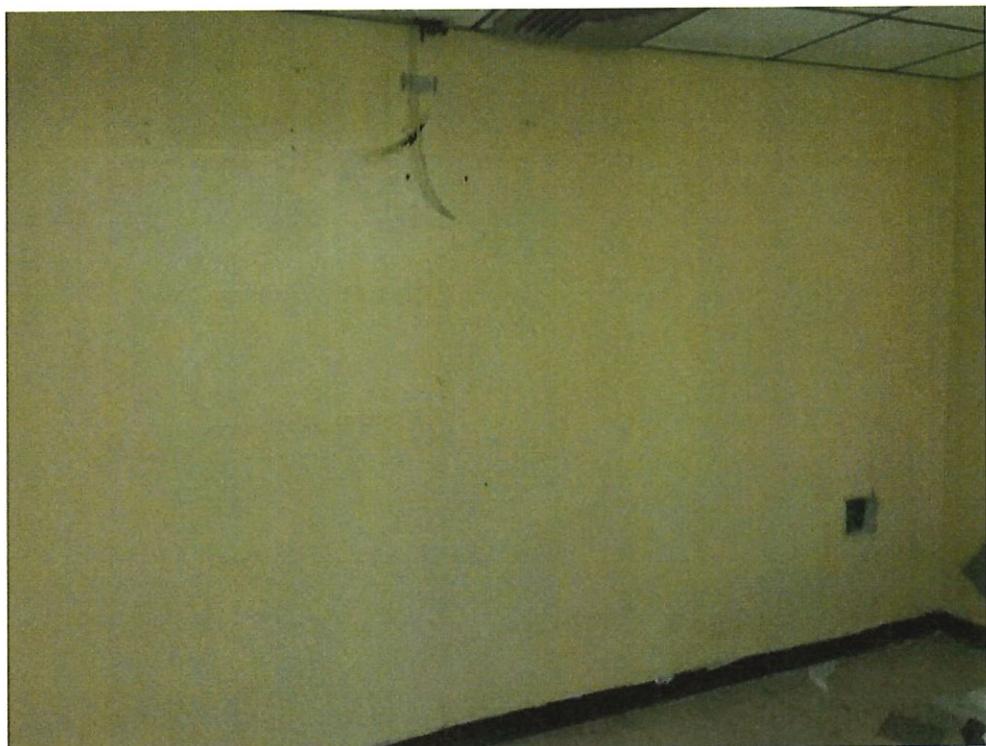
Photo Number 25 – Wall "B" Interior X-Ray Room

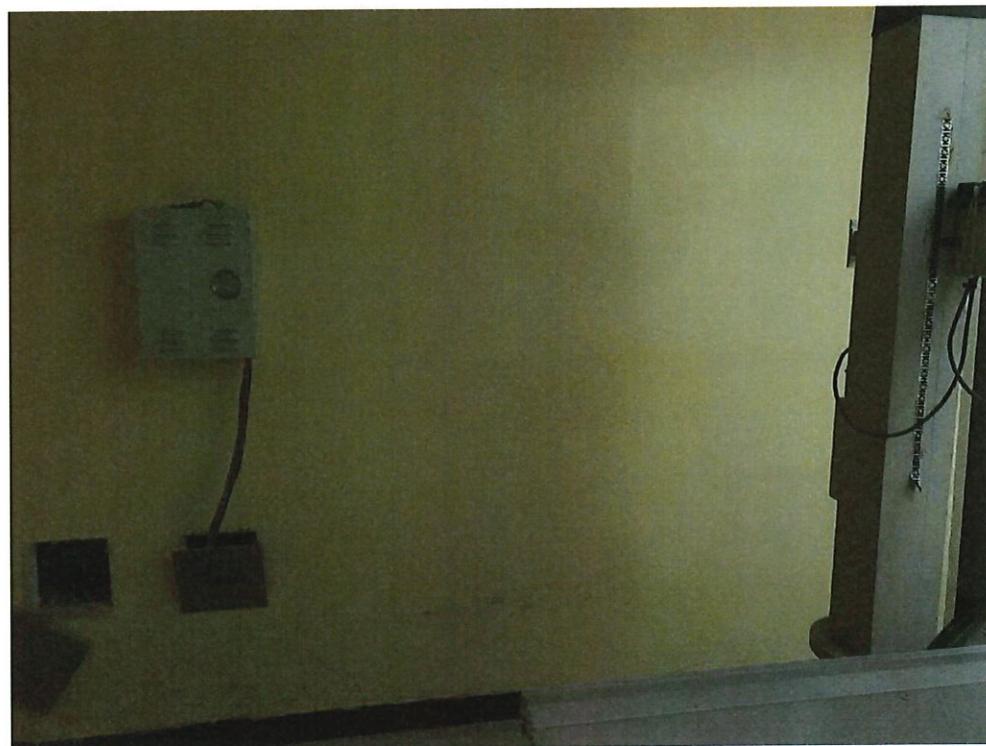
Photo Number 26 – Wall "D" Interior X-Ray Room

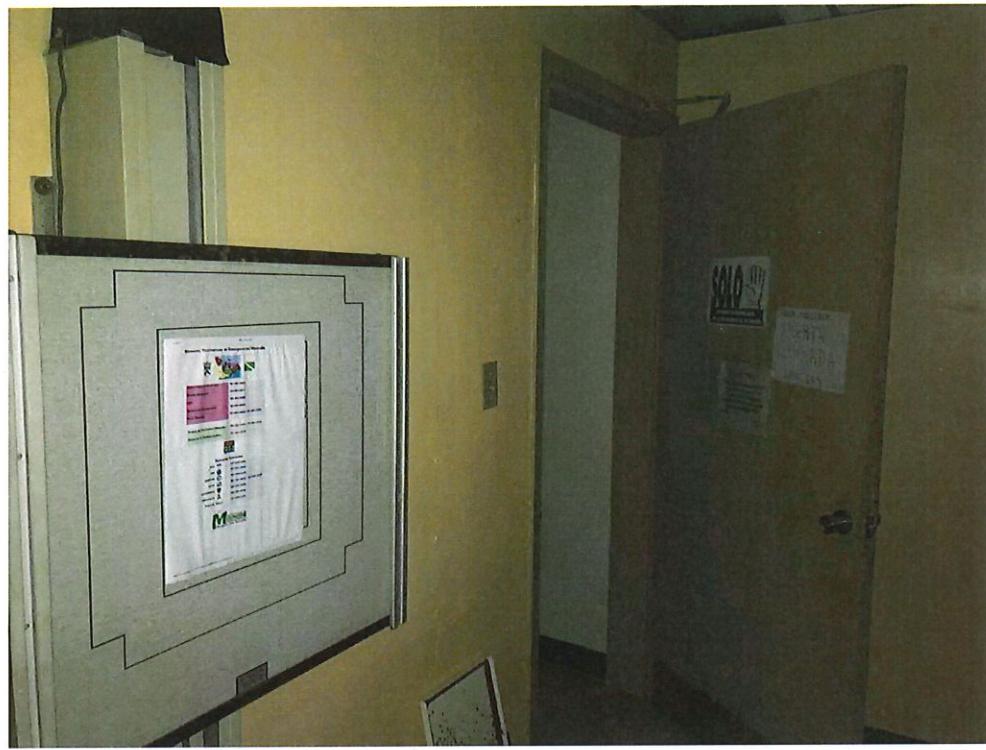
Photo Number 27 – Wall "C" Interior X-Ray Room

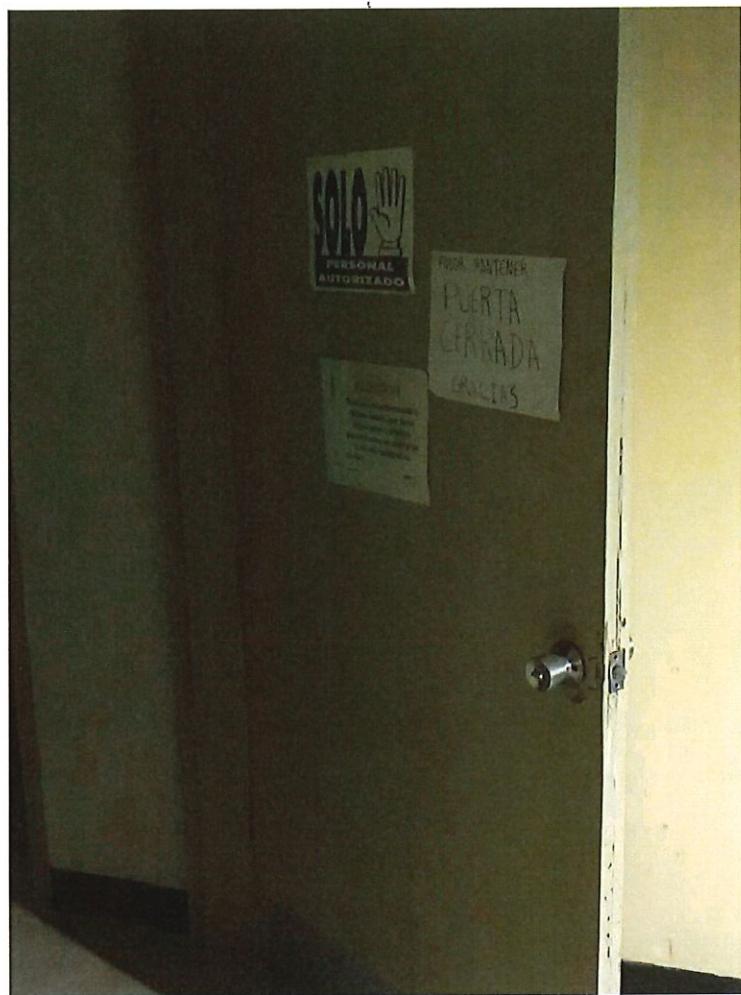
Photo Number 28 – Door Frame and Door Interior X-Ray Room

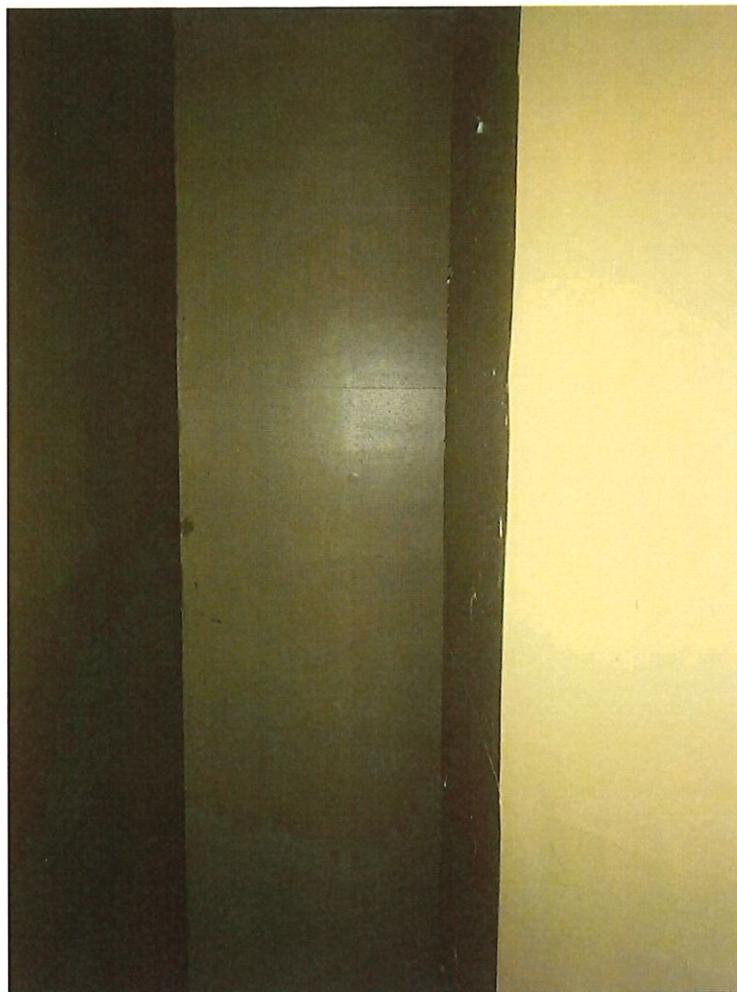
Photo Number 29 – Wall Interior Control X-Ray Room

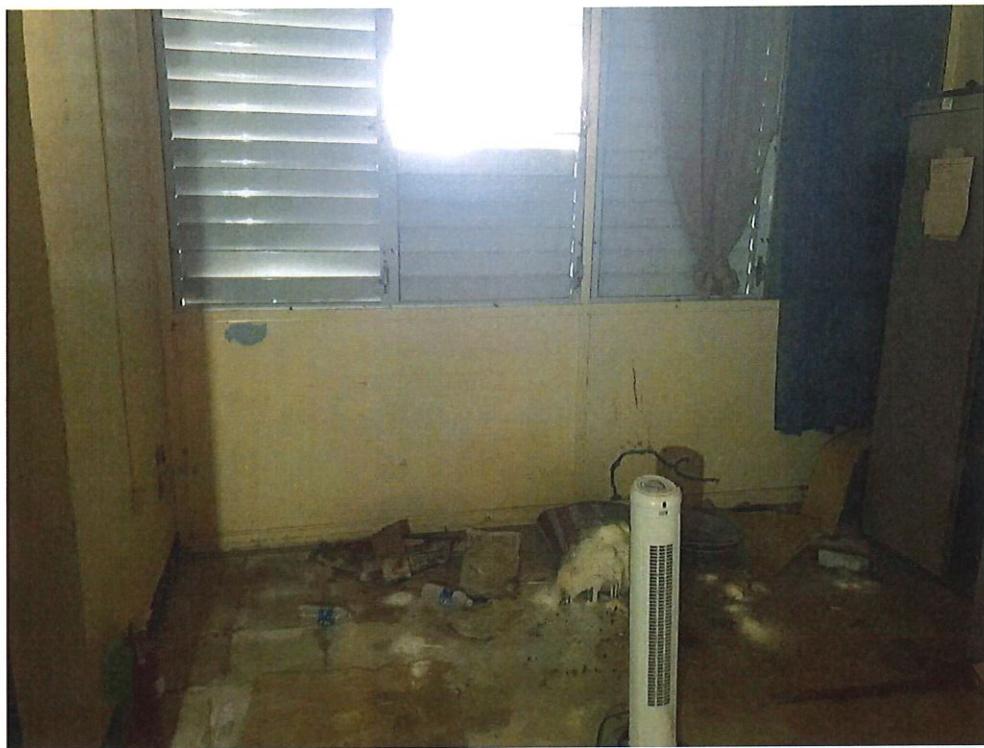
Photo Number 30 – Wall Interior “A” Soiled Linen

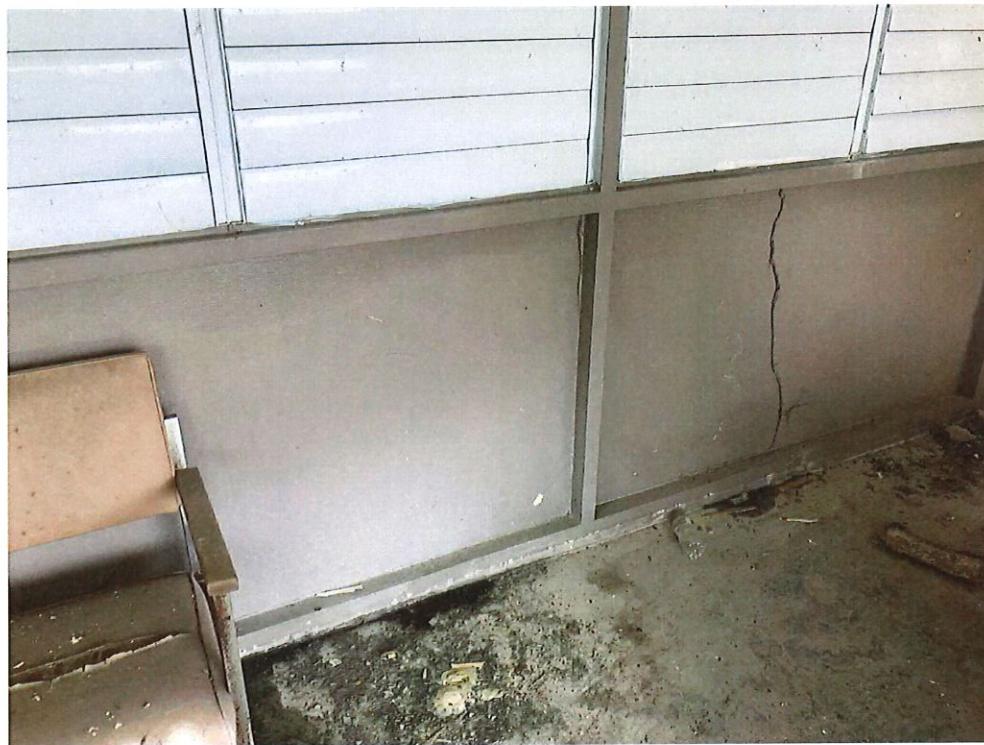
Photo Number 31 – Wall Interior “A” Loading Platform

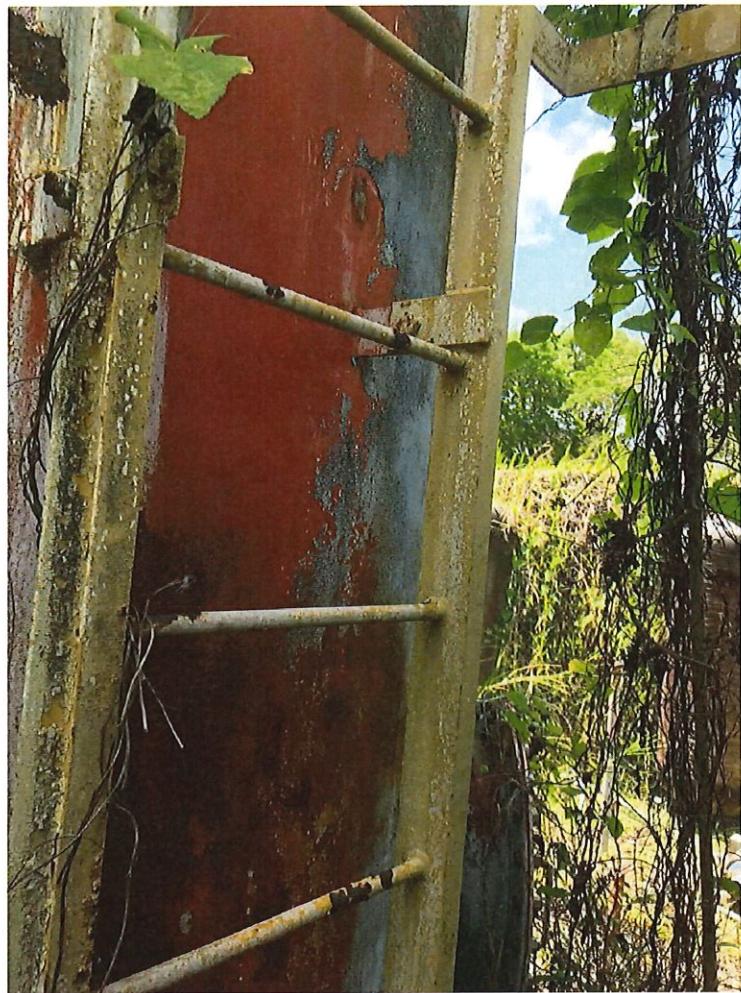
Photo Number 32 – Building Exterior Tank Stairs

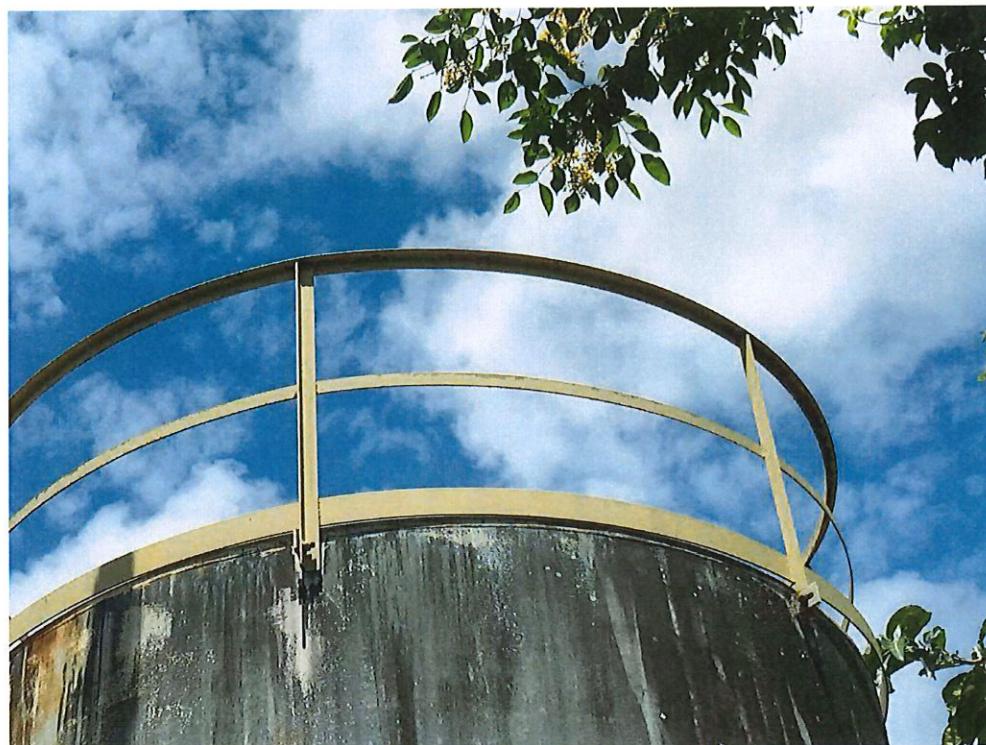
Photo Number 33 – Building Exterior Tank Handrail

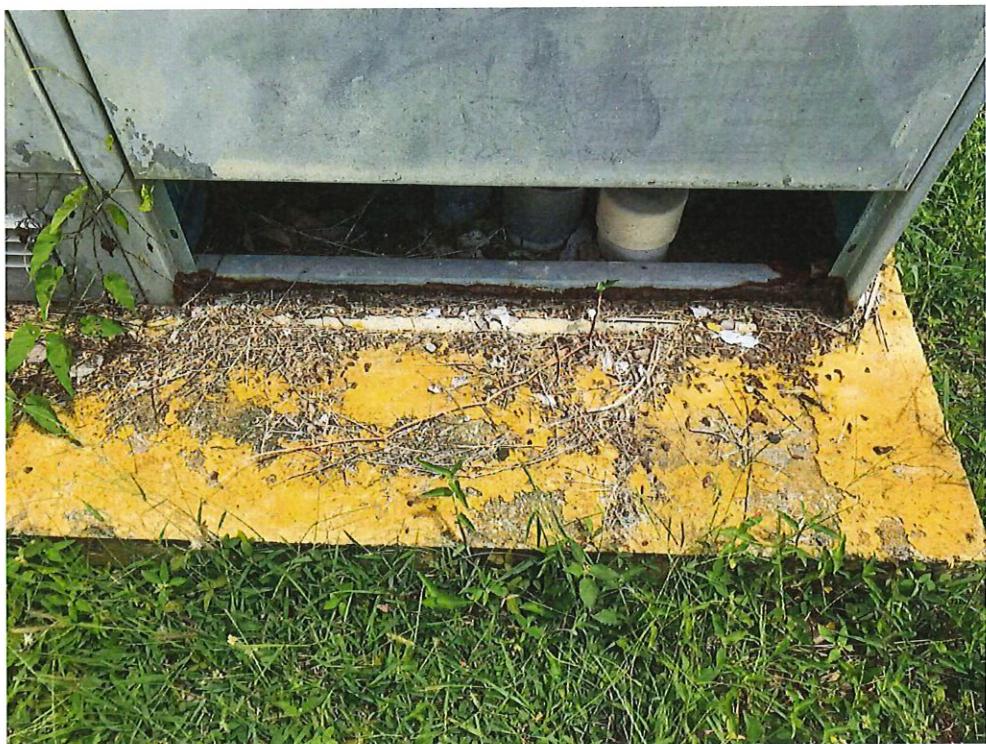
Photo Number 34 – Building Exterior Electric Transformer Slab

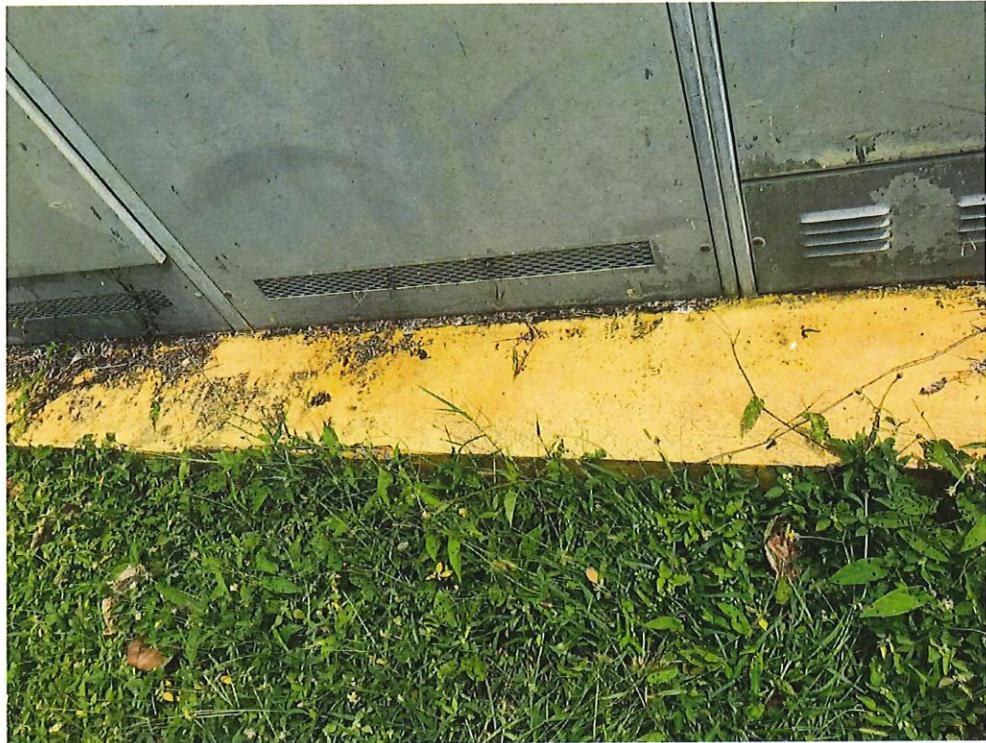
Photo Number 35 – Building Exterior Electric Transformer Slab
