LEAD BASED PAINT INSPECTION REPORT

CDT Maunabo

DEPARTAMENTO DE
SALUD

May 9, 2022

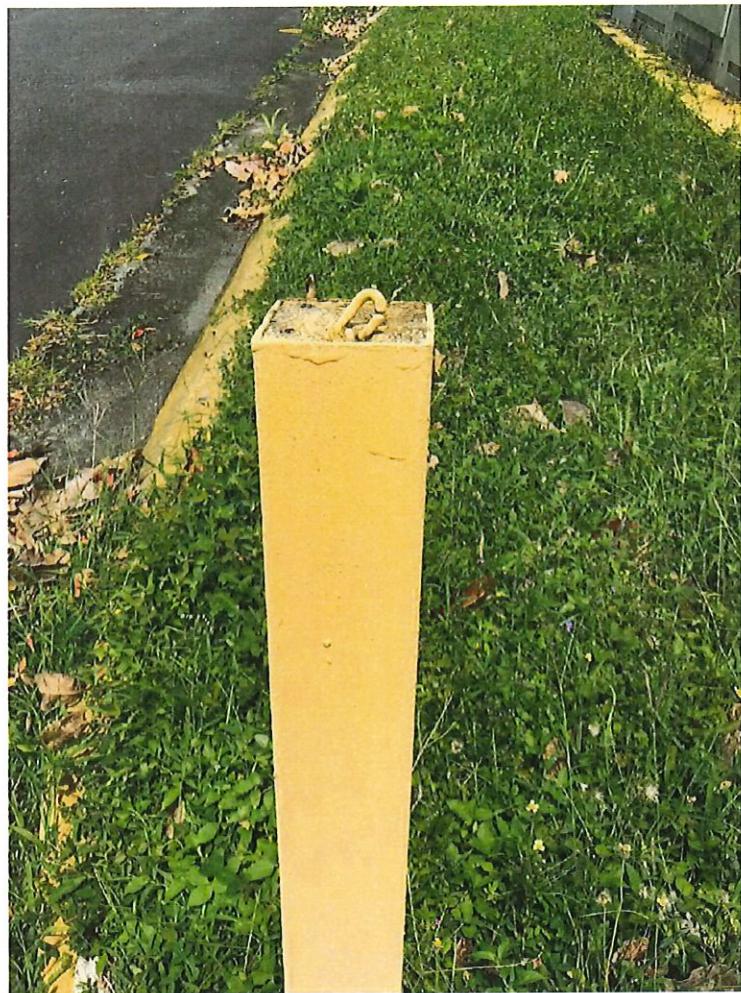
Photo Number 36 – Building Exterior Parking Bollard

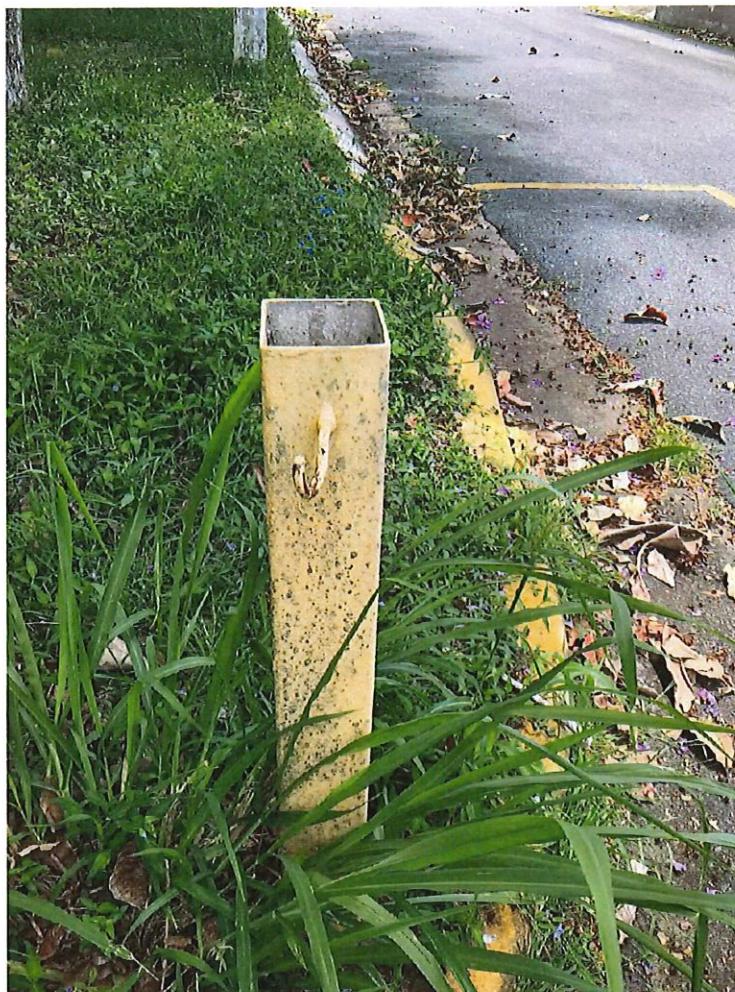
Photo Number 37 – Building Exterior Parking Bollard
