**SUBASTA FORMAL 22J-11066  
PARA LA ADQUISICIÓN DE SERVICIOS DE REPARACIÓN GENERAL DE LA  
INFRAESTRUCTURA DEL CENTRO SARAFS EN BAYAMÓN, ADSCRITO AL  
DEPARTAMENTO DE SALUD DEL GOBIERNO DE PUERTO RICO**

# LEAD BASED PAINT INSPECTION REPORT

SAMPLING CONDUCTED AT  
SARAFS, HEALTH DEPARTMENT FACILITIES  
BAYAMÓN, PUERTO RICO

ZEM-21215

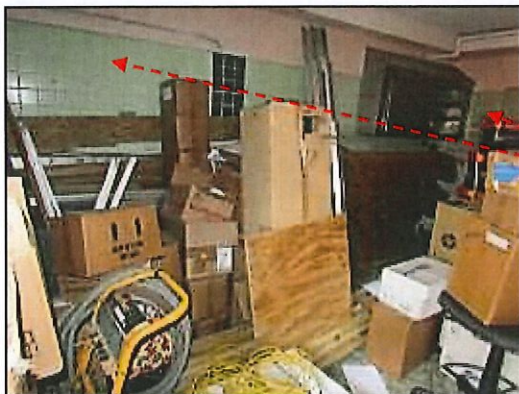
**1<sup>st</sup> Floor - Storage Room**  
Lead containing ceramic wall tiles.

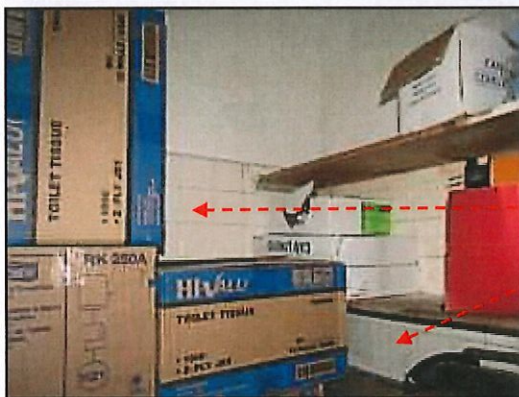
**2<sup>nd</sup> Floor - Storage Room 1**  
Lead containing ceramic wall tiles.

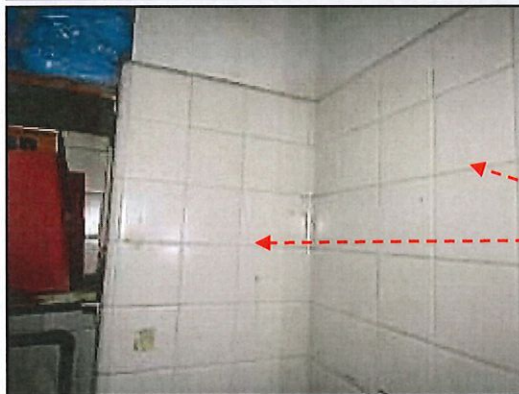
**2<sup>nd</sup> Floor - Storage Room 1**  
Lead containing ceramic wall tiles.

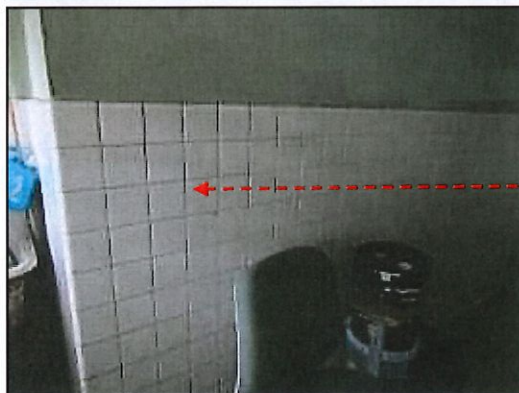
**2<sup>nd</sup> Floor - Janitor**  
Lead containing ceramic wall tiles.

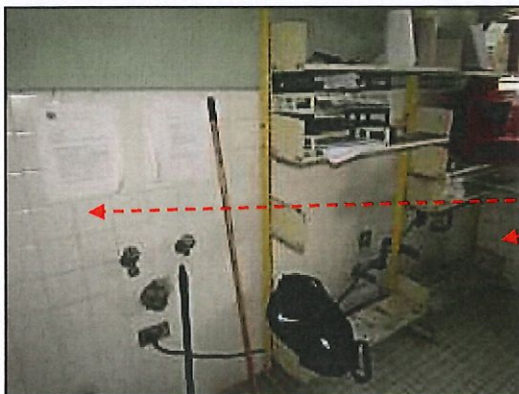
**2<sup>nd</sup> Floor - Janitor**

Lead containing ceramic wall tiles.
