**NOTIFICACIÓN NÚM. 1**

**SUBASTA FORMAL 22J-04684  
PARA LA ADQUISICIÓN DE SERVICIOS DE REPARACIÓN GENERAL DE LA  
INFRAESTRUCTURA DEL CDT DE LAJAS, ADSCRITO AL DEPARTAMENTO DE  
SALUD DEL GOBIERNO DE PUERTO RICO**

**Asunto: Fotos CDT de Lajas**

<b>SITE INSPECTION PHOTO PAGE</b>		<b>DISASTER:</b> DR4339PR		<b>APPLICANT (FIPS#):</b> 000-U40VB-00	
<b>INSPECTION DATE:</b> 4 Dec 2018	<b>WORK ORDER #:</b> 27905	<b>CATEGORY:</b> E	<b>COUNTY:</b> Lajas	<b>APPLICANT ADDRESS:</b> Lajas Center for Diagnostics & Treatment (CDT)	
<b>SITE INSPECTOR(S):</b> Steven Curtis, Juan Nomora, Mike Davis			<b>DAMAGE # / DAMAGE NAME:</b> 151665/CDT Lajas		<b>GPS COORDINATES:</b> 18.03927 -67.05563

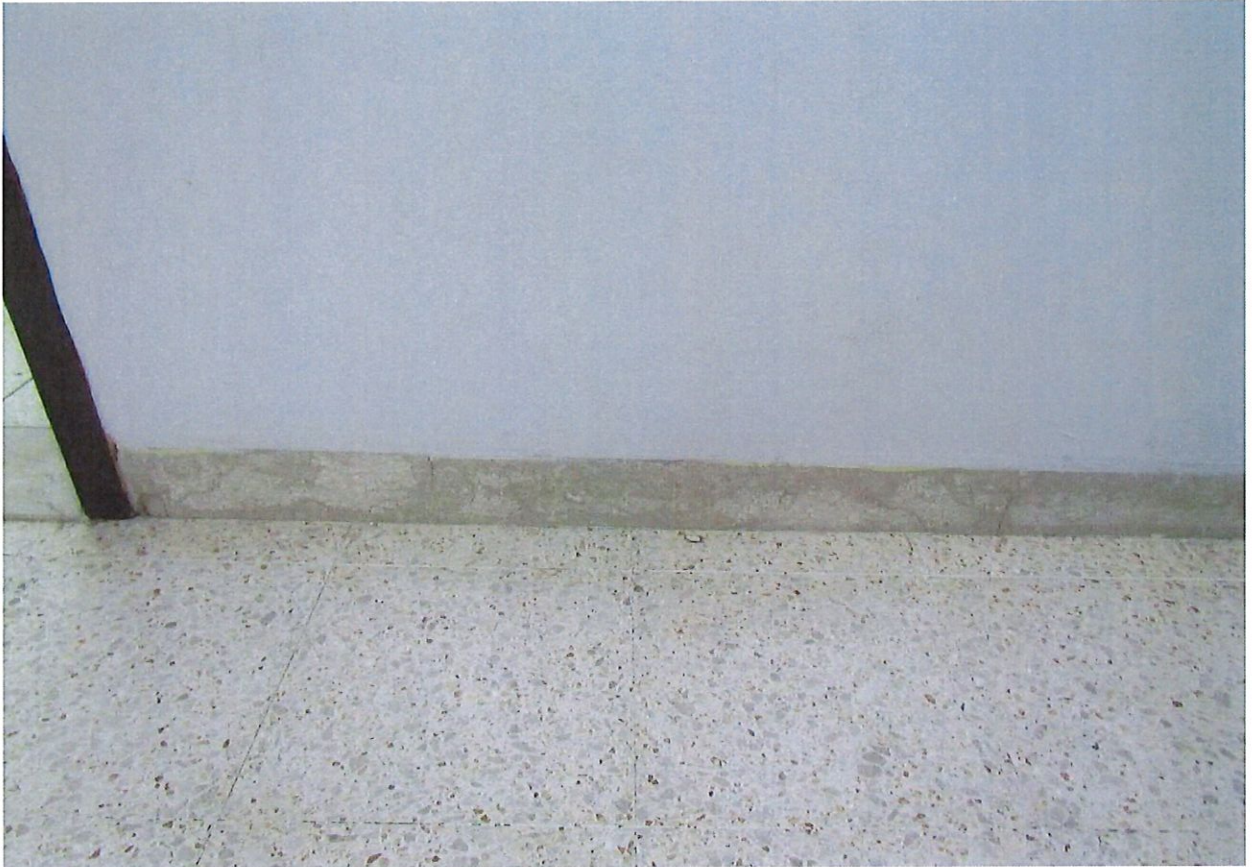
Item 8 en Tabla de Cotizar: 60 LF Flooring demolition, vinyl or rubber cove base, straight section. Install; wall base, rubber, straight or cove, standard colors, 4" high, 1/8" thick (60 pies lineales de zócalos).

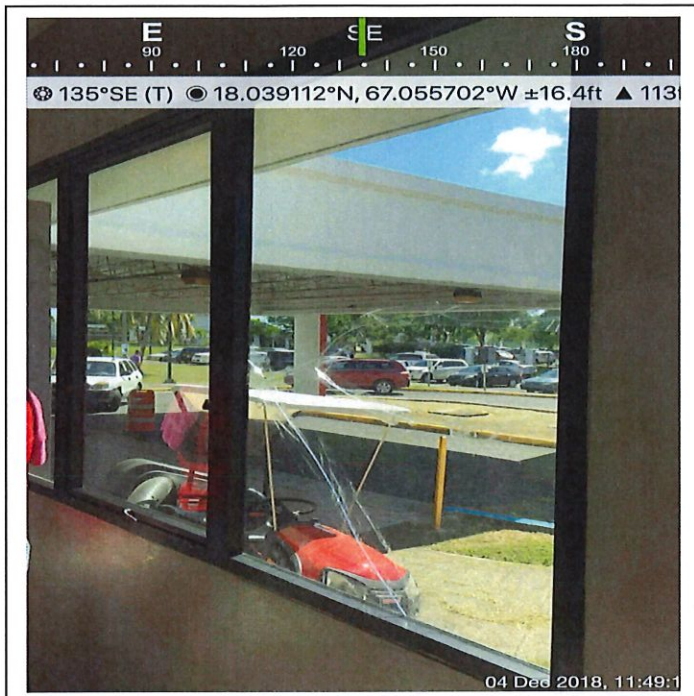
Lajas (CDT) front waiting room single pane uninsulated slight tint aluminum fram glass window. Temporary tape fix.

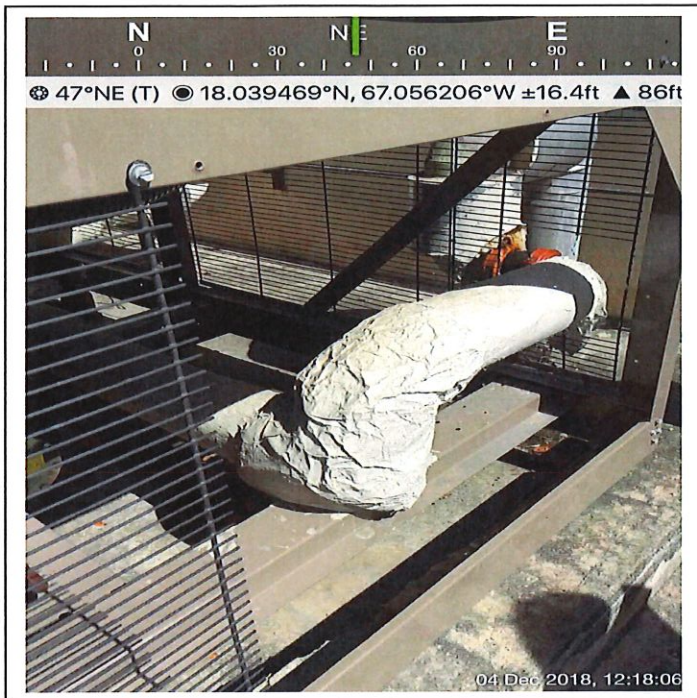
Lajas (CDT) chiller pipe insulation damage

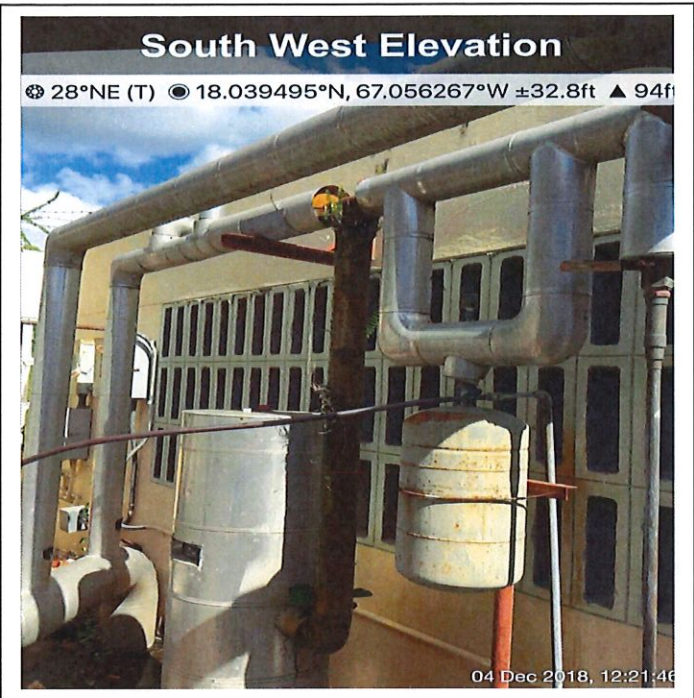
Lajas (CDT) chiller pipe insulation condition none disaster related

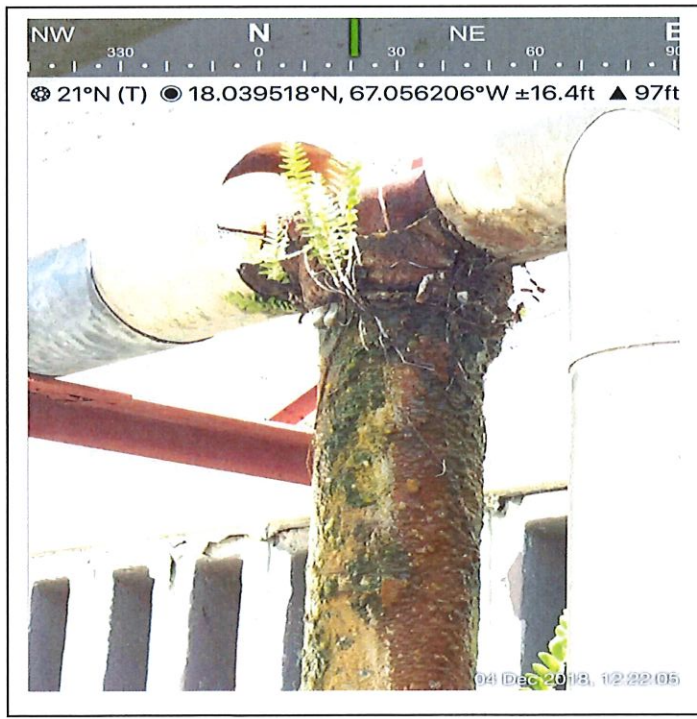
Lajas (CDT) chiller pipe insulation condition none disaster related

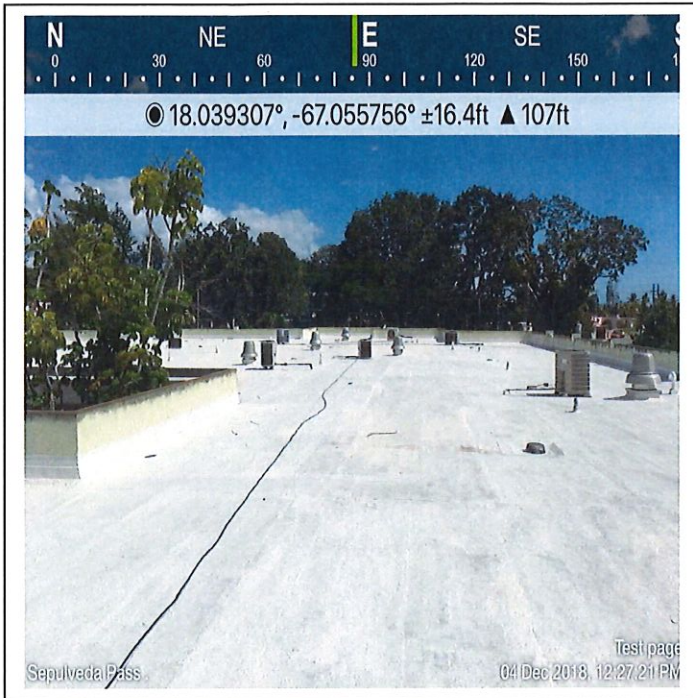
Lajas (CDT) roof temporary repair w/ insulation

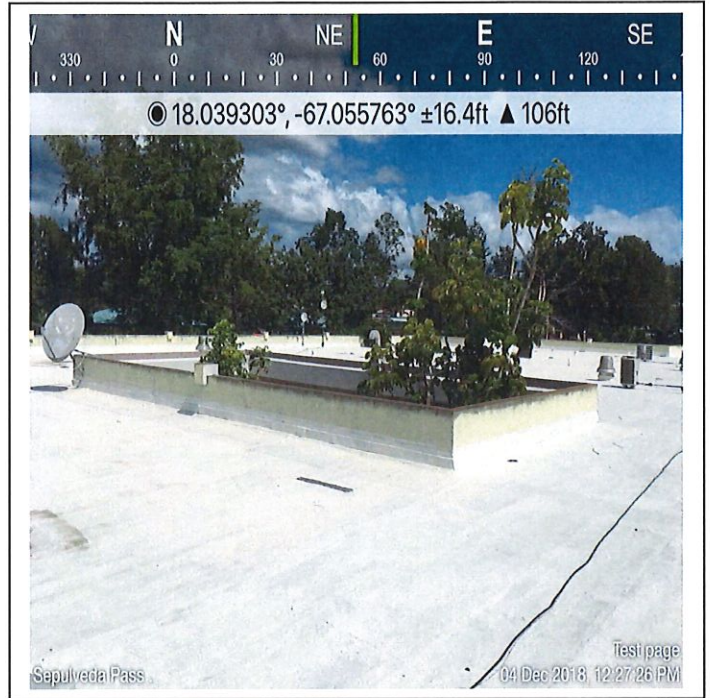
Lajas (CDT) roof temporary repair w/ insulation

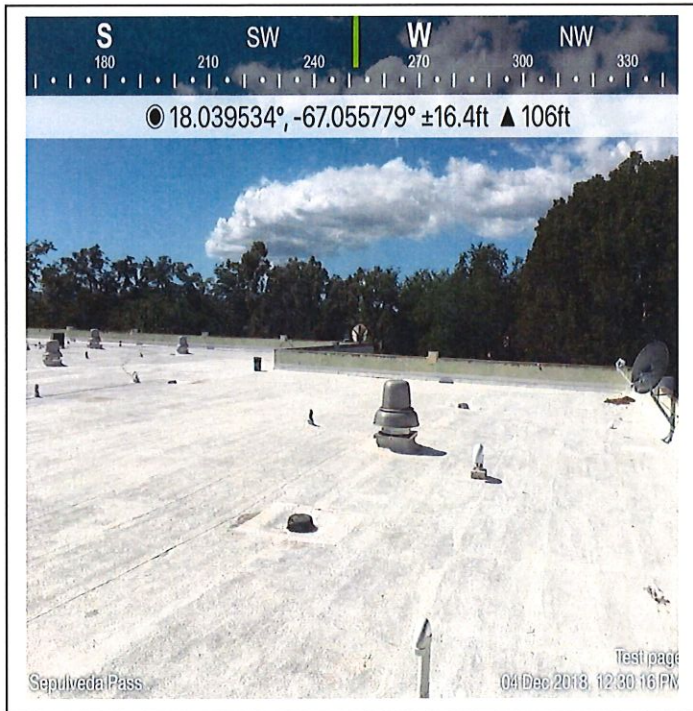
Lajas (CDT) roof temporary repair w/ insulation

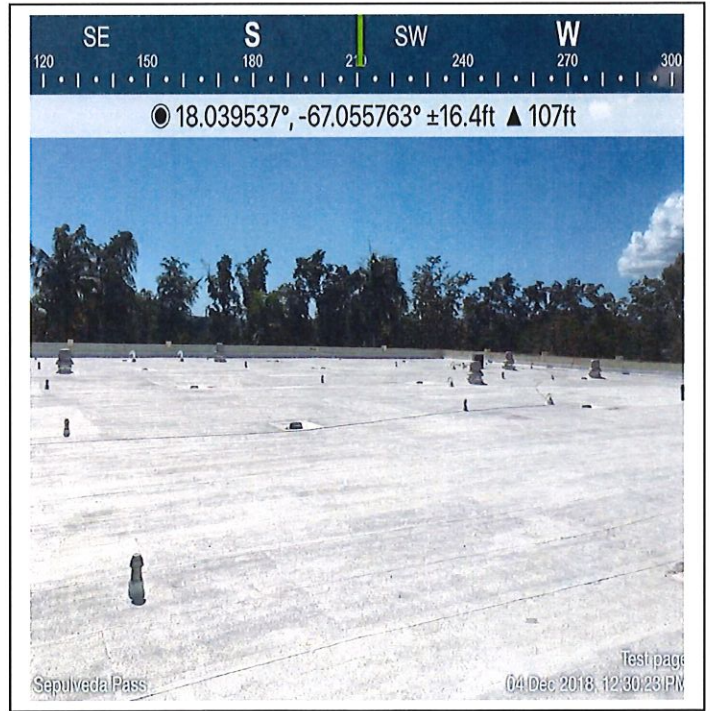
Lajas (CDT) roof temporary repair w/ insulation

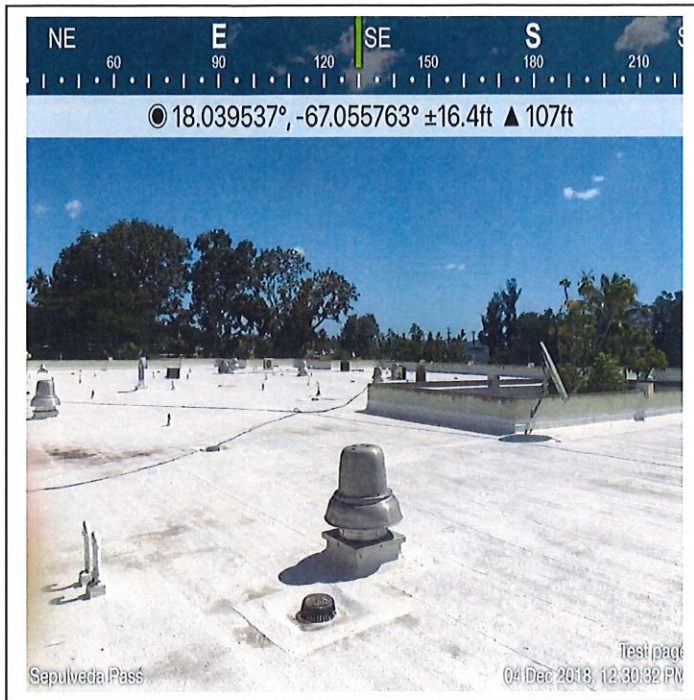
Lajas (CDT) roof temporary repair w/ insulation

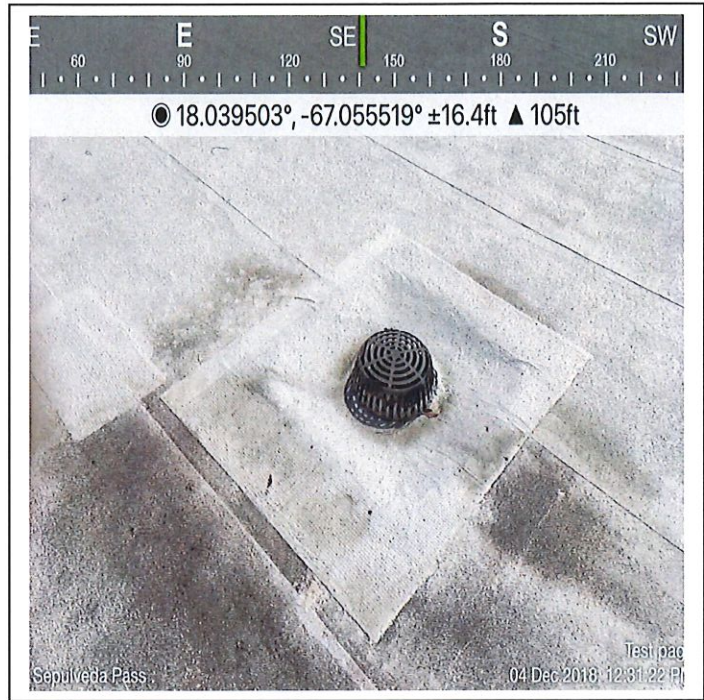
Lajas (CDT) roof temporary repair w/ insulation, roof drainage

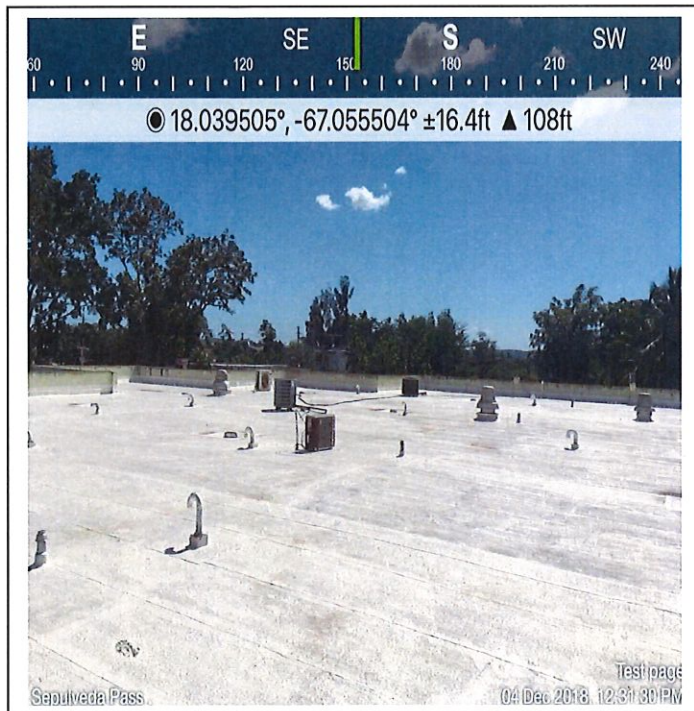
Lajas (CDT) roof temporary repair w/ insulation

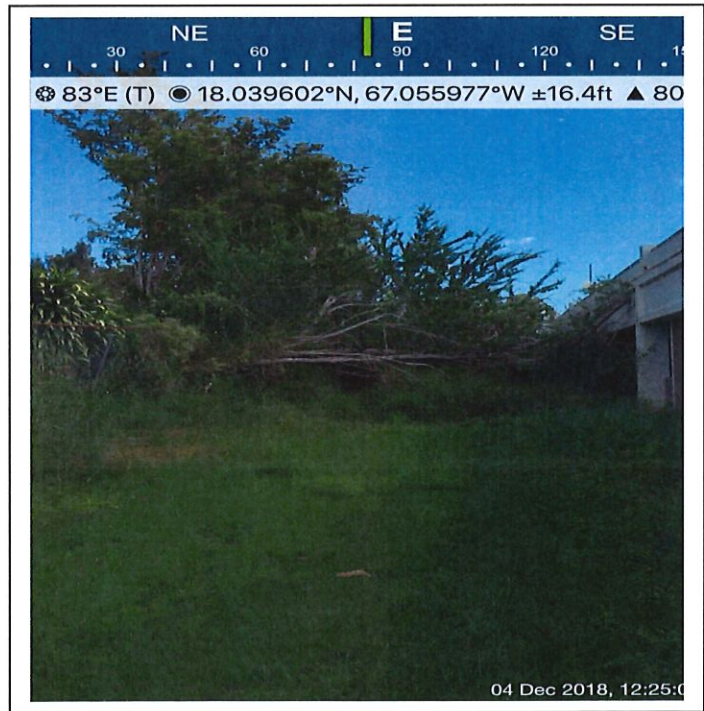
Lajas (CDT) trees from municipality side of back of facility fence has grown through, not disaster related damage

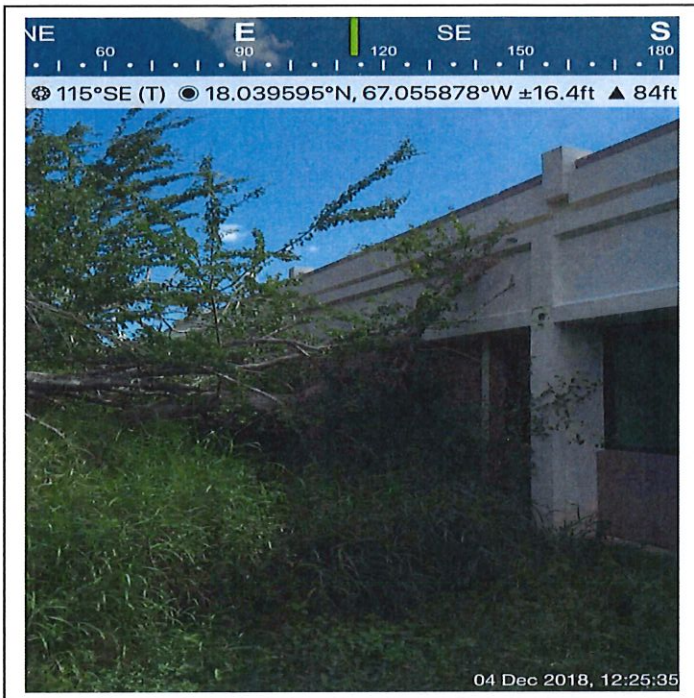
Lajas (CDT) trees from municipality side of back of facility fence has grown through, not disaster related damage to building

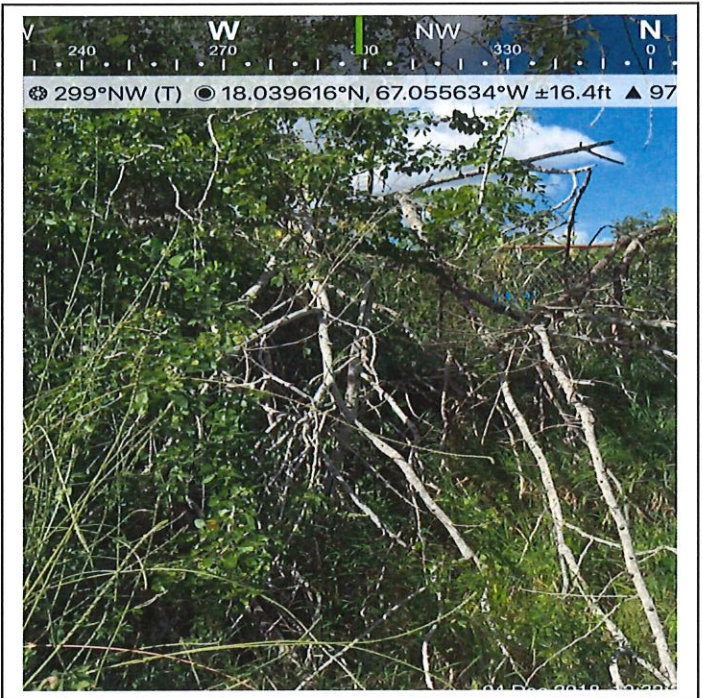
Lajas (CDT) trees from municipality side of back of facility fence has grown through, not disaster related damage

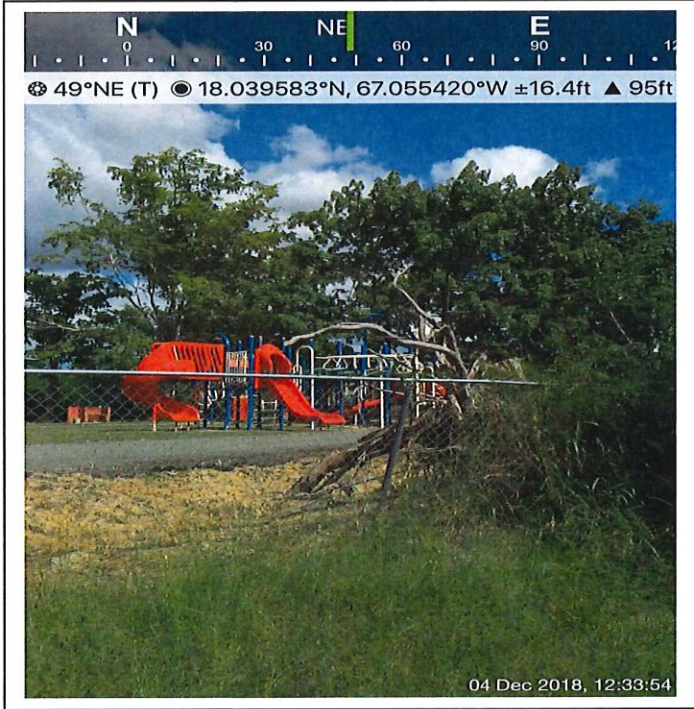
Lajas (CDT) trees from municipality side of back of facility fence has grown through, not disaster related damage
