## ENMIENDA NÚMERO 2

### SUBASTA FORMAL 22J-08291

**IMPERMEABILIZACIÓN DE TECHO EN EL EDIFICIO T-0953-0-70 LOCALIZADO EN EL MUNICIPIO DE GURABO, PERTENECIENTE A LA COMPAÑÍA DE FOMENTO INDUSTRIAL ADSCRITO AL DEPARTAMENTO DE DESARROLLO ECONÓMICO Y COMERCIO DEL GOBIERNO DE PUERTO RICO**

## **Asbestos Containing Materials Inspection**

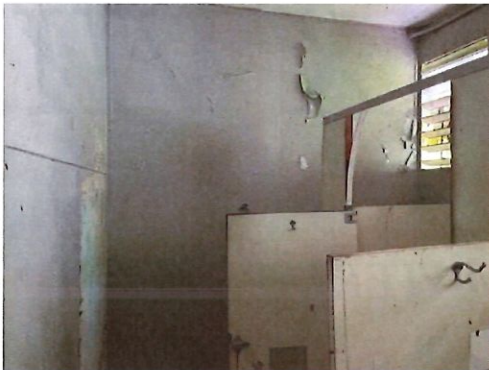
| MATERIAL | FUNCTIONAL SPACE | % WITH ASBESTOS | QUANTITY |
|---|---|---|---|
| Wall Panel | Bathroom #1 & Bathroom 2 | 15% Chrysotile | <b>120 sq.ft. approx.</b> |

Wall Panel with Asbestos

Global Environmental Services LLC recommends the owner or representative of the owner to hire a Certified Company by Department of Natural and Environmental Resources of Puerto Rico to removal and dispose positive area with Asbestos Containing Material if is going to touch, remodeling or demolish the reference building.

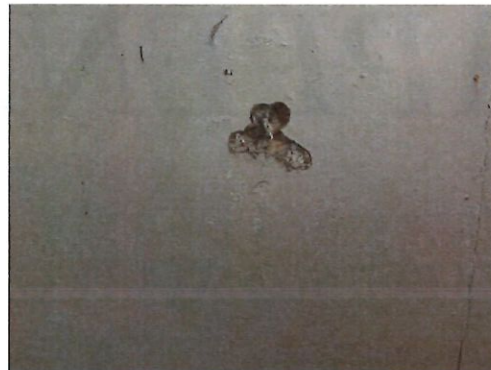
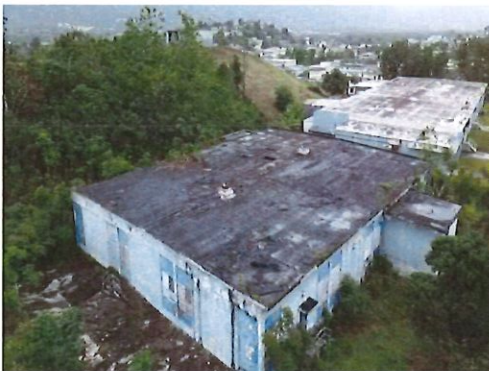
| MATERIAL | FUNCTIONAL SPACE | % WITH ASBESTOS | QUANTITY |
|---|---|---|---|
| Roofing Material | Roof area | 3% Chrysotile | <b>14,880 sq.ft. approx.</b> |

Roofing Materials with Asbestos
