ASBESTOS CONTAINING MATERIALS INSPECTION REPORT

CDT Maunabo

DEPARTAMENTO DE
SALUD

May 9, 2022

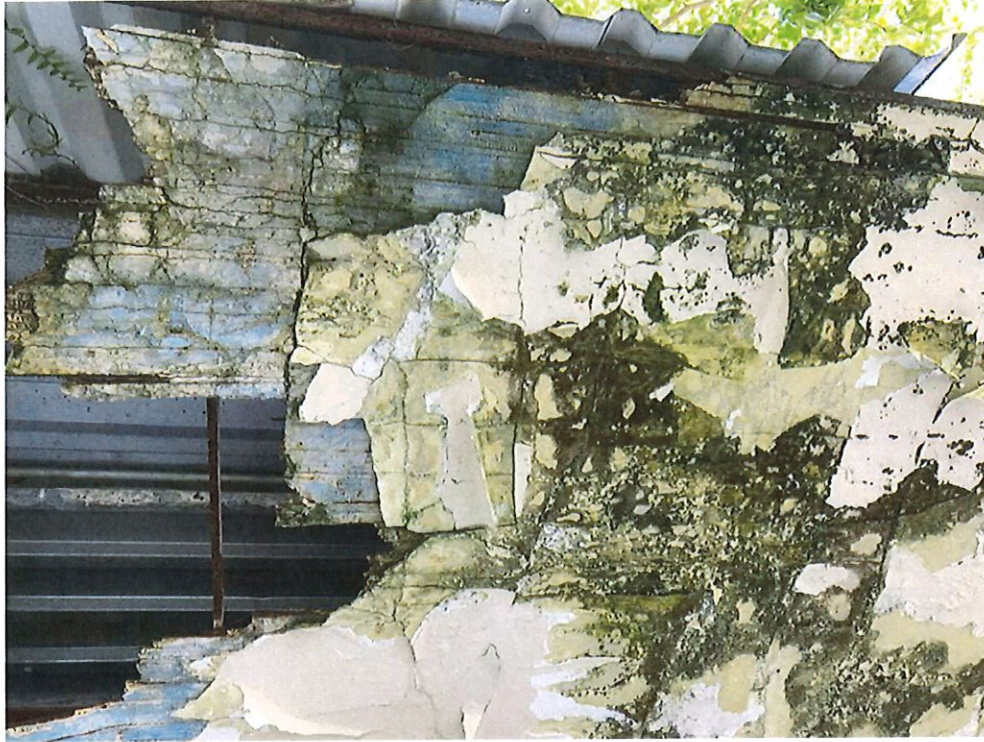
Photo Number 1 – Alero Building exterior, Wall “B”

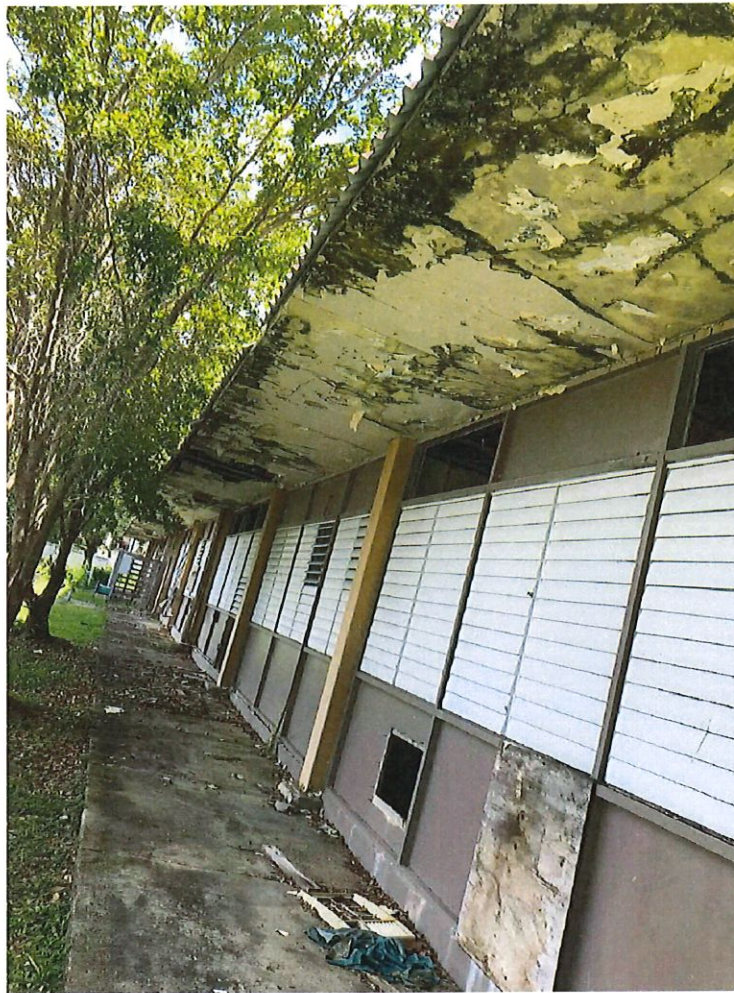
Photo Number 2 – Alero Building Exterior, Wall “C”

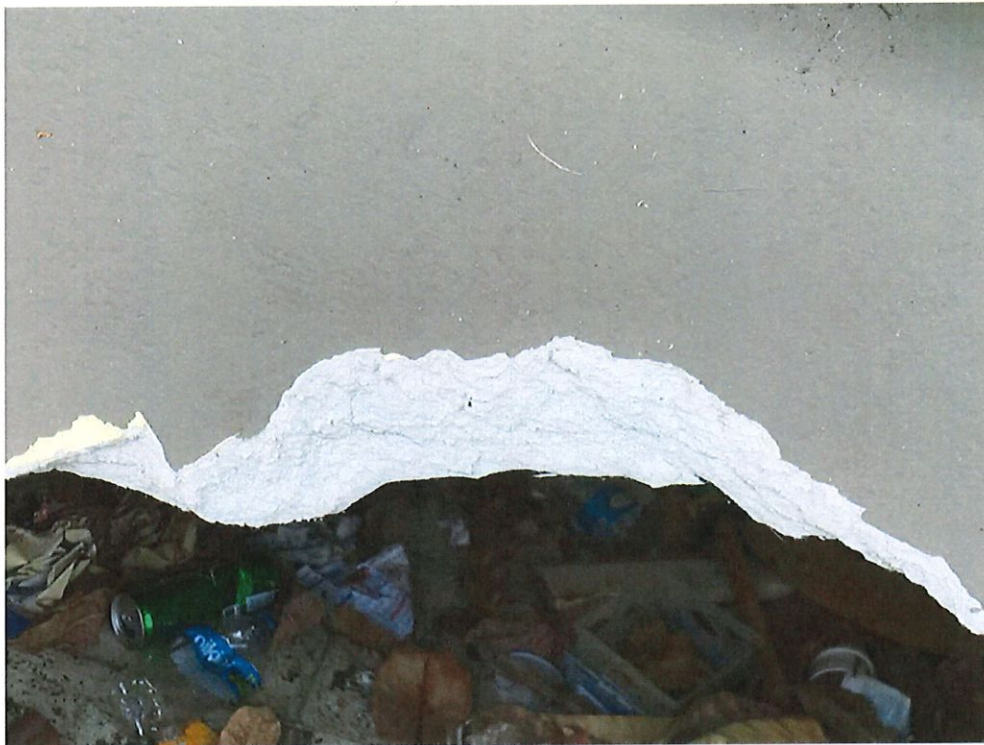
Photo Number 3 – Drywall Building Exterior, Wall "D"

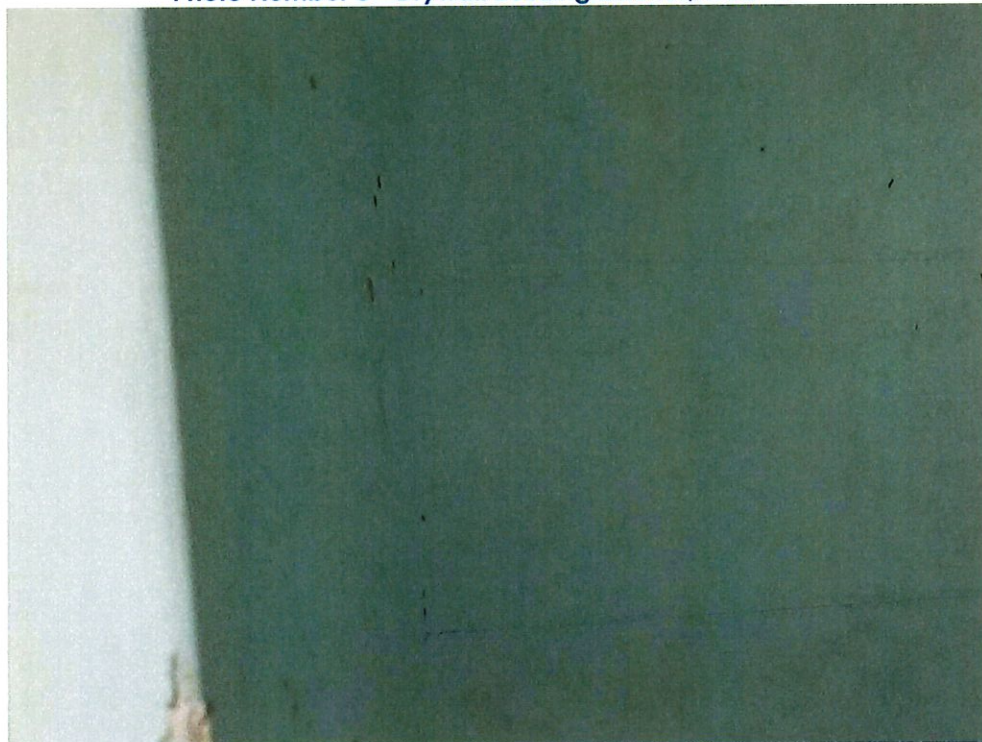
Photo Number 4 – Clinical Dental X-Ray Room Wall "C"

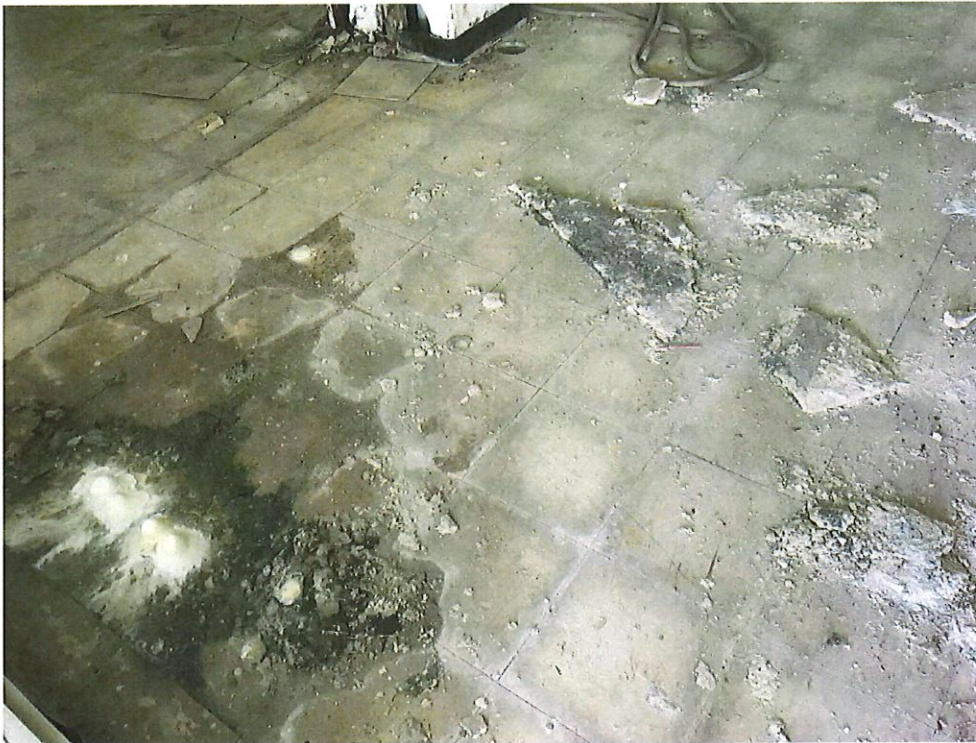
Photo Number 5 – Work Area Floor Tiles

Laboratory analysis confirmed the presence of asbestos in the red mastic air ducts at exam and treatment room (79C) and vinyl floor tiles bulk samples, from the information area (97C). Refer Appendix A & B Lay-out Plan Drawings and Laboratory Results.

If the materials with ACM will be impacted during the future projects, the ACM shall be removed prior to start the construction activity. The ACM abatement shall be carried out by a Licensed Asbestos Contractor with Certified Asbestos Supervisors and Workers. This report shall be kept by the owner and all future owners for the life of the building. A copy of the report shall be given to each tenant, buyer, or lessor, as to comply with federal requirements for disclosure under section 1018 of Title X and lead disclosure rule of 1996.

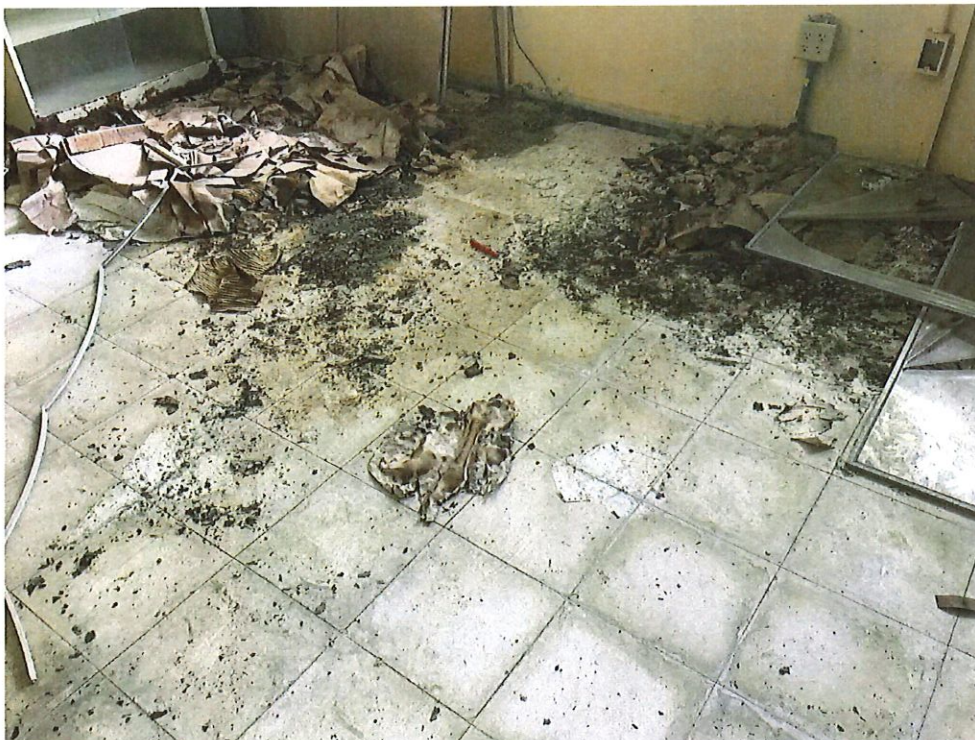
Photo Number 6 – Information Room Floor Tiles

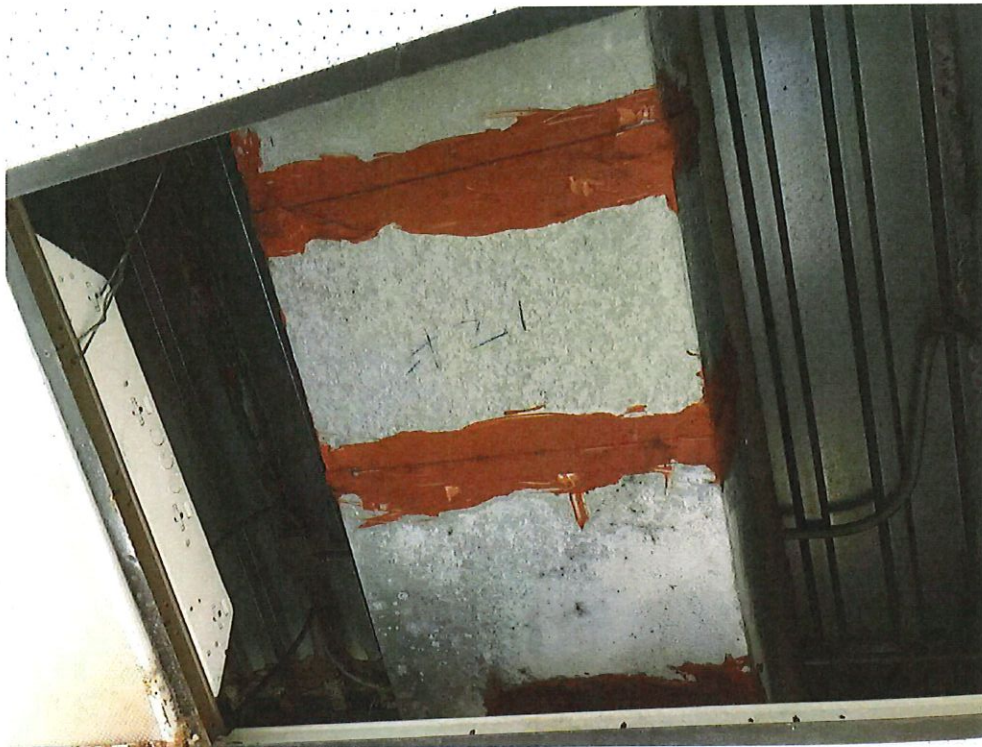
Photo Number 7 – Exam & Treatment Room Red Mastic Duct Air

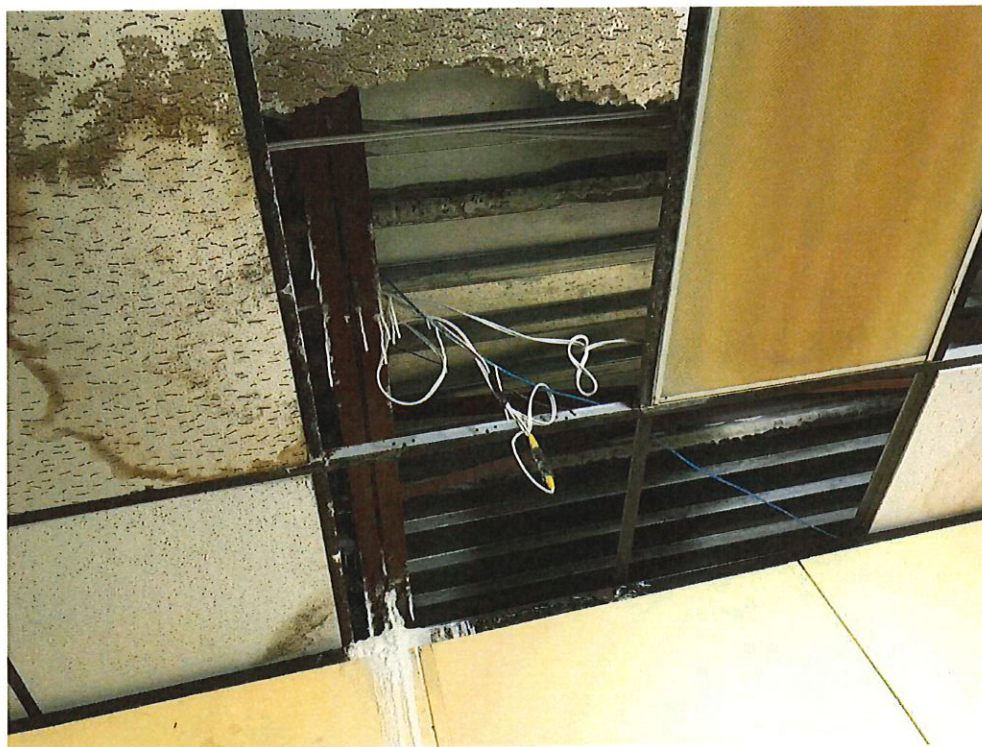
Photo Number 8 – Exam & Treatment Room Acoustic Ceiling

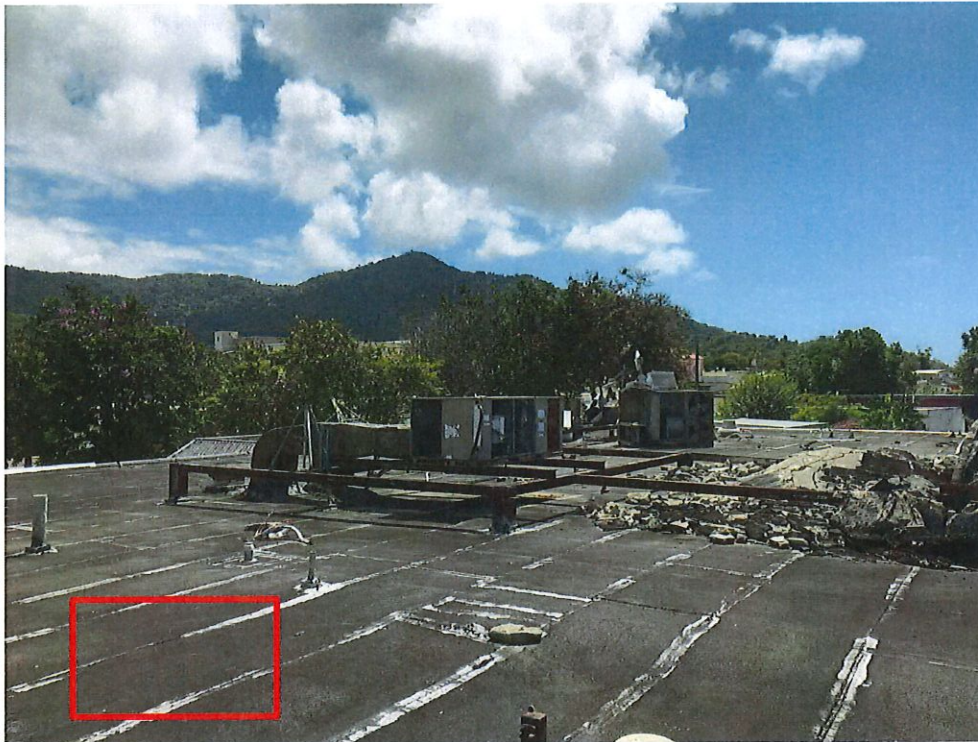
Photo Number 10 – Roof Treatment

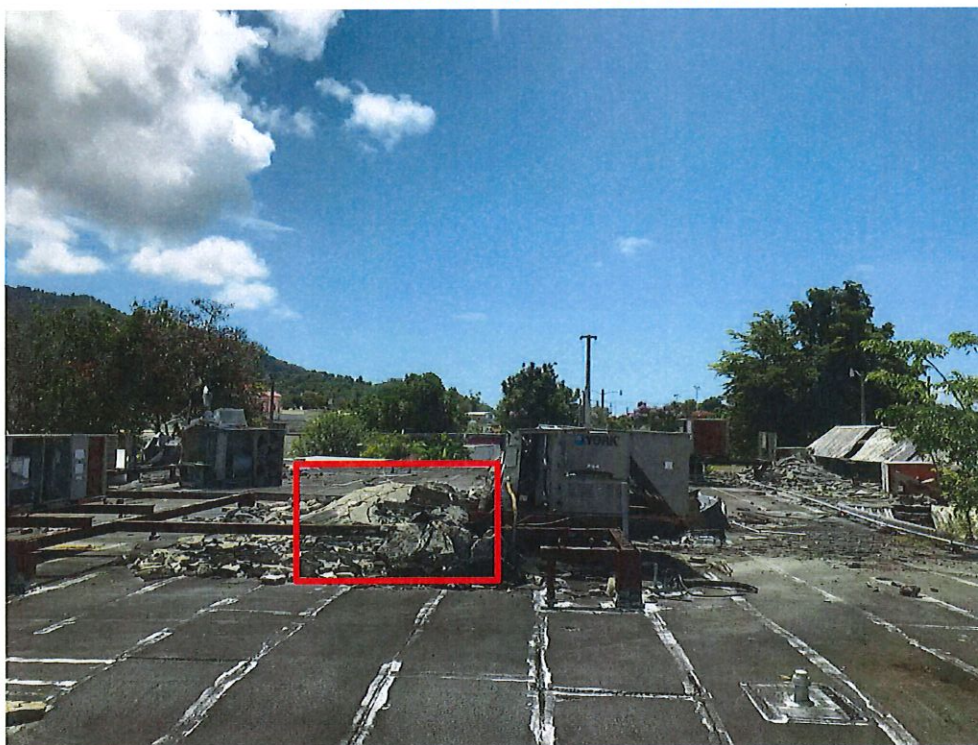
Photo Number 11 - Roof Concrete

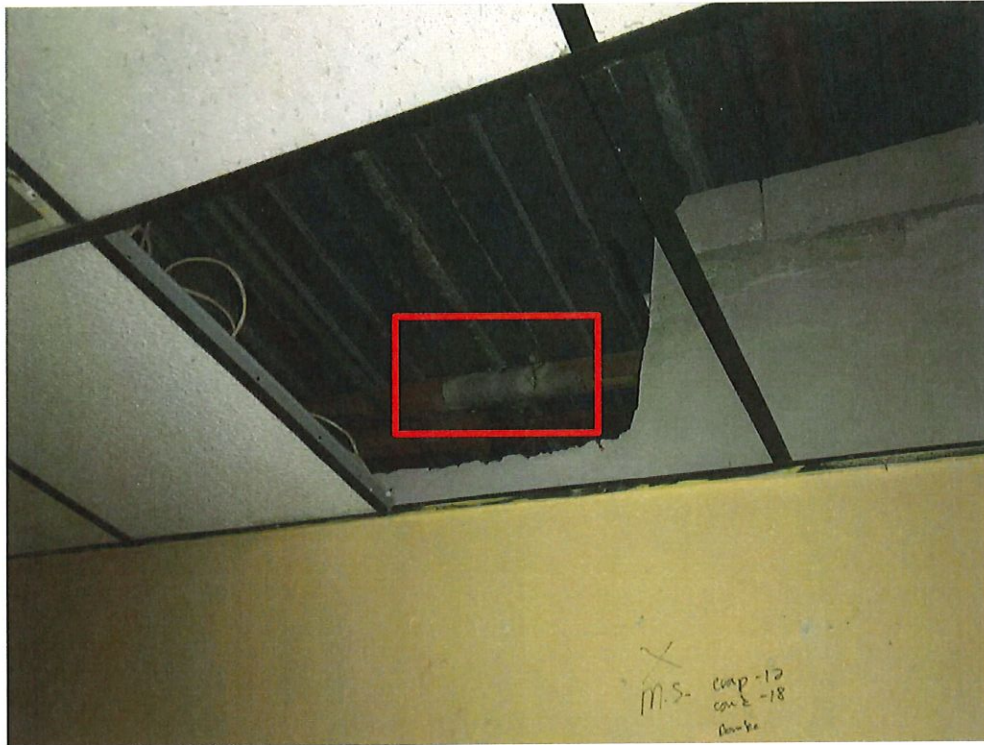
Photo Number 12- Hot Water Return Pipe Insulation
