## ENMIENDA NÚMERO 1

### SUBASTA INFORMAL NÚMERO 22J-08406-R2

**PARA LA ADQUISICIÓN DE SERVICIOS DE REPARACIÓN GENERAL DE LA  
INFRAESTRUCTURA DEL CTS PONCE DEL DEPARTAMENTO DE SALUD DEL  
GOBIERNO DE PUERTO RICO  
(FEMA REF. NO. 90019 P/W #6515 & REF. NO. 158747 P/W 281)**

**SCOPE OF WORK AMENDED I**

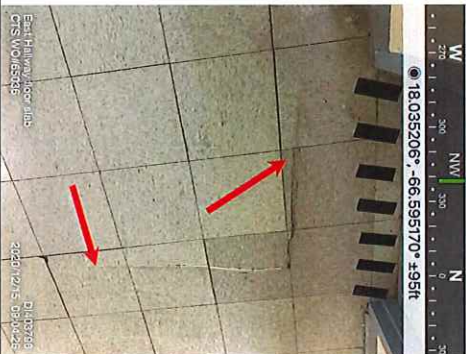
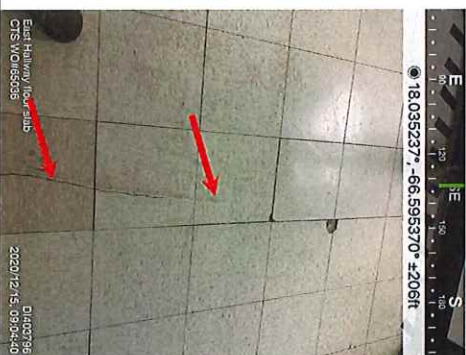
<b>Damage Description:</b>	<b>Photo #</b> 25	<b>Damage Description:</b>	<b>Photo #</b> 26
Hallway and Dining Hall, floor affected by cracks.		Hallway and Dining Hall, floor affected by cracks.

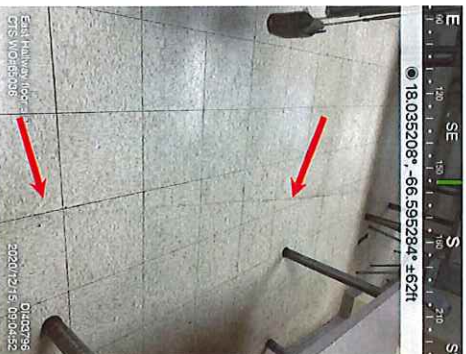
<b>Damage Description:</b>	<b>Photo #</b> 27	<b>Damage Description:</b>	<b>Photo #</b> 28
Hallway and Dining Hall, floor affected by cracks.		Kitchen, CMU wall and tiles affected by cracks.

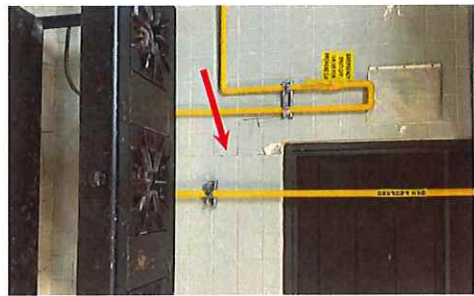
<b>Damage Description:</b>	<b>Photo #</b>	<b>Damage Description:</b>	<b>Photo #</b>
Kitchen, CMU wall and tiles affected by cracks.	31	Kitchen, CMU wall and tiles affected by cracks.	32

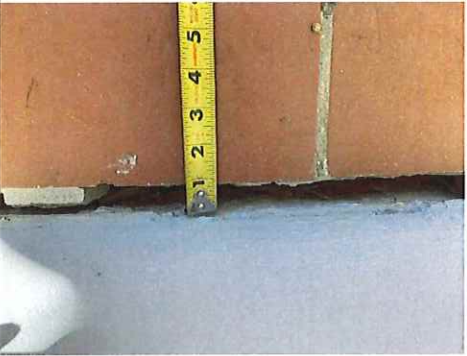
<b>Applicant:</b> PR Department of Health		<b>Damage Inventory #</b> 403796		<b>Category:</b> E	
<b>Work Order #</b> 65036		<b>FIPS #</b> 000-U40VB-00		<b>Date:</b> 12/15/2020	
<b>Site Inspector:</b> Montalvo, Hernandez, Peeva, Davila, Barrios		<b>Damage Facility:</b> Center for Transitional Services (CTS)		<b>GPS:</b> 18.03499, -66.59630	
<b>Damage Description:</b> Main entrance (Front Side), separation at joint.		<b>Photo #</b> 41		<b>Damage Description:</b> Main entrance (Front Side), separation at joint.

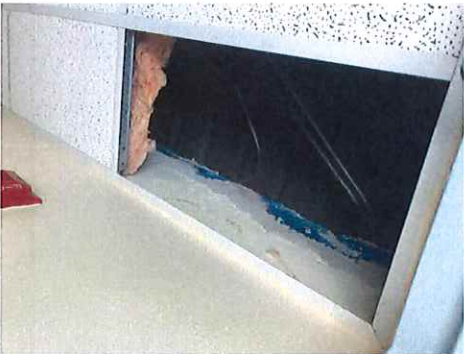
<b>Applicant:</b> PR DOH		<b>Damage Inventory #</b> 151645		<b>Category</b> E
<b>Work Order #</b> 37159		<b>FIPS #</b> 00-U4QVB-00		<b>Date:</b> 4/22/2019
<b>Site Inspector:</b> Jesus Garay, Harold Rivera		<b>GPS</b> 18.03499, -66.59530		
<b>Damage Description:</b>		<b>Damage Facility:</b> CTS Ponce		
Interior Building, 60 each of acoustic ceiling tile, 4 FT long x 2 FT wide, stained due to water infiltration, 0% work completed		<b>Photo#</b> 29	<b>Damage Description</b>

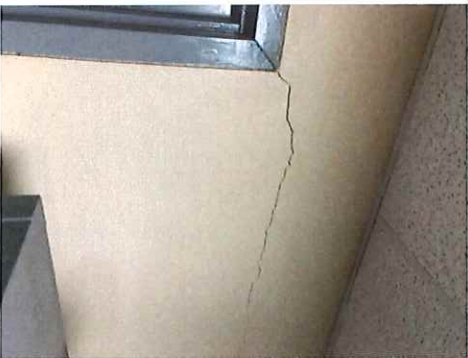
Unable to determine if surface crack is disaster related.	
<b>Damage Description:</b>		<b>Photo#</b>		<b>Damage Description</b>
