ENMIENDA NÚM. 3

SUBASTA FORMAL 23J-16945 PARA REALIZAR MEJORAS EN EL PRIMER PISO DE LA UNIDAD DE SALUD PÚBLICA (USP) DE RÍO PIEDRAS, ADSCRITA AL DEPARTAMENTO DE SALUD DEL GOBIERNO DE PUERTO RICO

Damage Description and Dimensions

Damage #151656; USP Rio Piedras

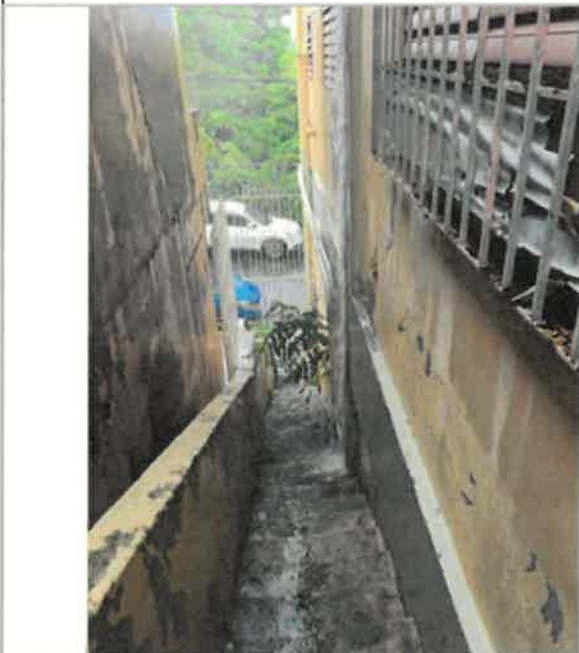
South Side Wall Exterior, 28 SF of Historic concrete stairs plaster and paint, 32 IN long x 12 IN wide x 6 IN high, 7 steps, eroded by falling water directly from the roof because of a blown off downspout, 0% work completed (photo 1 of 2)

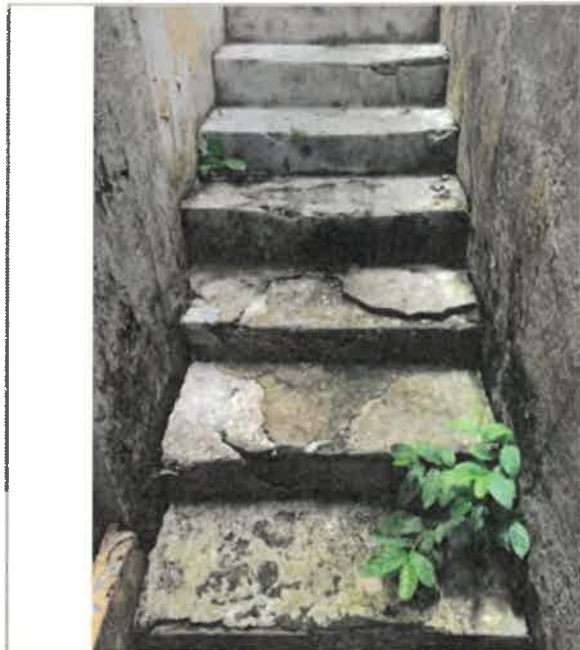
South Side Wall Exterior, 6 SF of Historic concrete sidewalk rail plaster and paint, 2 FT long x 3 FT wide, eroded by falling water from the roof because of a blown off downspout, 0% work completed

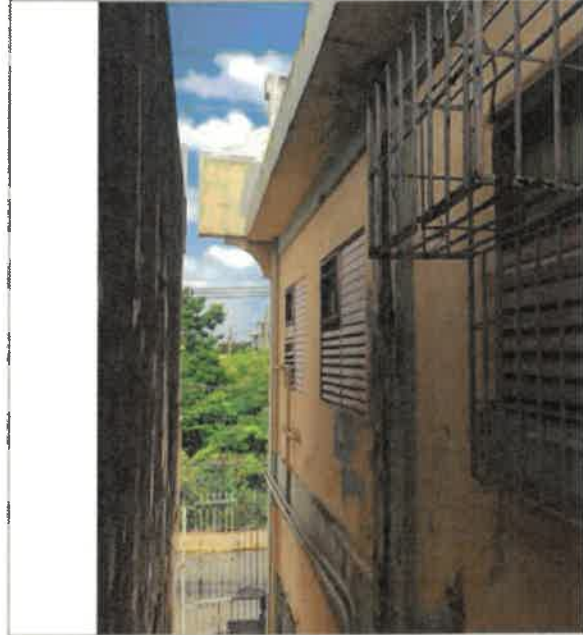
South Side Wall Exterior, 6 each of aluminum jalousie window, 5 FT long x 3 FT wide, high winds and wind blown debris broke and/or bent the windows, should be verified for Historic characteristics, 0% work completed (photo 2 of 2)

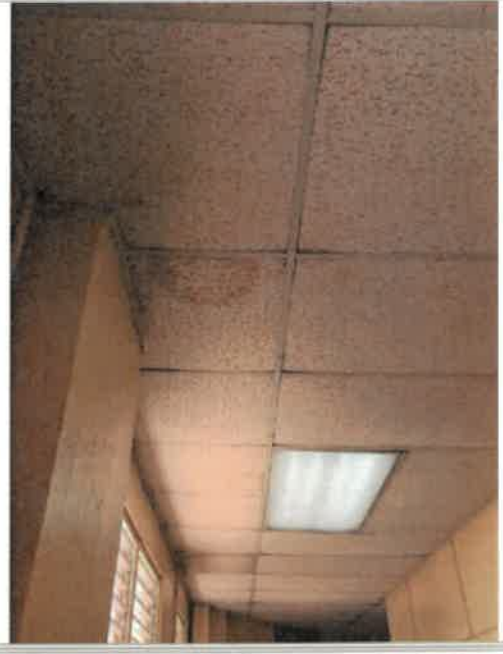
2nd Floor Main Hallway, 1,787 SF of Historic concrete wall paint, (119 + 119)ft x 86in high + (9ft x 9ft high), water intrusion through roof and window failure blistered and/or peeled off the paint, temporarily painted, 0% work completed

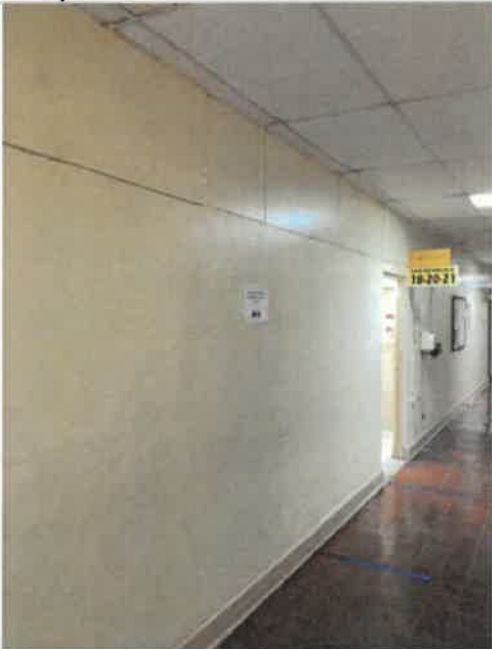
2nd Floor Stairs Hallway, 356 SF of Historic concrete wall paint, (22ft x 86 in high) + (22ft x 9ft high), water intrusion through roof and window failure blistered and/or peeled off the paint, temporarily painted, 0% work completed

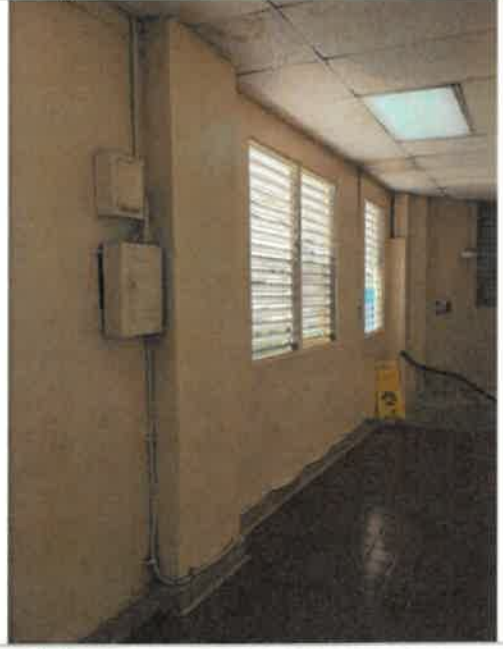
2nd Floor Main Hallway, 455 SF of wooden panel wall paint, 260 LF long x 21 IN high, water intrusion through roof and window failure blistered and/or peeled off the paint, temporarily painted, 0% work completed (photo 1 of 2)

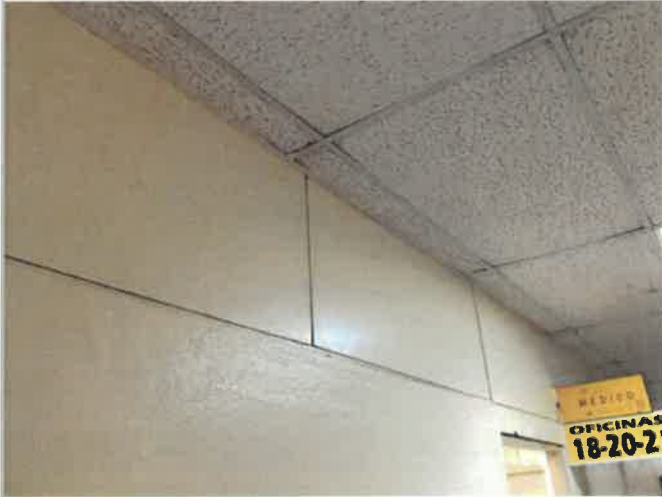
2nd Floor Main Hallway, 455 SF of wooden panel wall paint, 260 LF long x 21 IN high, water intrusion through roof and window failure blistered and/or peeled off the paint, temporarily painted, 0% work completed (photo 2 of 2)

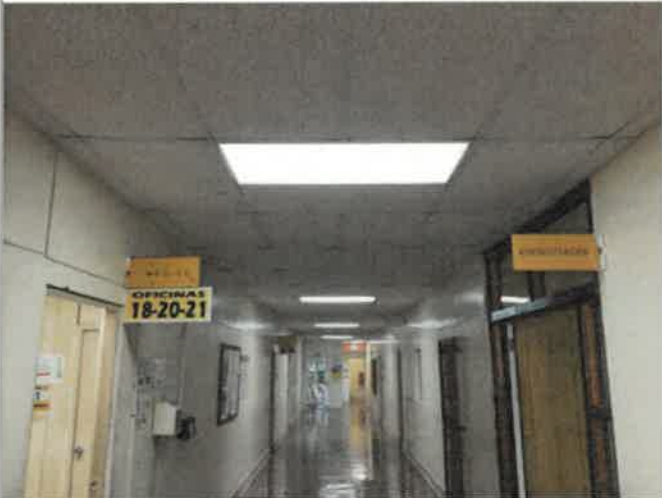
2nd Floor Doctor, Social Work and Mother & Child, 2 x 4 fluorescent drop-in ceiling light fixture, 4 tubes, and suspended acoustic ceiling tiles, water intrusion through roof and window failure damaged the fixtures, the tubes were replaced with LED types, (photo 1 of 3)

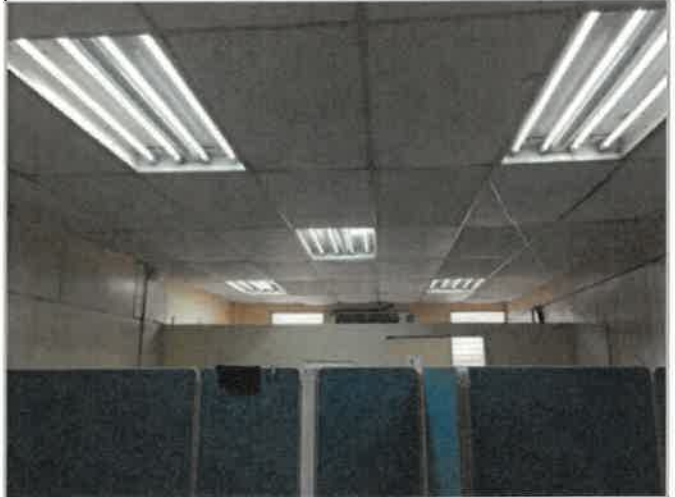
2nd Floor Doctor, Social Work and Mother & Child, 2 x 4 fluorescent drop-in ceiling light fixture, 4 tubes, and suspended acoustic ceiling tiles, water intrusion through roof and window failure damaged the fixtures, the tubes were replaced with LED types, (photo 2 of 3)

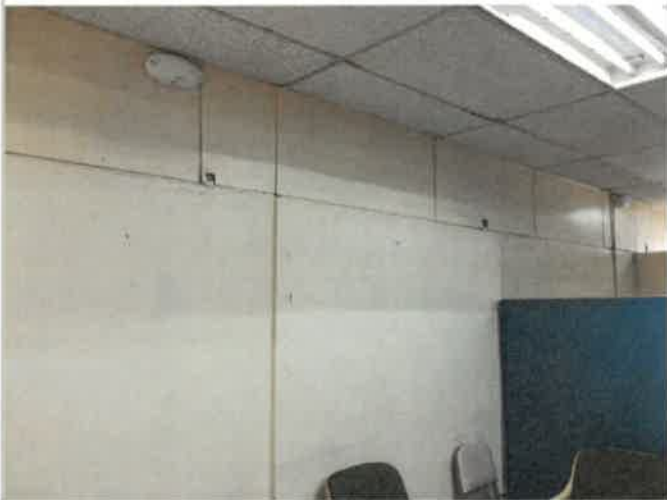
2nd Floor Doctor, Social Work and Mother & Child, 2 x 4 fluorescent drop-in ceiling light fixture, 4 tubes, and suspended acoustic ceiling tiles, water intrusion through roof and window failure damaged the fixtures, (photo 3 of 3)

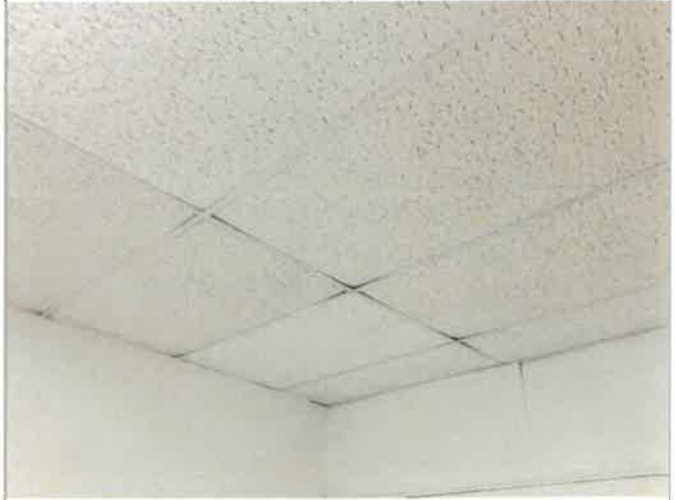
2nd Floor Health Certificate, 735 SF of Historic concrete wall paint, (17ft x 9ft high) + 2 walls of (17ft x 86in high) + (32ft x 86in high) + (15ft x 86in high), water intrusion through roof and window failure blistered and/or peeled off the paint, temporarily painted, 0% work completed (photo 1 of 2)

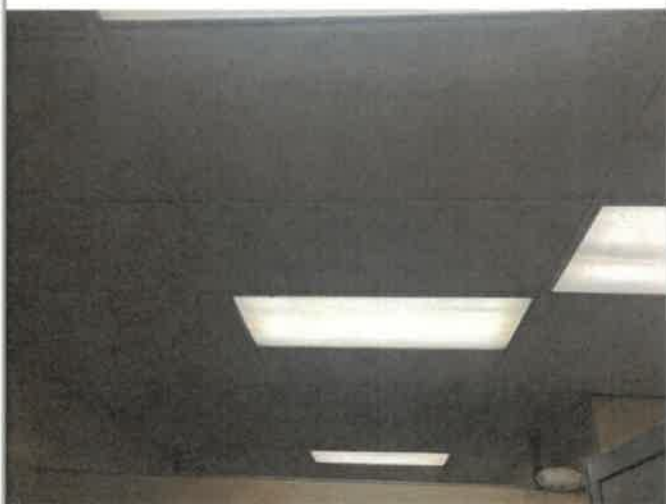
2nd Floor Health Certificate, 735 SF of Historic concrete wall paint and 112 SF of wooden panel wall paint, water intrusion through roof and window failure blistered and/or peeled off the paint, temporarily painted, 0% work completed (photo 2 of 2)

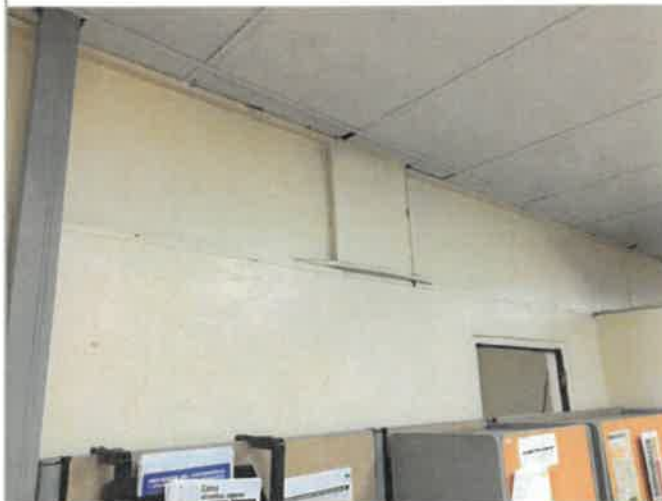
2nd Floor Vaccination, 12 each of fluorescent drop-in ceiling light fixture, 4 tubes, 2 FT long x 4 FT wide, and 720 SF of suspended lay-in acoustic 2 x 4 ceiling tile, 36 FT long x 20 FT wide, water intrusion through roof and window failure damage the tile and fixtures, temporarily replaced tiles and tubes

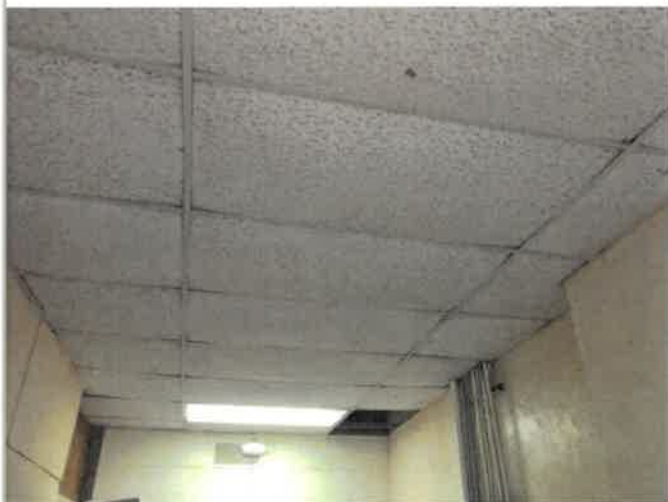
2nd Floor Vaccination, 309 SF of Historic concrete wall paint, (20ft x 9ft high) + (18ft x 86in high), water intrusion through roof and window failure blistered and/or peeled off the paint, temporarily painted, 0% work completed

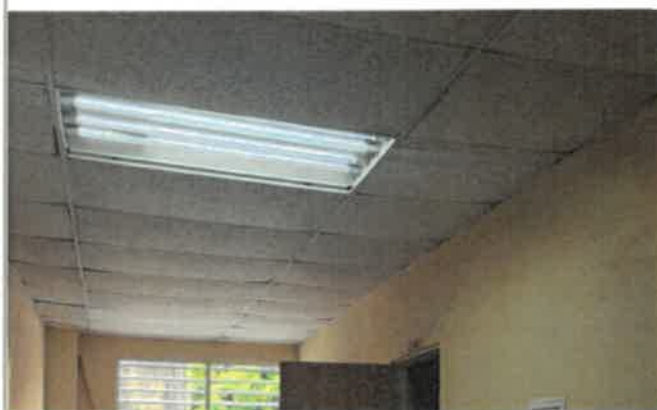
2nd Floor Restrooms Hallway, 720 SF of Historic concrete wall paint, 80 LF long x 9 FT high, water intrusion through roof and window failure blistered and/or peeled off the paint, temporarily painted, 0% work completed

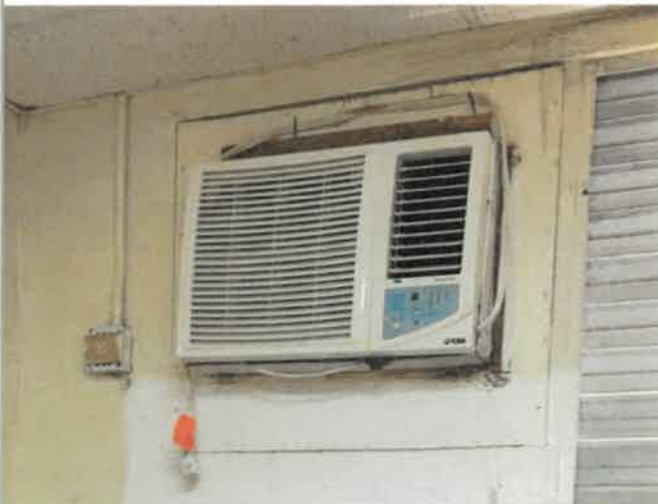
2nd Floor Health Certificate, 2 each of wall mounted 3 ton split A/C unit (blower specifications), high winds, wind driven rain, wind blown debris and water intrusion damage the unit, 100% work completed (photo 1 of 3)

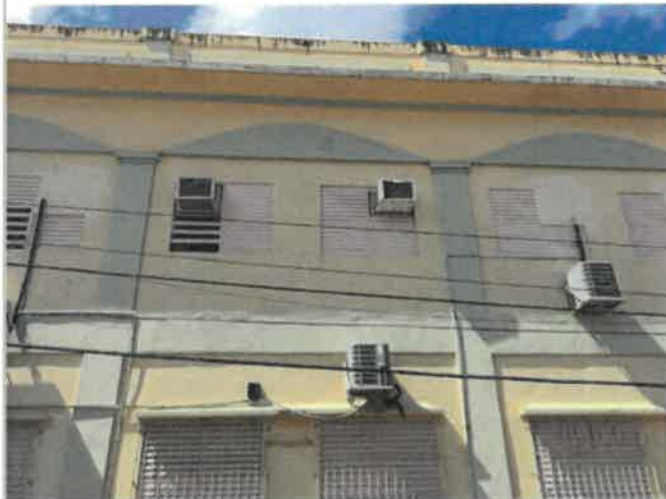
Building Exterior, aluminum jalousie window sealing to concrete, 1,054 LF long, 43 windows (6ft x 5ft) + 5 windows (3ft x 5ft) + 2 windows (5ft x 2ft), high winds, wind driven rain, and wind blown debris damage the seal, 0% work completed (photo 1 of 2)

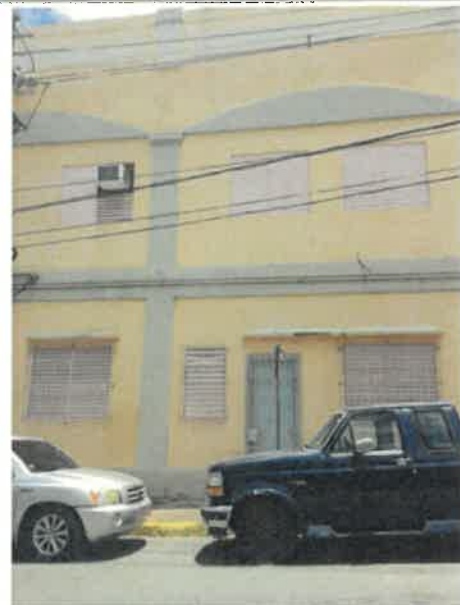
Building Exterior, aluminum jalousie window sealing to concrete, 1,054 LF long, 43 windows (6ft x 5ft) + 5 windows (3ft x 5ft) + 2 windows (5ft x 2ft), high winds, wind driven rain, and wind blown debris damage the seal, 0% work completed (photo 2 of 2)

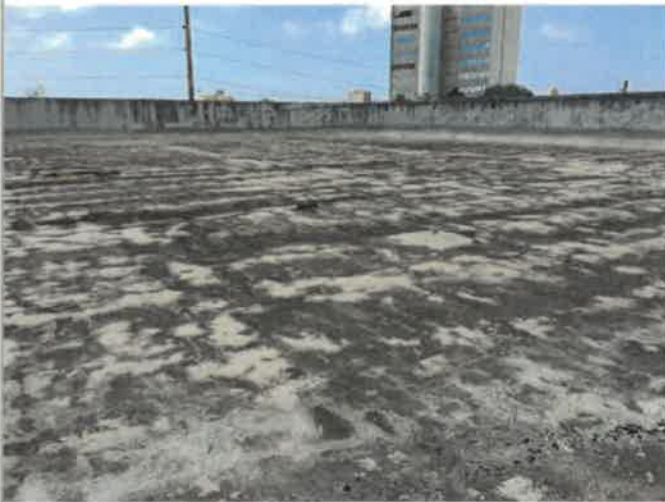
Roof, 9,600 SF of built-up membrane roof waterproofing treatment, 120 FT long x 80 FT wide, high winds, wind driven rain, and wind blown debris detached, bubbled, and peeled off the treatment, 0% work completed (photo 1 of 2)

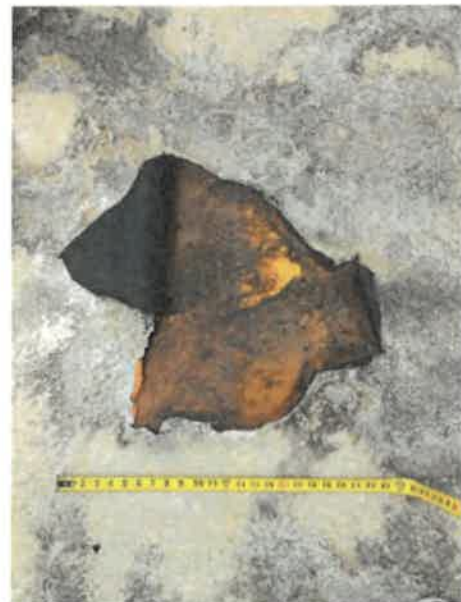
Roof, 9,600 SF of built-up membrane roof waterproofing treatment, 120 FT long x 80 FT wide, high winds, wind driven rain, and wind blown debris detached, bubbled, and peeled off the treatment, 0% work completed (photo 2 of 2)

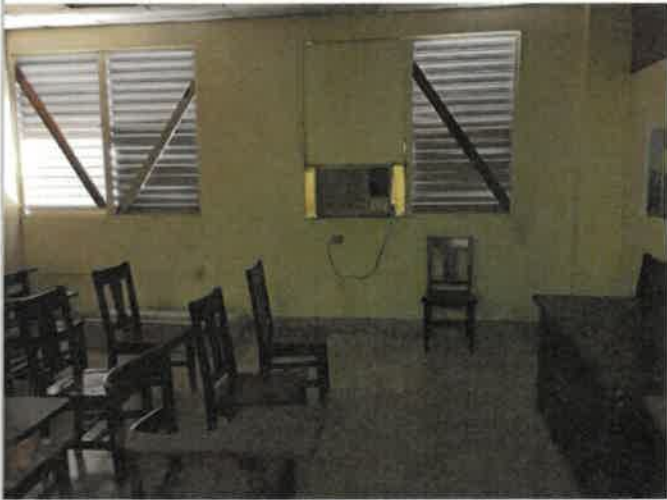
2nd Floor Conference Room 1, 497 SF of Historic concrete wall paint, side walls (31 + 17)ft x 86 in high + outside wall (17ft x 9ft high), water intrusion through roof and window failure blistered and/or peeled off the paint, temporarily painted, 0% work completed

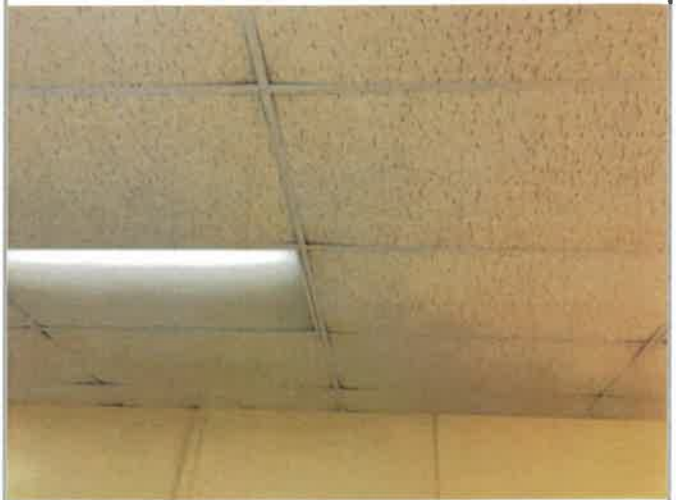
2nd Floor Finances, 448 SF of suspended lay-in acoustic 2 x 4 ceiling tile, 32 FT long x 14 FT wide, temporarily replaced, and 4 each of fluorescent drop-in ceiling light fixture, 4 tubes, 2 FT long x 4 FT wide, water intrusion through roof and window failure damage the fixture, 0% work completed

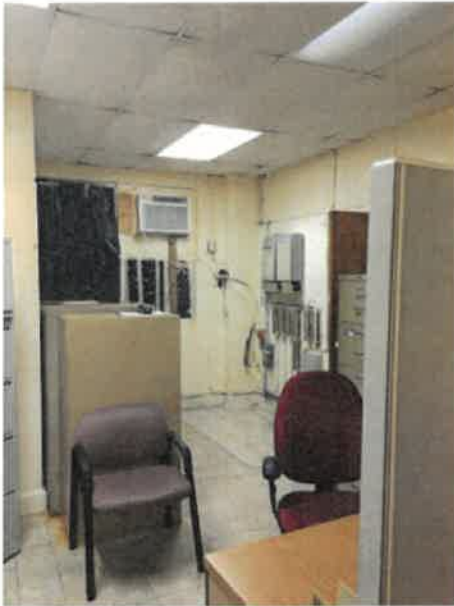
2nd Floor Finance, suspended lay-in acoustic 2 x 4 ceiling tile, temporarily replaced, fluorescent 2 x 4 drop-in ceiling light fixtures, and wall paint, all temporarily fixed, 0% work completed

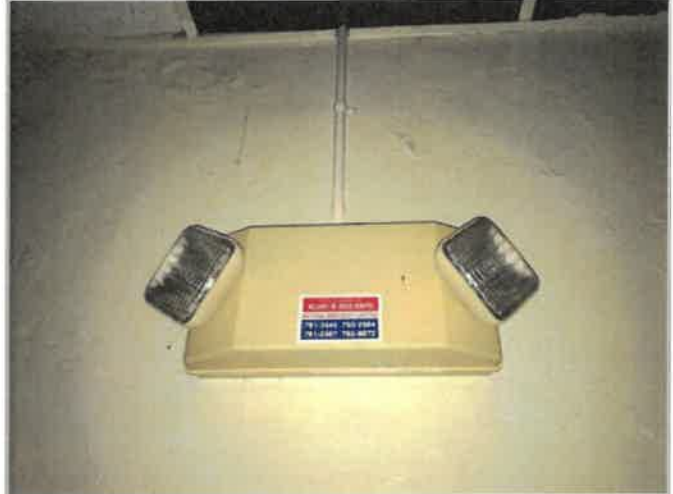
2nd Floor Hallways and Offices, 7 each of wall mounted Lithonia Emergency light fixture, 2 lamps, water intrusion through roof and window failure damaged the fixtures, 100% work completed (photo 1 of 3)

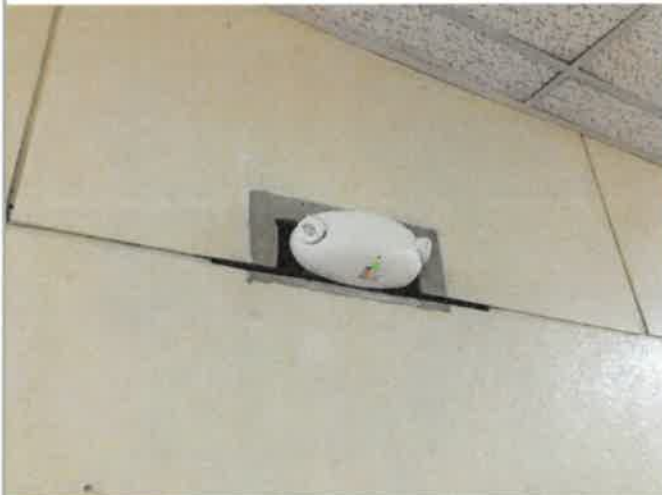
2nd Floor Hallways and Offices, 7 each of wall mounted Lithonia Emergency light fixture, 2 lamps, view of the new ones, water intrusion through roof and window failure damaged the fixtures, 100% work completed (photo 2 of 3)

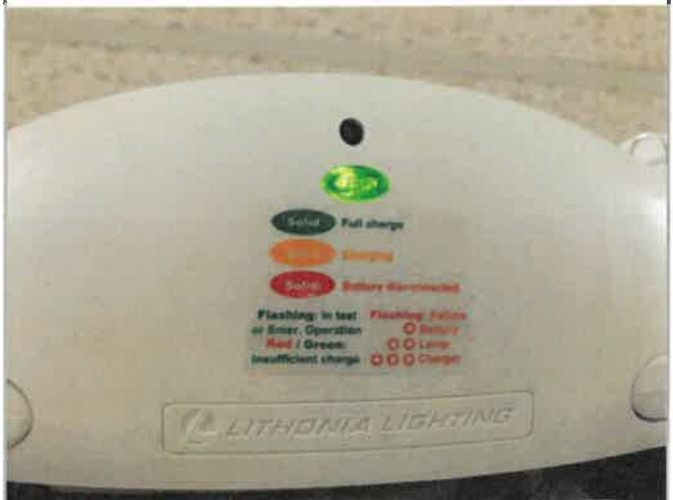
2nd Floor Hallways and Offices, 7 each of wall mounted Lithonia Emergency light fixture, 2 lamps, view of the new ones, water intrusion through roof and window failure damaged the fixtures, 100% work completed (photo 3 of 3)

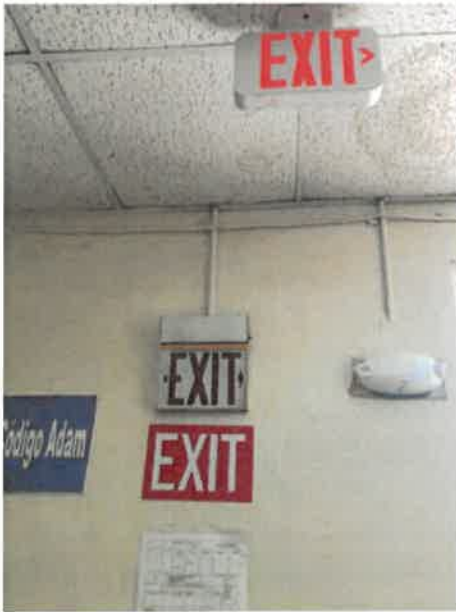
2nd Floor Main Hallway, 1 each of suspended ceiling mounted Exit light fixture, water intrusion through roof and window failure damaged the fixtures, 100% work complete

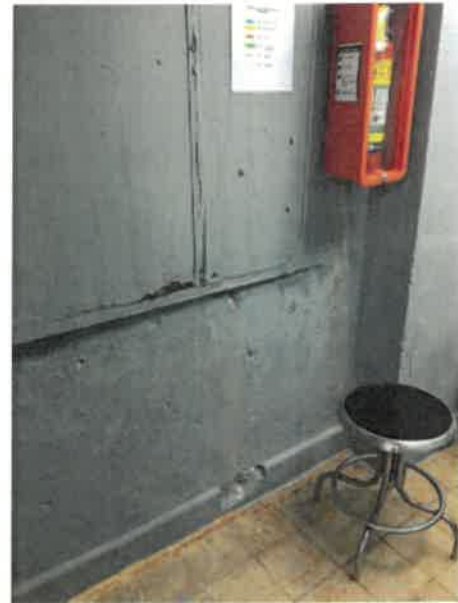
1st Floor Clinical Laboratory, 416 SF of Historic concrete wall paint, 52 LF long x 8 FT high, water intrusion through window failure blistered, and/or peeled off the paint, temporarily painted, 0% work completed (photo 1 of 2)

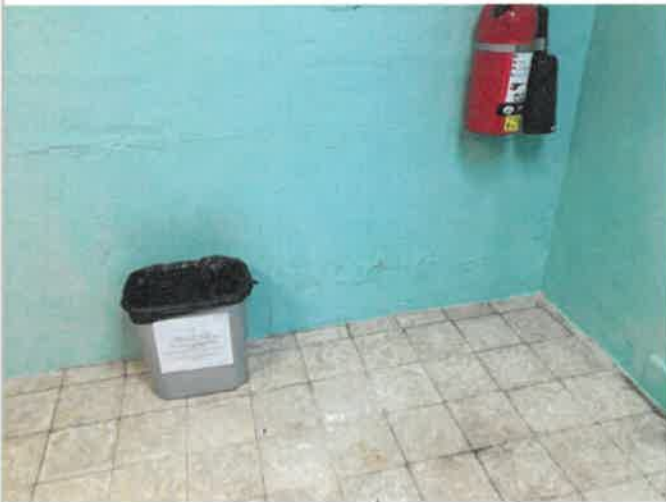
1st Floor Clinical Laboratory, 416 SF of Historic concrete wall paint, 52 LF long x 8 FT high, water intrusion through window failure blistered, and/or peeled off the paint, temporarily painted, 0% work completed (photo 2 of 2)

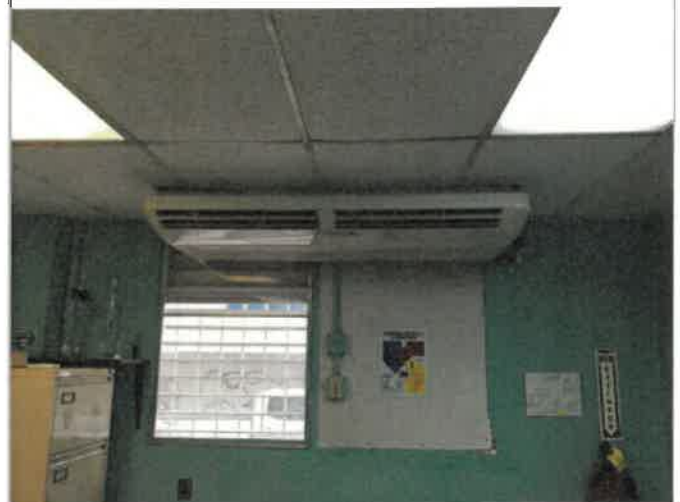
1st Floor Clinical Laboratory, 1 each of wall mounted AirMax CCF4-60CR 5 ton split A/C unit repairs, high winds, wind driven rain, wind blown debris and water intrusion damage the unit, 100% work completed (photo 1 of 2)

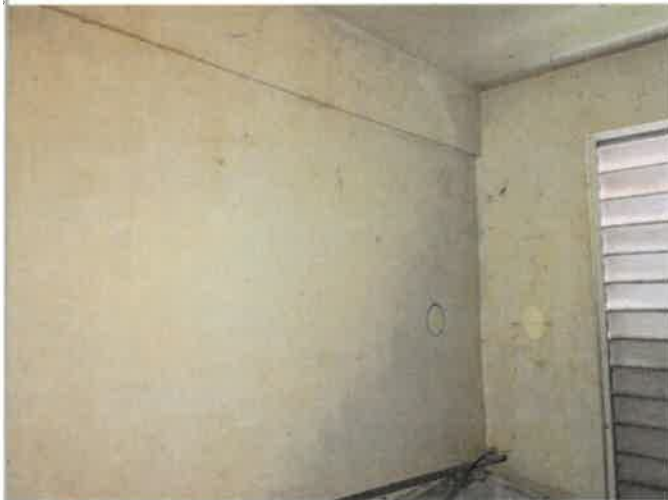
1st Floor Storage Room next to Serology, 470 SF of concrete wall paint, 54.75 LF long x 8.58 FT high, water intrusion through window failure, surface water flooding, and prolonged humidity blistered and/or peeled off the paint, 0% work completed (photo 1 of 2)

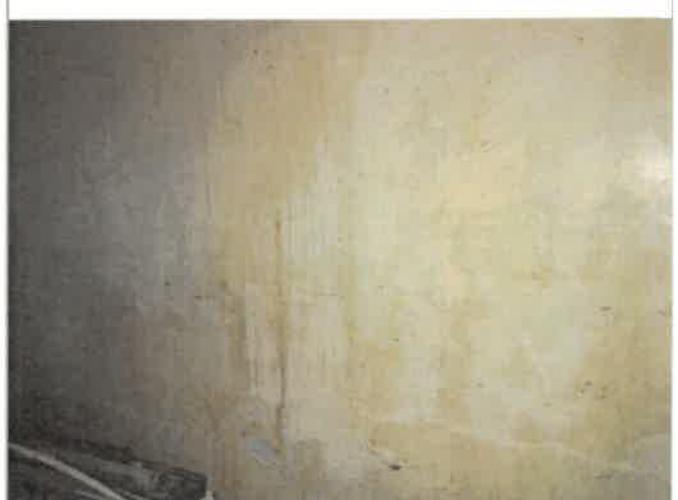
1st Floor Storage Room next to Serology, 470 SF of concrete wall paint, 54.75 LF long x 8.58 FT high, water intrusion through window failure, surface water flooding, and prolonged humidity blistered and/or peeled off the paint, 0% work completed (photo 2 of 2)

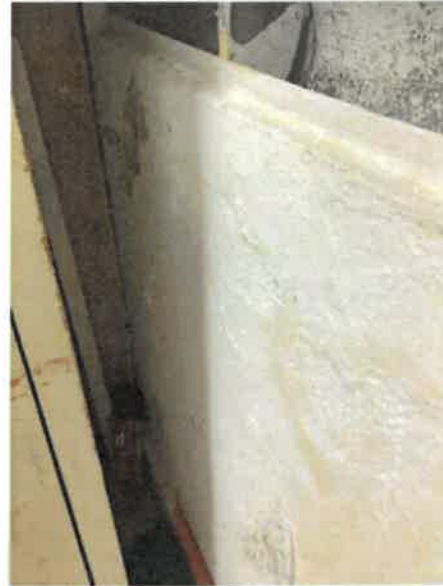
1st Floor Serology, 219 SF of Historic concrete wall paint, 24.25 FT long x 9 FT high, water intrusion through window failure and surface water flooding from water accumulated between the affected and the adjacent buildings blistered and/or peeled off the paint, ongoing problem, temporarily painted, 0% work completed (photo 2 of 2)

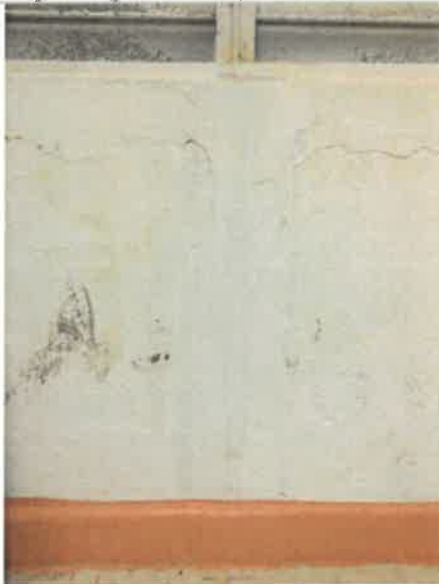
1st Floor Tuberculin Results Reading, 60 SF of Historic concrete wall paint, 6.67 FT long x 9 FT high, water intrusion through window failure and surface water flooding from water accumulated between the affected and the adjacent buildings blistered and/or peeled off the paint, ongoing problem, temporarily painted, 0% work completed

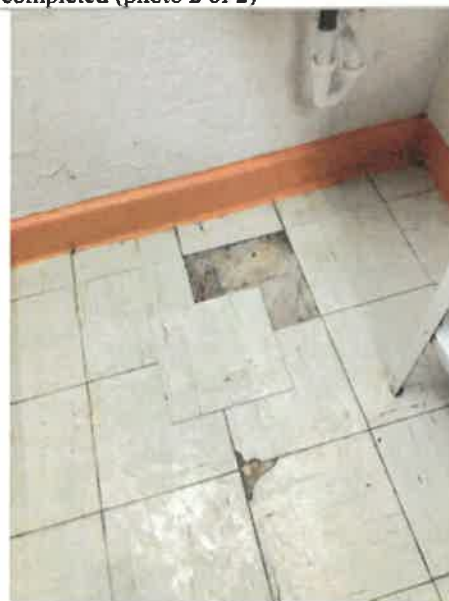
1st Floor Tuberculin Results Reading, 80 SF of vinyl composition tile (VCT) flooring, 12 FT long x 6.67 FT wide, surface water flooding, and prolonged humidity detached, lifted and stained the tiles, ongoing problem, 0% work completed (photo 1 of 2)

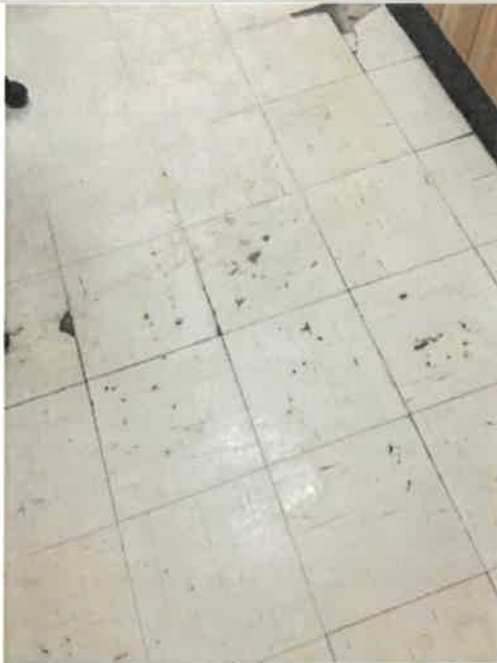
1st Floor Tuberculin Results Reading, 80 SF of vinyl composition tile (VCT) flooring, 12 FT long x 6.67 FT wide, surface water flooding, and prolonged humidity detached, lifted and stained the tiles, ongoing problem, 0% work completed (photo 2 of 2)

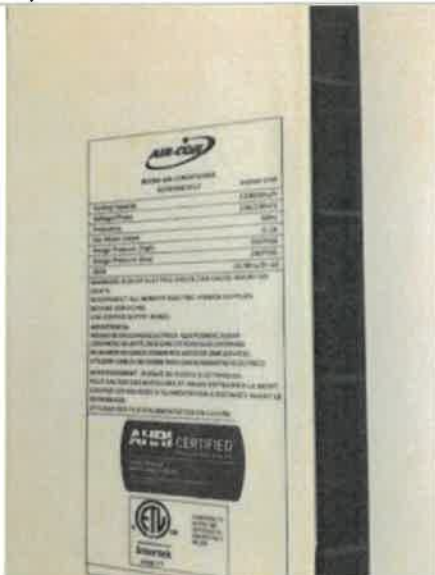
1st Floor Tuberculin Results Reading, 1 each of window mounted 12,000 BTU A/C unit, high winds, wind driven rain, wind blown debris and water intrusion damage the unit, replaced with Air-Con AEDM4C4512 split unit, 100% work completed (photo 2 of 2)

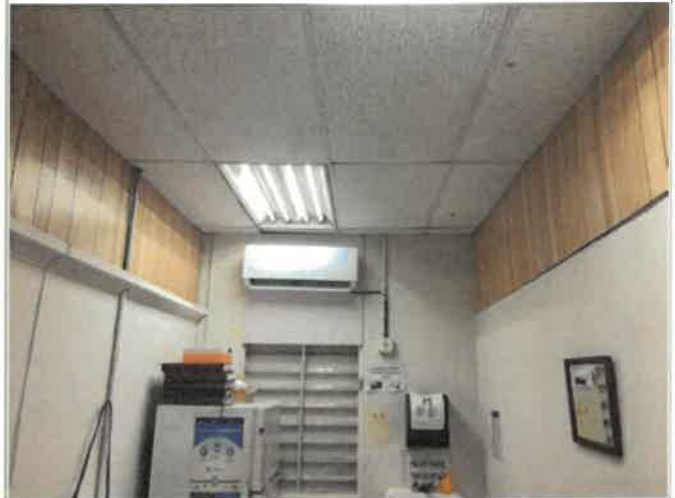
1st Floor Tuberculin Results Reading, 1 each of window mounted 12,000 BTU A/C unit, high winds, wind driven rain, wind blown debris and water intrusion damage the unit, replaced with Air-Con AEDM4C4512 split unit, 100% work completed (photo 1 of 2)

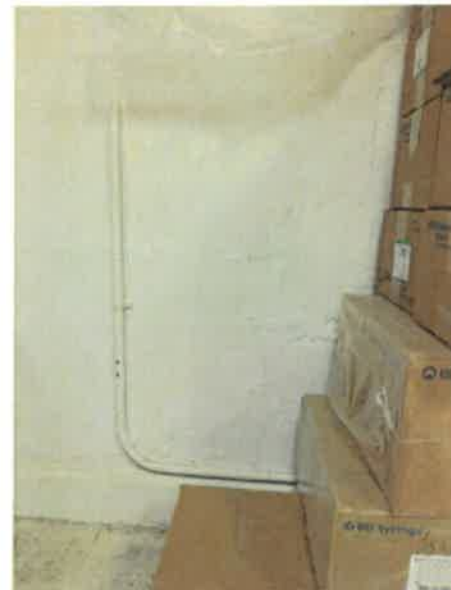
1st Floor Storage Room, 405 SF of Historic concrete wall paint, 45 FT long x 9 FT high, water intrusion through window failure and surface water flooding blistered and/or peeled off the paint, 0% work completed (photo 1 of 3)

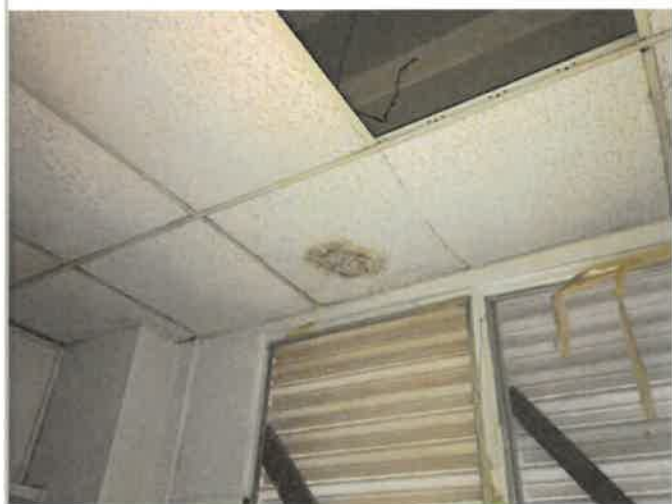
1st Floor Storage Room, 270 SF of suspended lay-in acoustic 2 x 4 ceiling tile, 45 FT long x 6 FT wide, the first two rows next to the outside wall, water intrusion through window failure damage the tile, 0% work completed (photo 1 of 2)

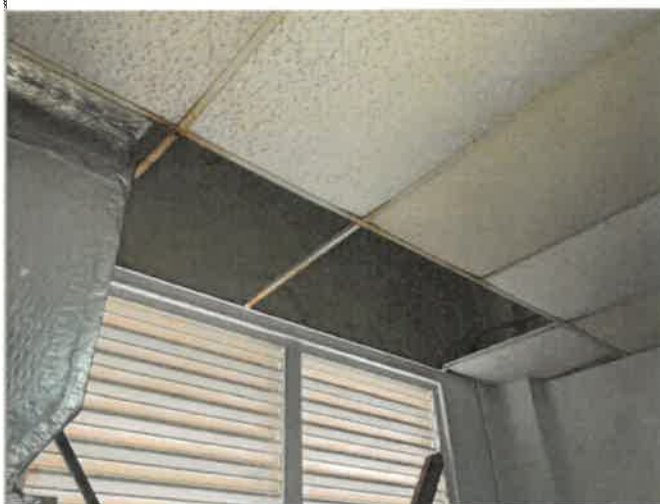
1st Floor Storage Room, 270 SF of suspended lay-in acoustic 2 x 4 ceiling tile, 45 FT long x 6 FT wide, the first two rows next to the outside wall, water intrusion through window failure damage the tile, 0% work completed (photo 2 of 2)

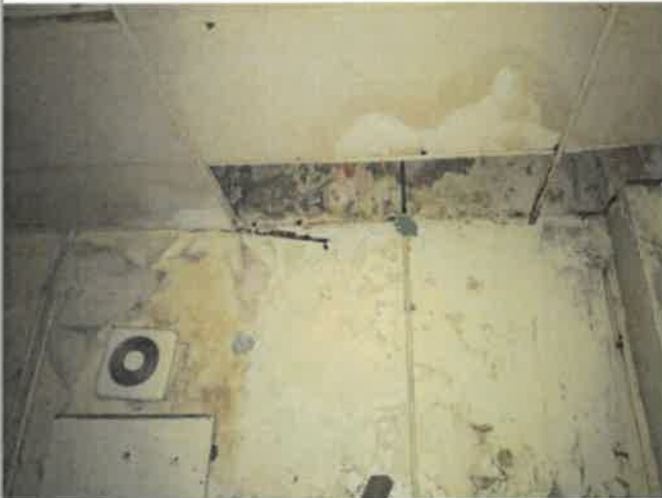
1st Floor Lunch Area, 162 SF of Historic concrete wall paint, 18 FT long x 9 FT high, and 144 SF of suspended lay-in acoustic 2 x 4 ceiling tile, 18 FT long x 8 FT wide, the first two rows next to the outside wall, excessive humidity caused damage, 0% work completed

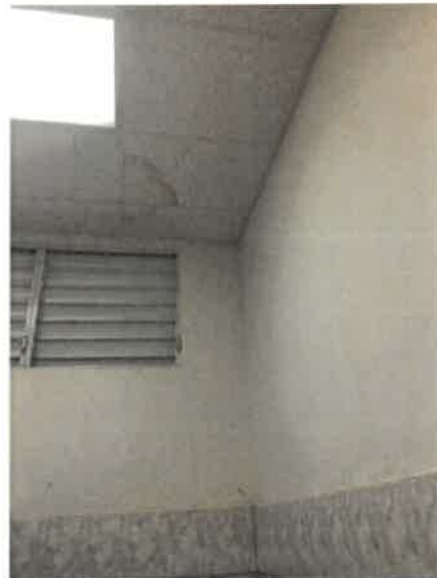
1st Floor Men's Restroom, 48 SF of suspended lay-in acoustic 2 x 4 ceiling tile, 9.5 FT long x 5 FT wide, the first two rows next to the outside wall, water intrusion through window failure damage the tile, ongoing problem, 0% work completed

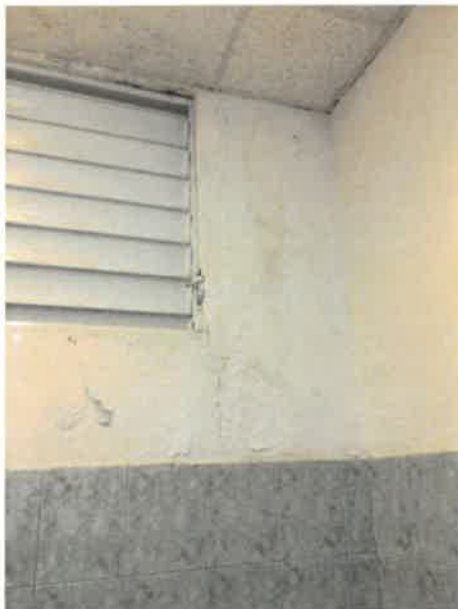
1st Floor Women's Restroom, 35 SF of Historic concrete wall paint, 8.67 FT long x 4 FT high, there are glazed tiles on the lower part of the wall, water intrusion through window failure blistered and/or peeled off the paint, 0% work complete

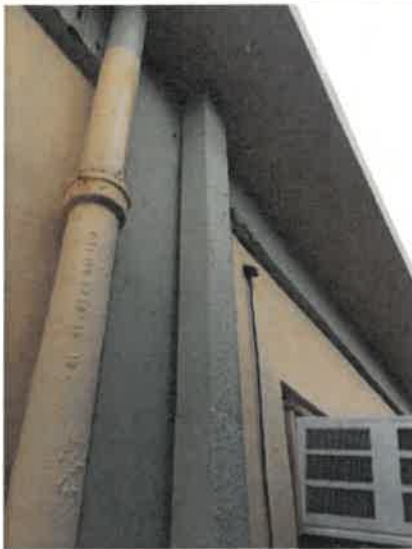
South Side Wall Exterior, metal 4in x 6in downspout, 90 LF long (view of an undamaged one), high winds, wind driven rain, and wind blown debris blew off three 30ft long pieces, possible mitigation to effectively drain the south side of the building because all the roof drainage is on that side (where another building structure is erected just 5 ft apart) plus the emergency concrete stairs are on that side of the building, closing more that drainage area, 0% work completed (photo 1 of 3)

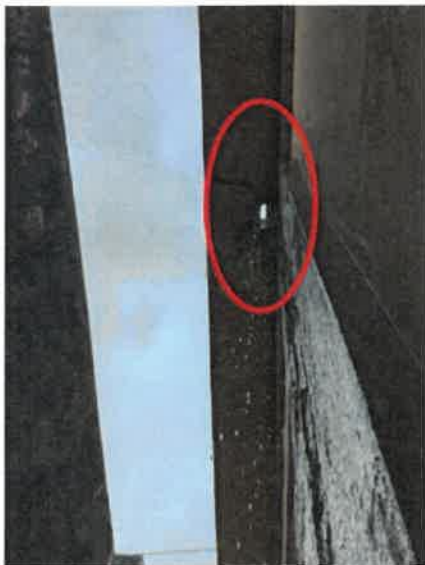
South Side Wall Exterior, metal 4in x 6in downspout, 90 LF long (view of an opening on the roof where the downspout was), wind driven rain, and wind blown debris blew off three 30ft long pieces, 0% work completed (photo 2 of 3)

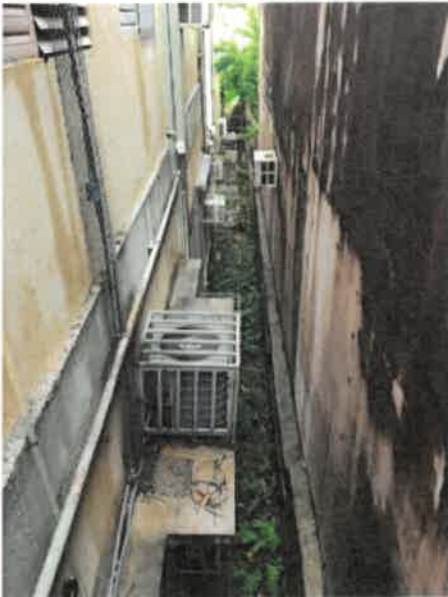
South Side Wall Exterior, view of the narrow space between the affected building and the adjacent building, which serves as the roof water drainage area to the outside of the property, possible mitigation (photo 1 of 3)

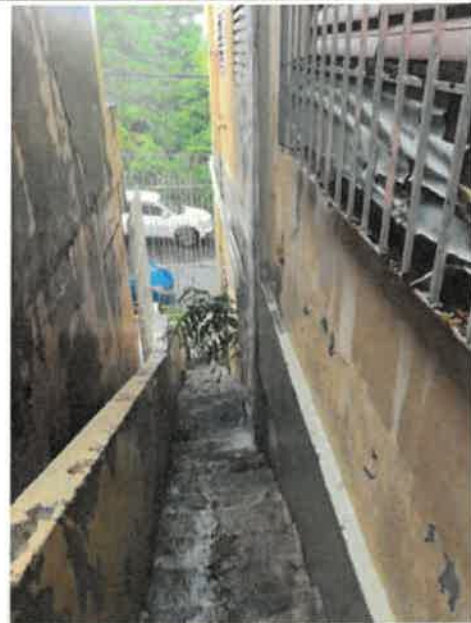
South Side Wall Exterior, view of the narrow space (few inches) between the affected building stairs and the adjacent building, which serves as the roof water drainage area to the outside of the property, possible mitigation (photo 2 of 3)

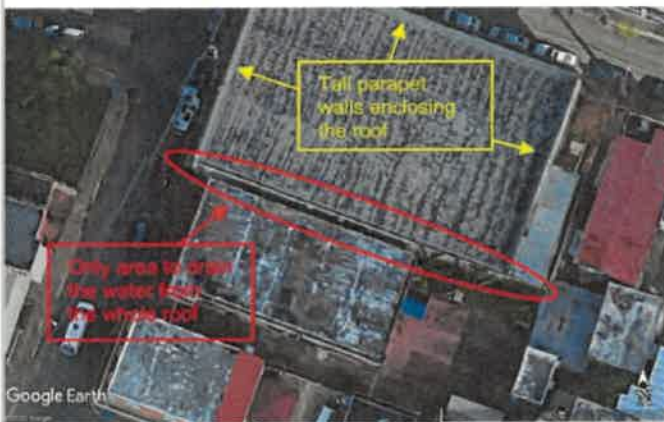
Google Top View of the Building, showing the roof side where the water drains from the roof, and the narrow area between buildings where the water should drain to the public drainage system, possible mitigation (photo 3 of 3)

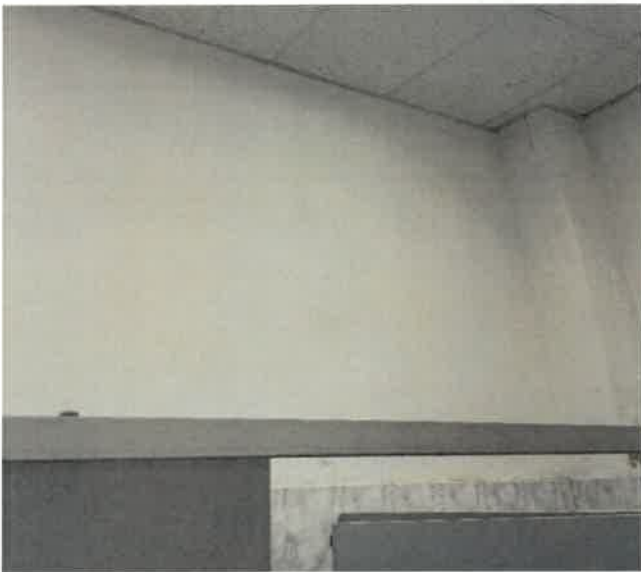
**White Concrete Upper Wall B
Painted with LBP
Men Bathroom, 1st Floor**

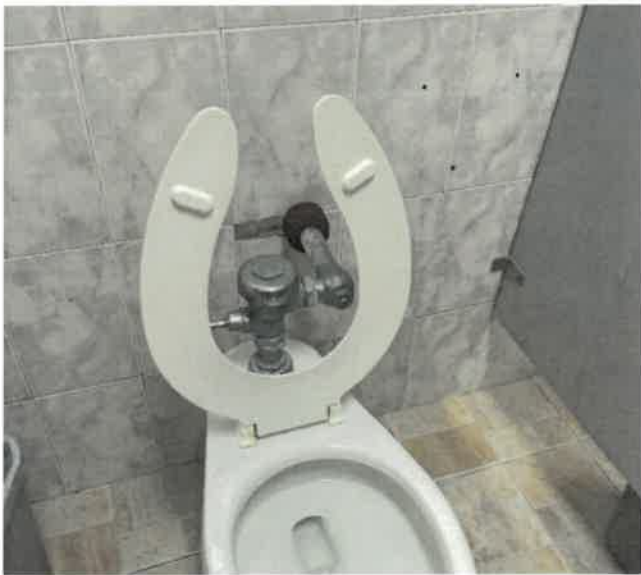
**Typical Gray Metal Toilet Valve
Painted with LBP
Men Bathroom, 1st Floor**

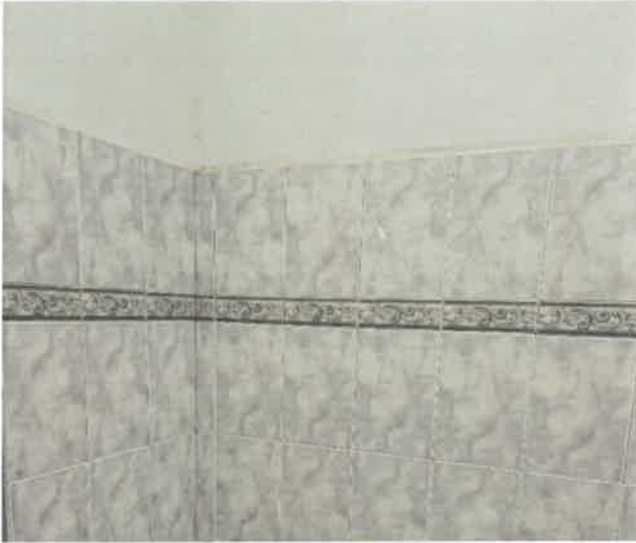
**Typical Green/Gray Ceramic Strip
Painted with LBP
Men Bathroom, 1st Floor**

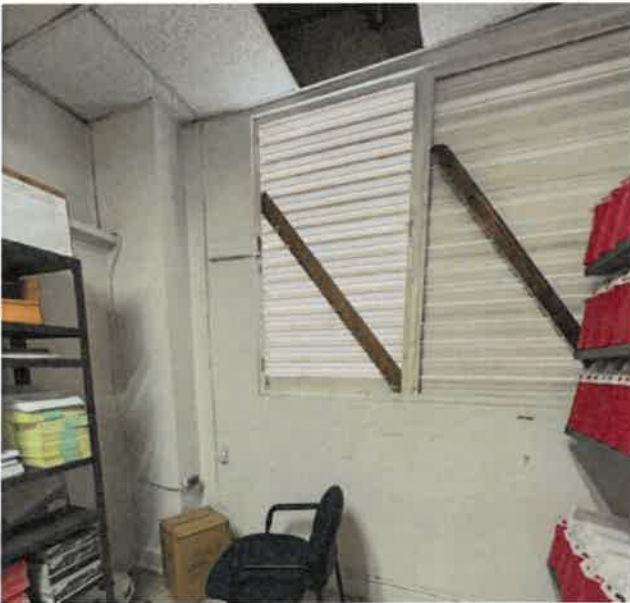
**Typical White Concrete Wall B
and Column
Painted with LBP
Storage 1, 1st Floor**

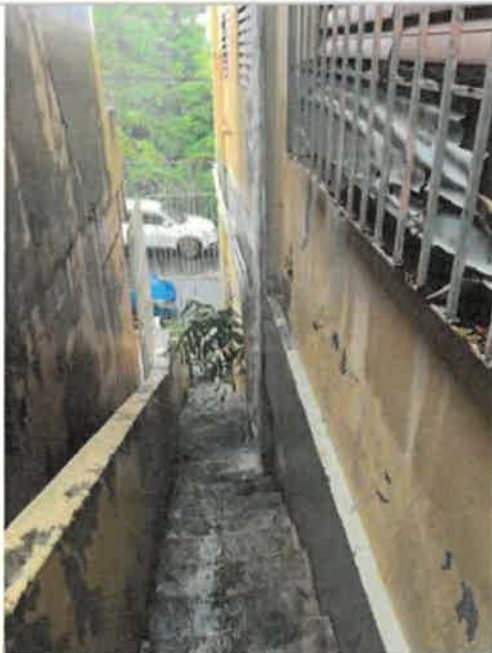
South Side Wall Exterior, 28 SF of Historic concrete stairs plaster and paint, view of the water falling from the roof directly on the stairs, about a 30 feet waterfall, because of a blown off downspout, 0% work completed (photo 2 of 2)

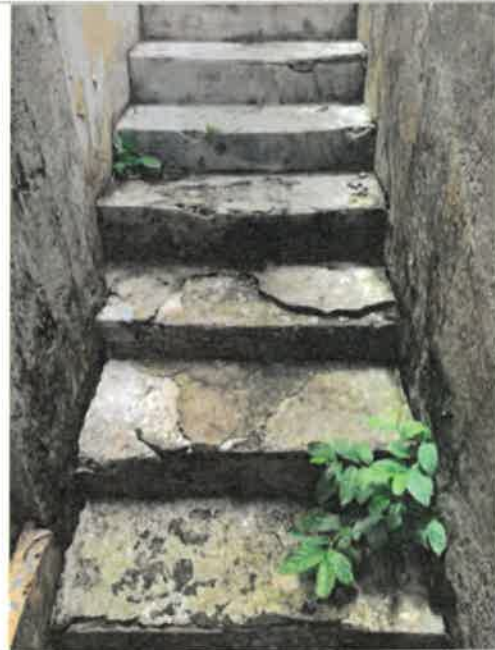
South Side Wall Exterior, 28 SF of Historic concrete stairs plaster and paint, 32 IN long x 12 IN wide x 6 IN high, 7 steps, eroded by falling water directly from the roof because of a blown off downspout, 0% work completed (photo 1 of 2)

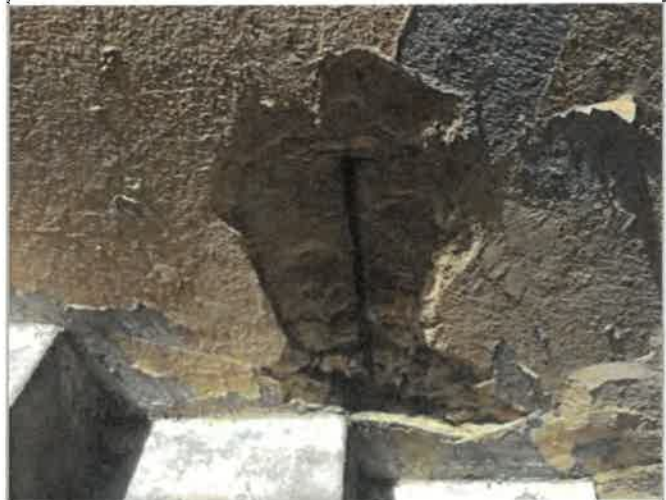
South Side Wall Exterior, 6 SF of Historic concrete sidewalk plaster and paint, 2 FT long x 3 FT wide, eroded by falling water from the roof because of a blown off downspout, 0% work completed

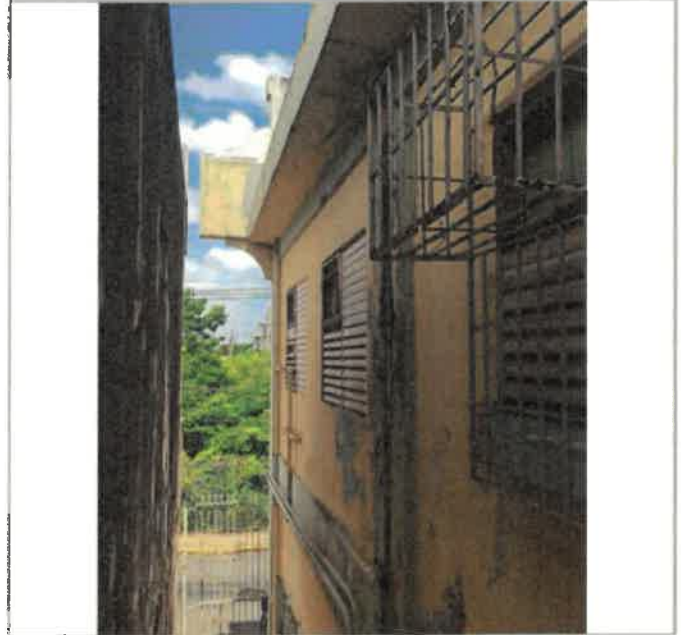
South Side Wall Exterior, 6 each of aluminum jalousie window, 5 FT long x 3 FT wide, high winds and wind blown debris broke and/or bent the windows, should be verified for Historic characteristics. 0% work completed (photo 2 of 2)

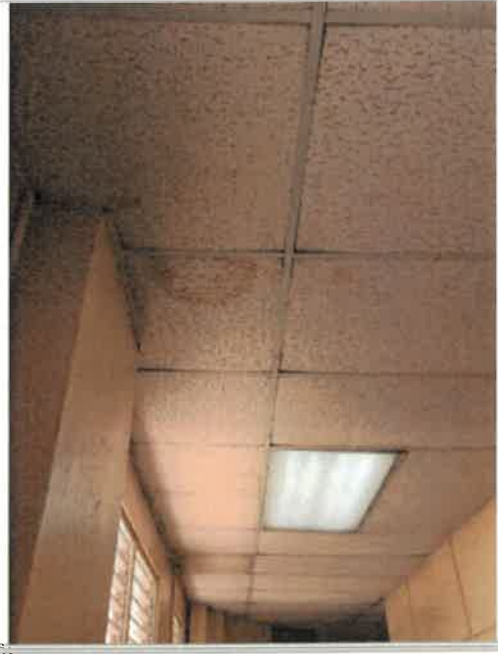
2nd Floor Stairs Hallway, 132 SF of suspended lay-in acoustic 2 x 4 ceiling tile, 22 FT long x 6 FT wide, water intrusion through roof failure damage the tile, temporarily replaced, 0% work completed

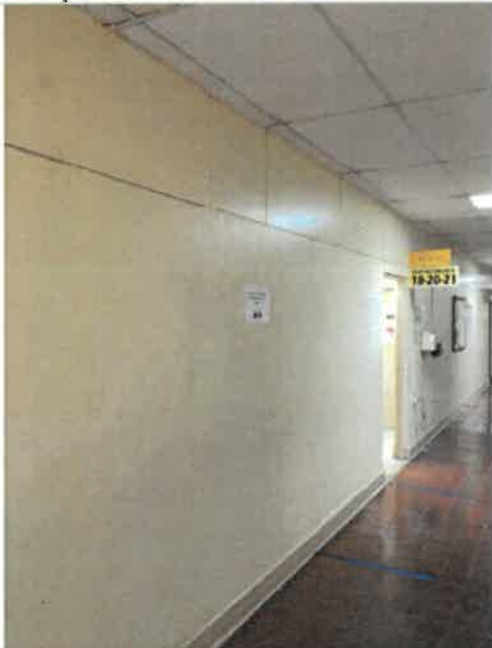
2nd Floor Main Hallway, 1,787 SF of Historic concrete wall paint, (119 + 119)ft x 86in high + (9ft x 9ft high), water intrusion through roof and window failure blistered and/or peeled off the paint, temporarily painted, 0% work completed
