ENMIENDA NÚM. 3

SUBASTA FORMAL 23J-16945 PARA REALIZAR MEJORAS EN EL PRIMER PISO DE LA UNIDAD DE SALUD PÚBLICA (USP) DE RÍO PIEDRAS, ADSCRITA AL DEPARTAMENTO DE SALUD DEL GOBIERNO DE PUERTO RICO

Damage Description and Dimensions

Damage #151656; USP Rio Piedras

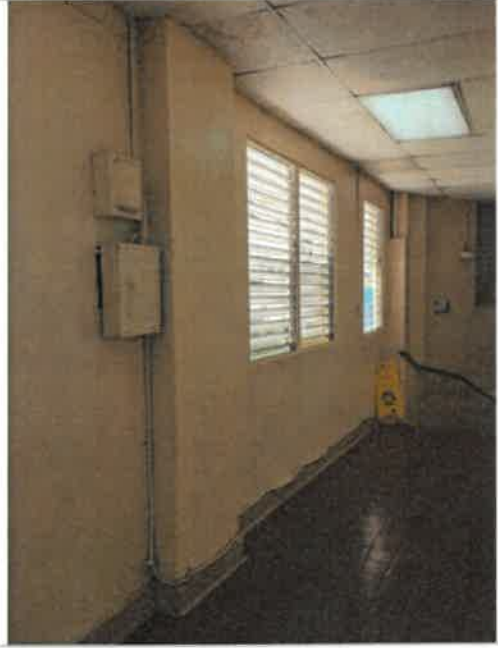
2nd Floor Stairs Hallway, 356 SF of Historic concrete wall paint, (22ft x 86 in high) + (22ft x 9ft high), water intrusion through roof and window failure blistered and/or peeled off the paint, temporarily painted, 0% work completed

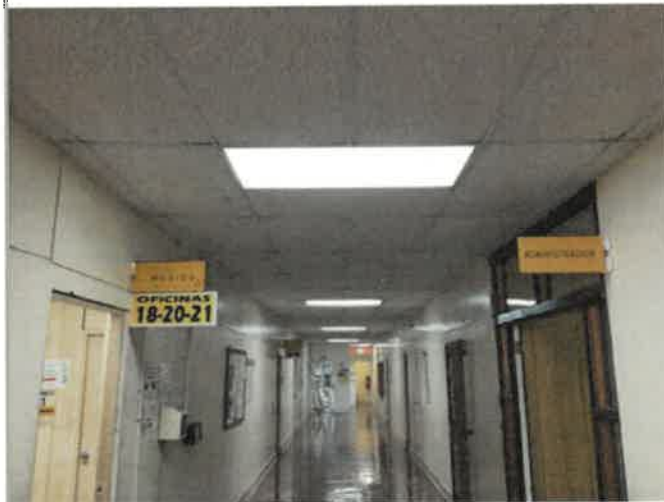
2nd Floor Main Hallway, 6 each of fluorescent drop-in ceiling light fixture, 4 tubes, 2 FT long x 4 FT wide, water intrusion through roof and window failure damage the fixture, the tubes were replaced with LED, 0% work completed

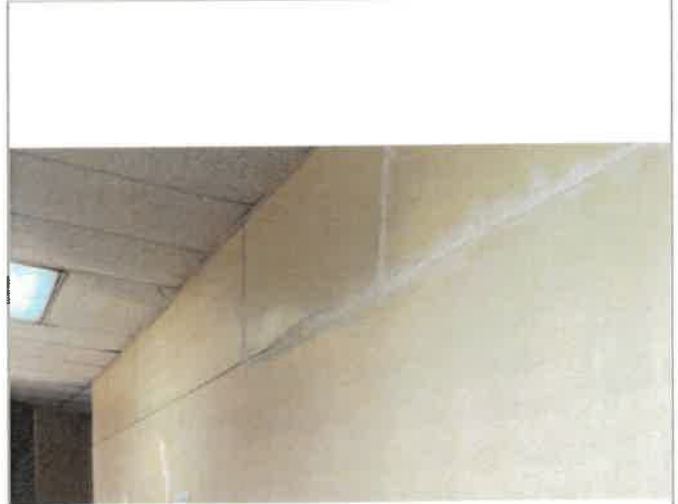
2nd Floor Main Hallway, 455 SF of wooden panel wall paint, 260 LF long x 21 IN high, water intrusion through roof and window failure blistered and/or peeled off the paint, temporarily painted, 0% work completed (photo 2 of 2)

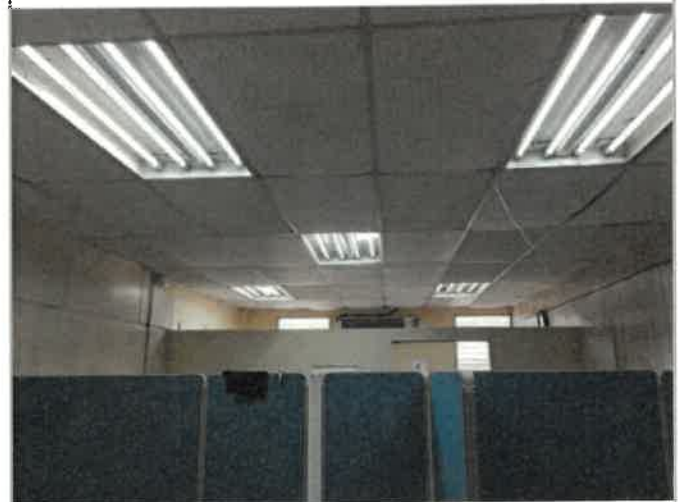
2nd Floor Doctor, Social Work and Mother & Child, 2 x 4 fluorescent drop-in ceiling light fixture, 4 tubes, and suspended acoustic ceiling tiles, water intrusion through roof and window failure damaged the fixtures, the tubes were replaced with LED types, (photo 1 of 3)

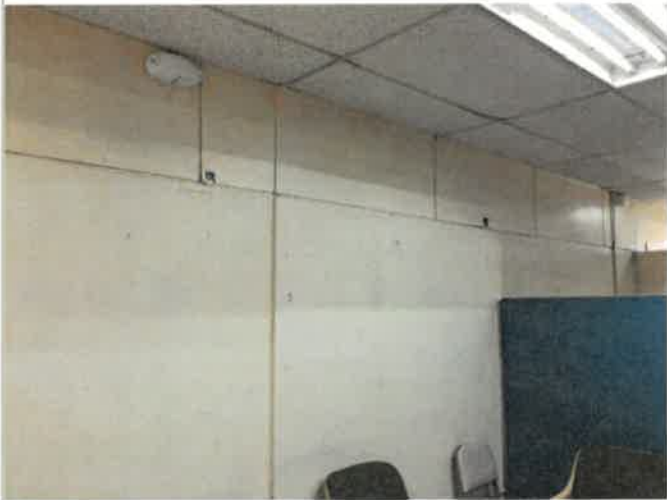
2nd Floor Doctor, Social Work and Mother & Child, 518 SF of Historic concrete wall paint, and 56 SF of wooden panel wall paint, water intrusion through roof and window failure blistered and/or peeled off the paint, temporarily painted, 0% work completed

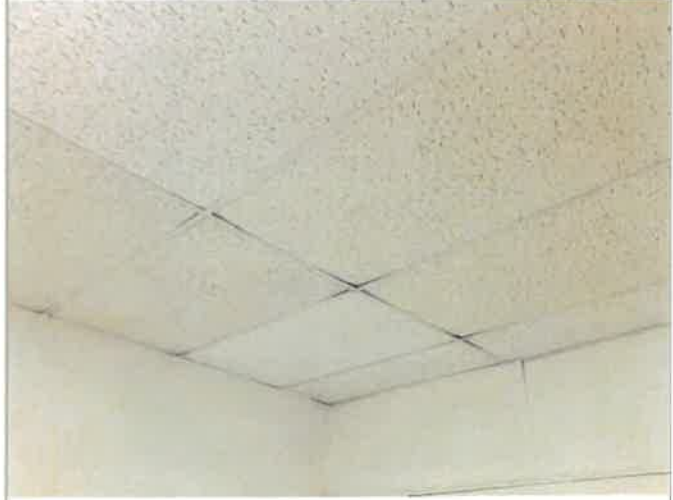
2nd Floor Health Certificate, 448 SF of suspended lay-in acoustic 2 x 4 ceiling tile, 32 FT long x 14 FT wide, water intrusion through roof and window failure damage the tile, temporarily replaced, 0% work completed

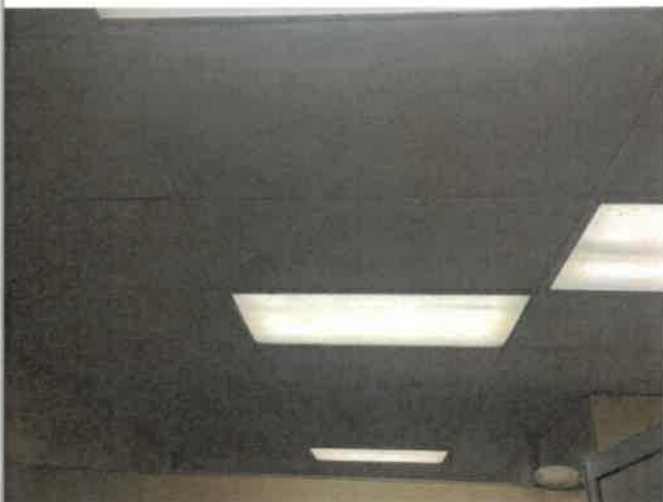
2nd Floor Epidemiology, 704 SF of suspended lay-in acoustic 2 x 4 ceiling tile, 22 FT long x 32 FT wide, and 7 each of fluorescent drop-in ceiling light fixture, 4 tubes, 2 FT long x 4 FT wide, water intrusion through roof and window failure damage the fixture and tiles, temporarily replaced tiles and tubes, 0% work completed

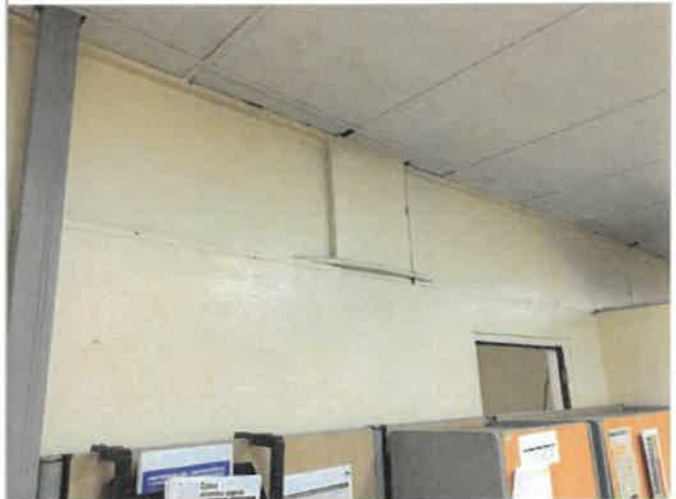
2nd Floor Epidemiology, 657 SF of Historic concrete wall paint, (22ft x 9ft high) + 2 walls of (32ft x 86in high), and 112 SF of wooden panel wall paint, 64 LF long x 21 IN high, 2 walls of (32ft x 21in high), water intrusion through roof and window failure blistered and/or peeled off the paint, temporarily painted, 0% work completed

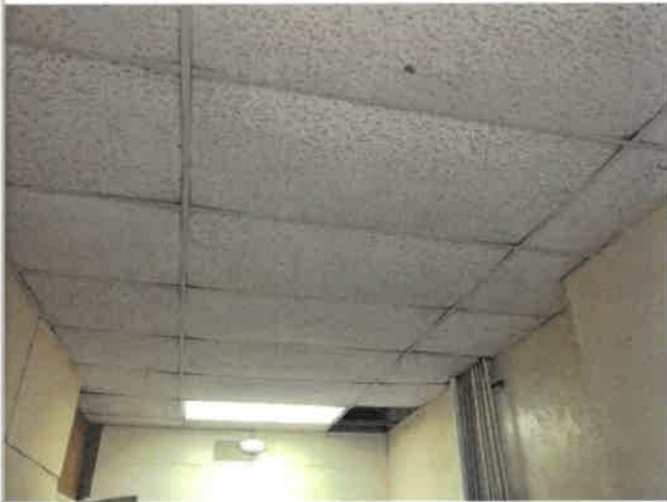
2nd Floor Restrooms Hallway, 288 SF of suspended lay-in acoustic 2 x 4 ceiling tile, 36 FT long x 8 FT wide, water intrusion through roof and window failure damage the tile, temporarily replaced, 0% work completed

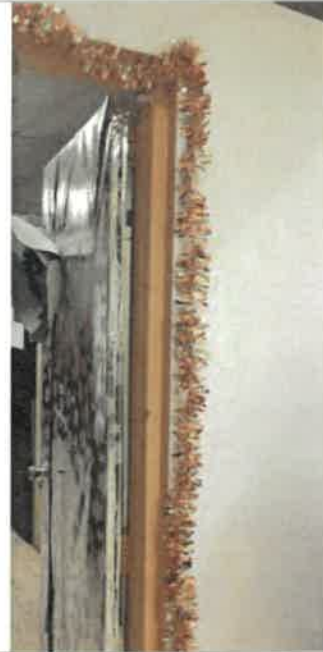
2nd Floor Vaccination, 309 SF of Historic concrete wall paint, (20ft x 9ft high) + (18ft x 86in high), water intrusion through roof and window failure blistered and/or peeled off the paint, temporarily painted, 0% work completed

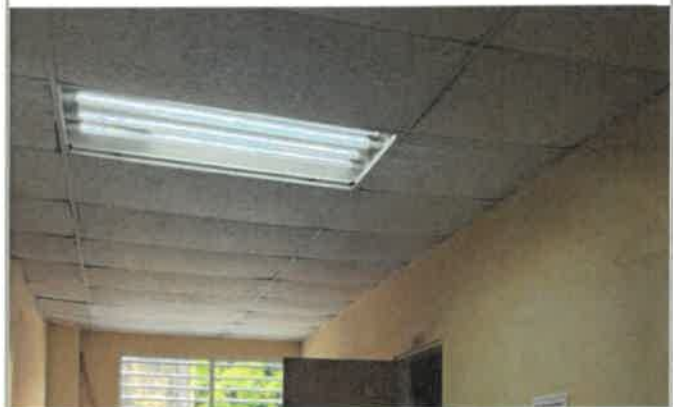
2nd Floor Restrooms Hallway, 2 each of fluorescent drop-in ceiling light fixture, 4 tubes, 2 FT long x 4 FT wide, water intrusion through roof and window failure damage the fixture, the tubes were replaced with LED, 0% work completed

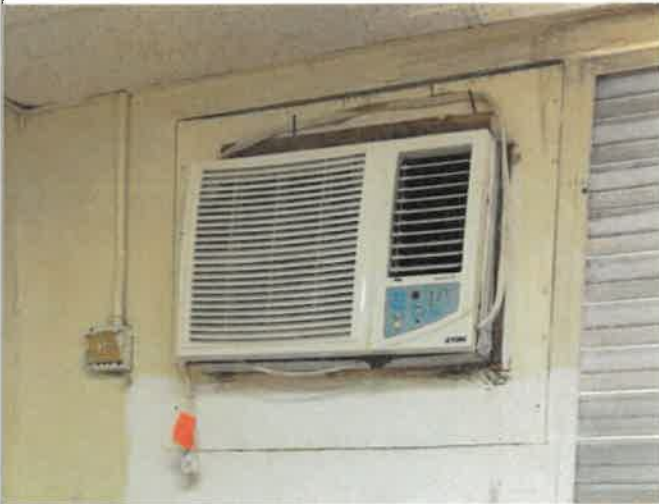
2nd Floor Finances, Epidemiology and Vaccination, 1 each (for each room) of window mounted 18,500 BTU A/C unit, high winds, wind driven rain, wind blown debris and water intrusion damage the units, 0% work completed

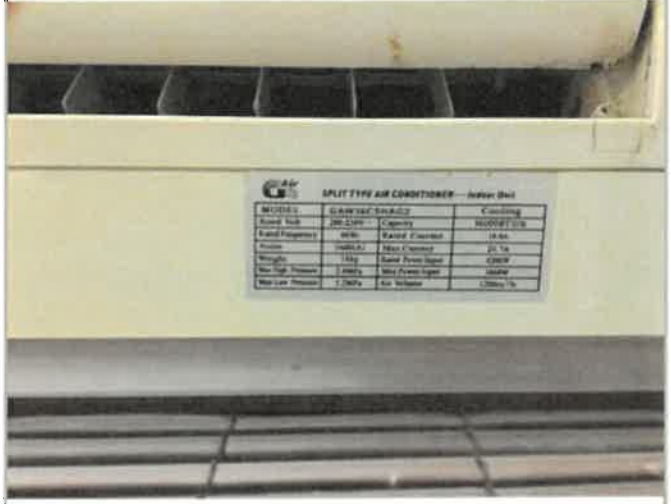
2nd Floor Health Certificate, 2 each of wall mounted 3 ton split A/C unit (blower specifications), high winds, wind driven rain, wind blown debris and water intrusion damage the unit, 100% work completed (photo 1 of 3)

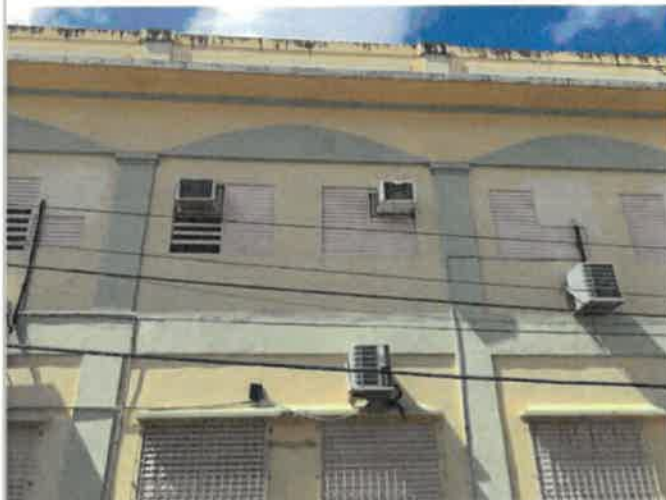
Building Exterior, aluminum jalousie window sealing to concrete, 1,054 LF long, 43 windows (6ft x 5ft) + 5 windows (3ft x 5ft) + 2 windows (5ft x 2ft), high winds, wind driven rain, and wind blown debris damage the seal, 0% work completed (photo 1 of 2)

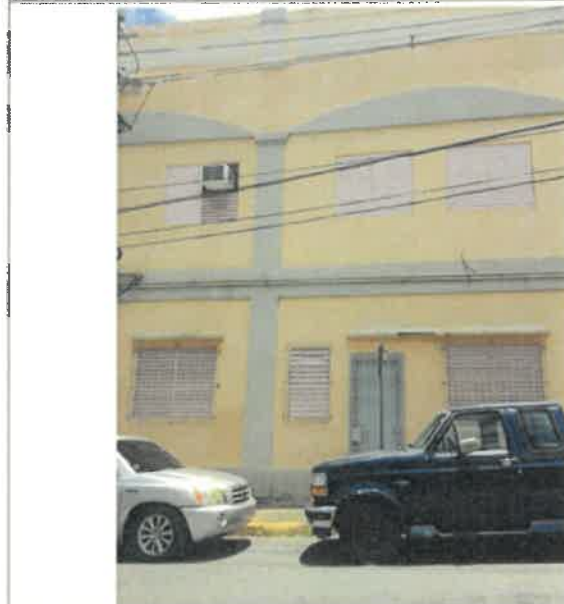
Building Exterior, aluminum jalousie window sealing to concrete, 1,054 LF long, 43 windows (6ft x 5ft) + 5 windows (3ft x 5ft) + 2 windows (5ft x 2ft), high winds, wind driven rain, and wind blown debris damage the seal, 0% work completed (photo 2 of 2)

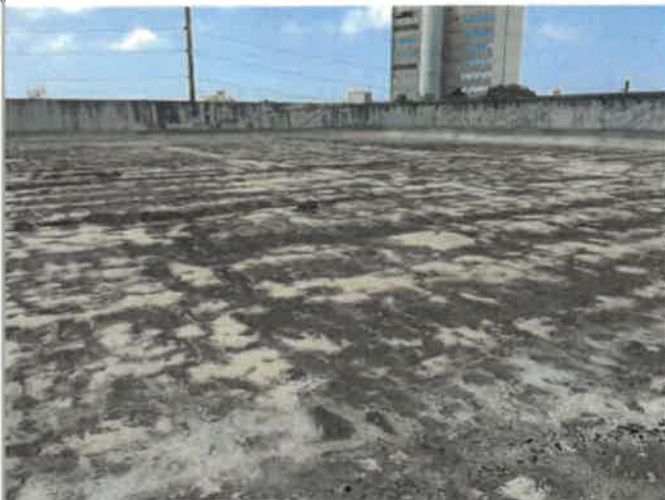
Roof, 9,600 SF of built-up membrane roof waterproofing treatment, 120 FT long x 80 FT wide, high winds, wind driven rain, and wind blown debris detached, bubbled, and peeled off the treatment, 0% work completed (photo 1 of 2)

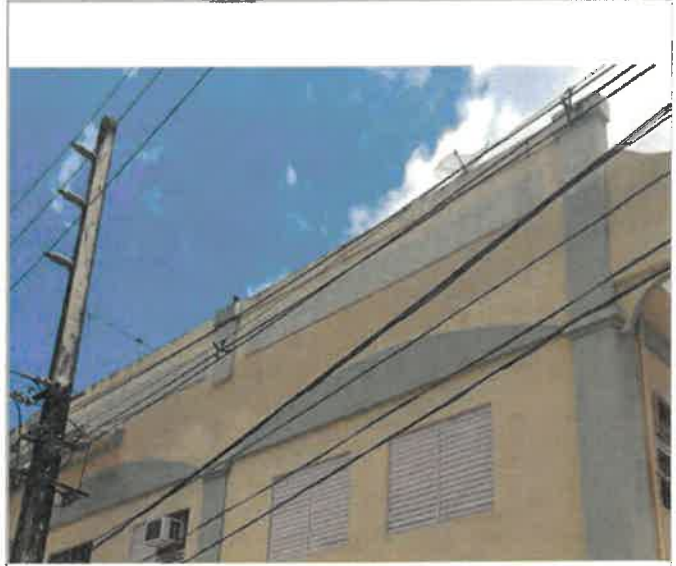
West Side Wall Building Exterior, 3 CY of Historic concrete cornice and paint, 40 FT long x 30 IN wide x 8 IN high, high winds, wind driven rain, and wind blown debris broke and/or loosened the cornice, it was demolished by Applicant, 0% work completed (photo 2 of 2)

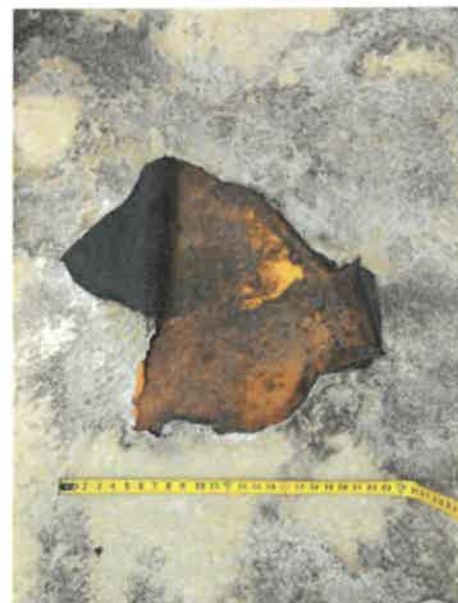
Roof, 9,600 SF of built-up membrane roof waterproofing treatment, 120 FT long x 80 FT wide, high winds, wind driven rain, and wind blown debris detached, bubbled, and peeled off the treatment, 0% work completed (photo 2 of 2)

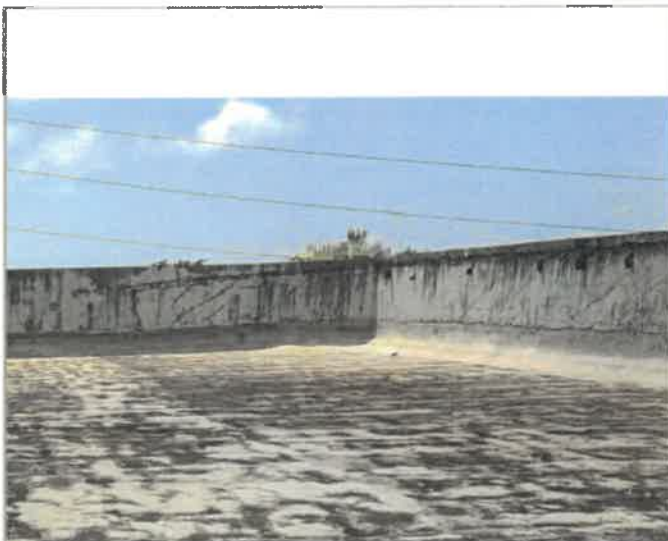
Roof Parapet, 1,960 SF of parapet wall paint, 280 LF long x 7 FT high, high winds, wind driven rain, and wind blown debris blistered and peeled off the paint, 0% work completed

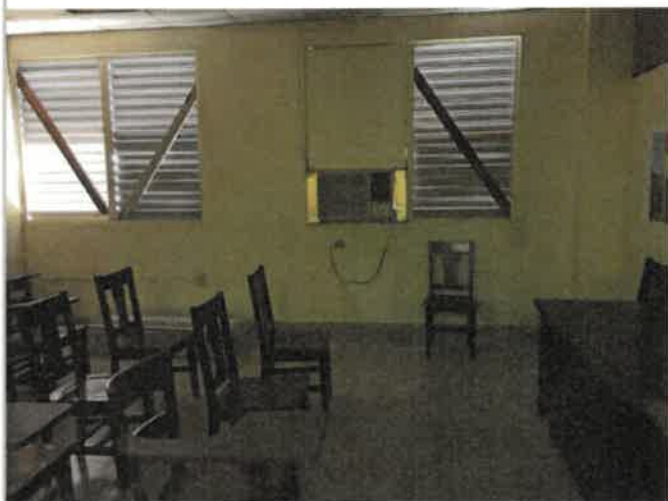
2nd Floor Conference Room 1, 497 SF of Historic concrete wall paint, side walls (31 + 17)ft x 86 in high + outside wall (17ft x 9ft high), water intrusion through roof and window failure blistered and/or peeled off the paint, temporarily painted, 0% work completed

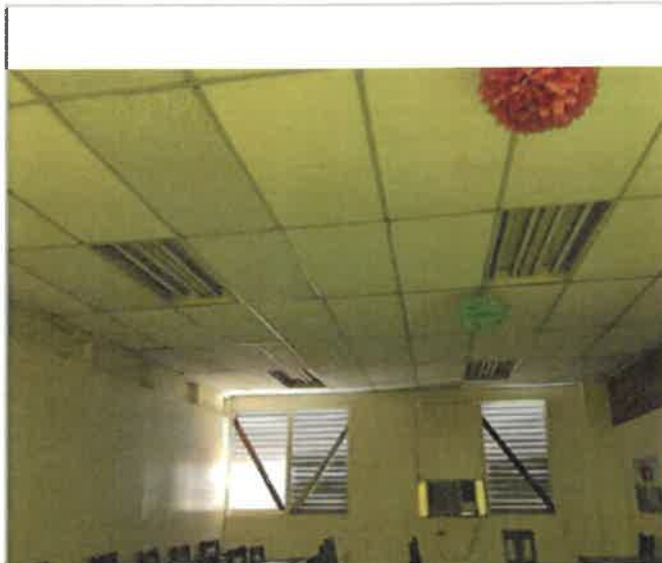
2nd Floor Conference Room 1, suspended lay-in acoustic 2 x 4 ceiling tile; fluorescent 2 x 4 drop-in ceiling light fixture, 4 tubes; and wall paint, water intrusion through roof and window failure damaged the area, 0% work completed

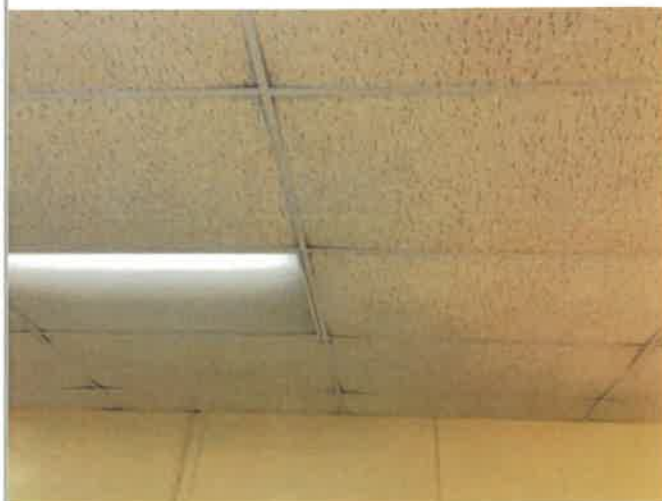
2nd Floor Finances, 448 SF of suspended lay-in acoustic 2 x 4 ceiling tile, 32 FT long x 14 FT wide, temporarily replaced, and 4 each of fluorescent drop-in ceiling light fixture, 4 tubes, 2 FT long x 4 FT wide, water intrusion through roof and window failure damage the fixture, 0% work completed

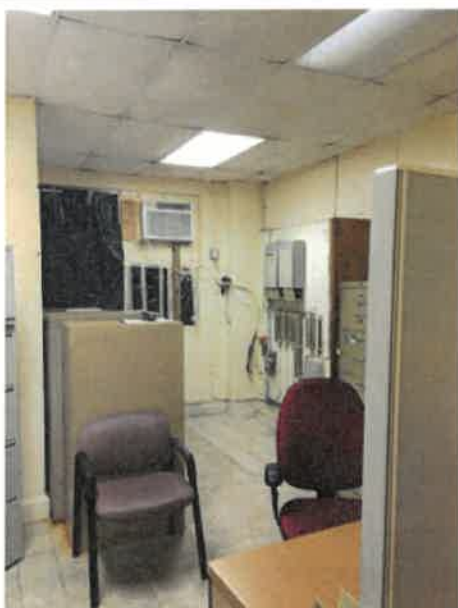
2nd Floor Finance, suspended lay-in acoustic 2 x 4 ceiling tile, temporarily replaced, fluorescent 2 x 4 drop-in ceiling light fixtures, and wall paint, all temporarily fixed, 0% work completed

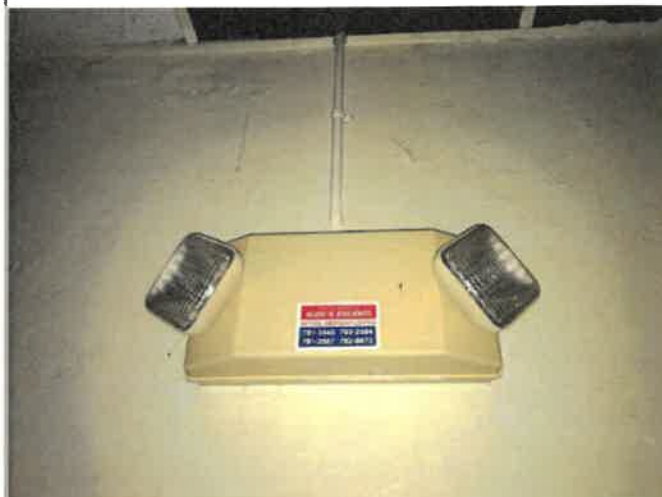
2nd Floor Hallways and Offices, 7 each of wall mounted Lithonia Emergency light fixture, 2 lamps, water intrusion through roof and window failure damaged the fixtures, 100% work completed (photo 1 of 3)

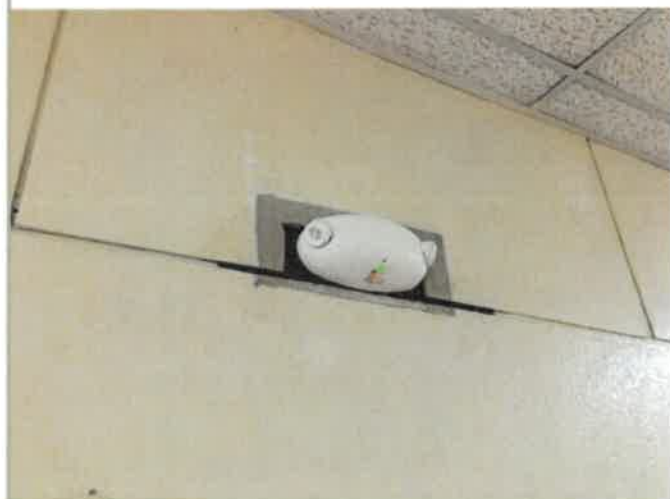
2nd Floor Hallways and Offices, 7 each of wall mounted Lithonia Emergency light fixture, 2 lamps, view of the new ones, water intrusion through roof and window failure damaged the fixtures, 100% work completed (photo 2 of 3)

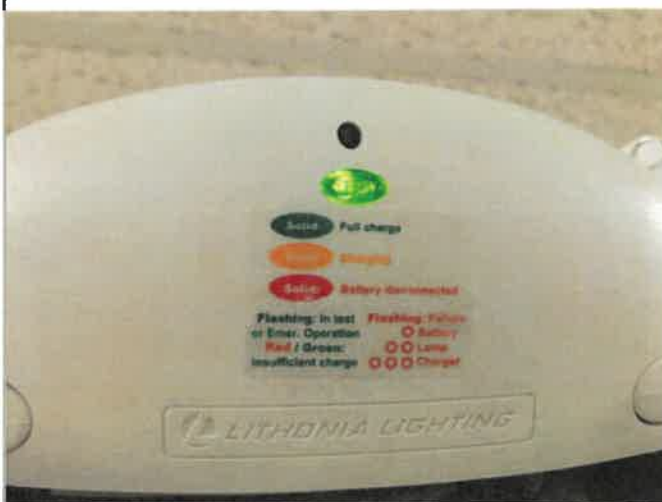
2nd Floor Hallways and Offices, 7 each of wall mounted Lithonia Emergency light fixture, 2 lamps, view of the new ones, water intrusion through roof and window failure damaged the fixtures, 100% work completed (photo 3 of 3)

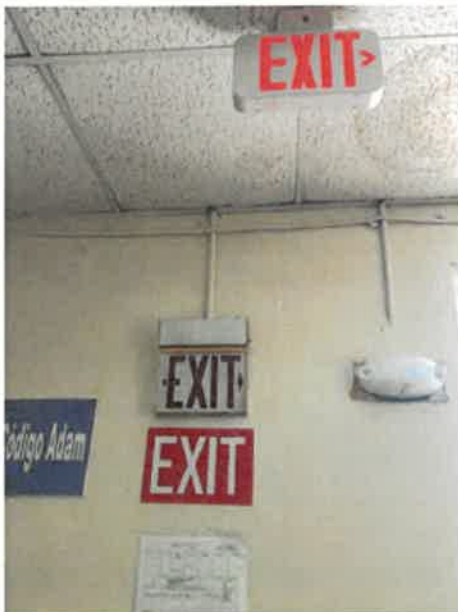
2nd Floor Main Hallway, 1 each of suspended ceiling mounted Exit light fixture, water intrusion through roof and window failure damaged the fixtures, 100% work complete

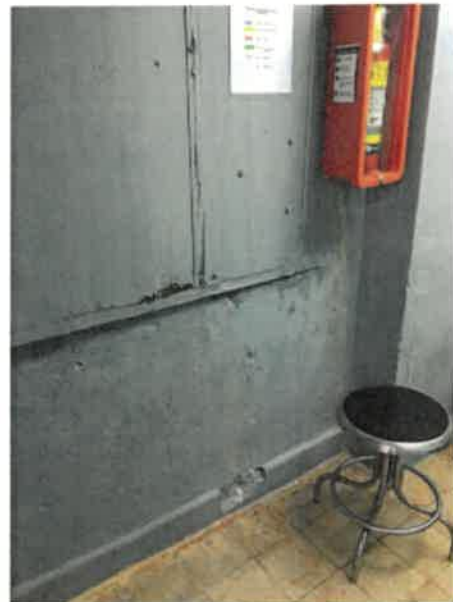
1st Floor Clinical Laboratory, 416 SF of Historic concrete wall paint, 52 LF long x 8 FT high, water intrusion through window failure blistered, and/or peeled off the paint, temporarily painted, 0% work completed (photo 1 of 2)

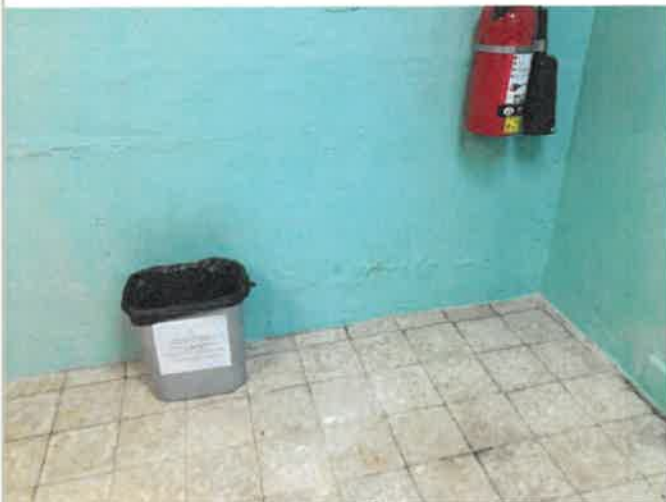
1st Floor Clinical Laboratory, 416 SF of Historic concrete wall paint, 52 LF long x 8 FT high, water intrusion through window failure blistered, and/or peeled off the paint, temporarily painted, 0% work completed (photo 2 of 2)

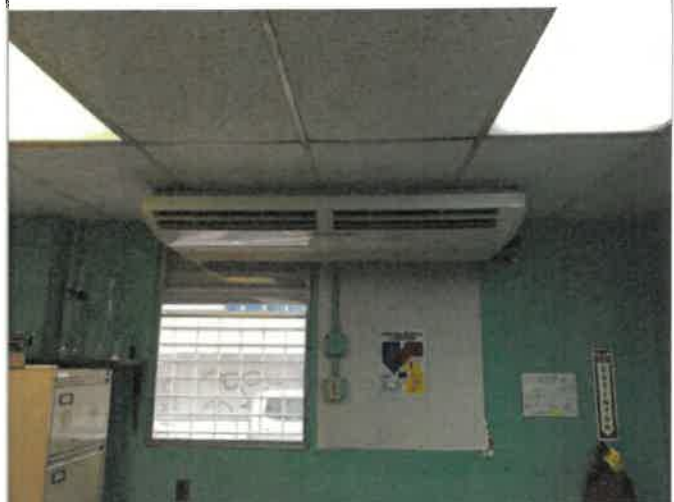
1st Floor Clinical Laboratory, 1 each of wall mounted AirMax CCF4-60CR 5 ton split A/C unit repairs, high winds, wind driven rain, wind blown debris and water intrusion damage the unit, 100% work completed (photo 1 of 2)

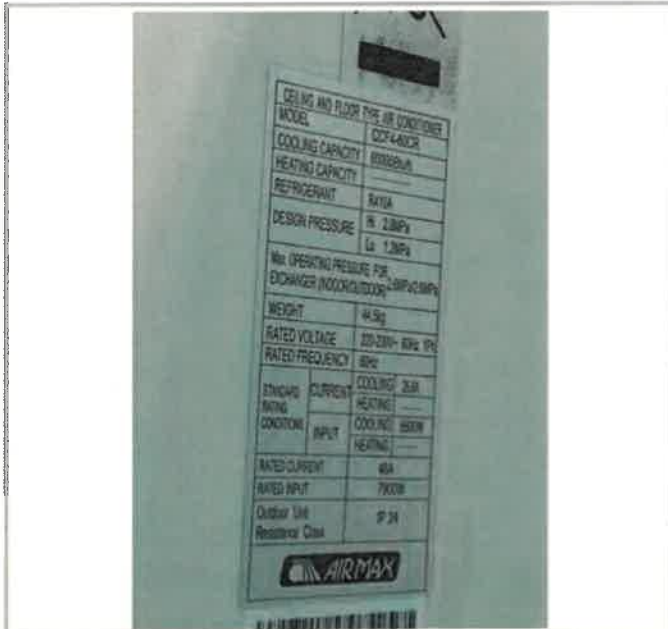
1st Floor Clinical Laboratory, 1 each of wall mounted AirMax CCF4-60CR 5 ton split A/C unit repairs, high winds, wind driven rain, wind blown debris and water intrusion damage the unit, 100% work completed (photo 2 of 2)

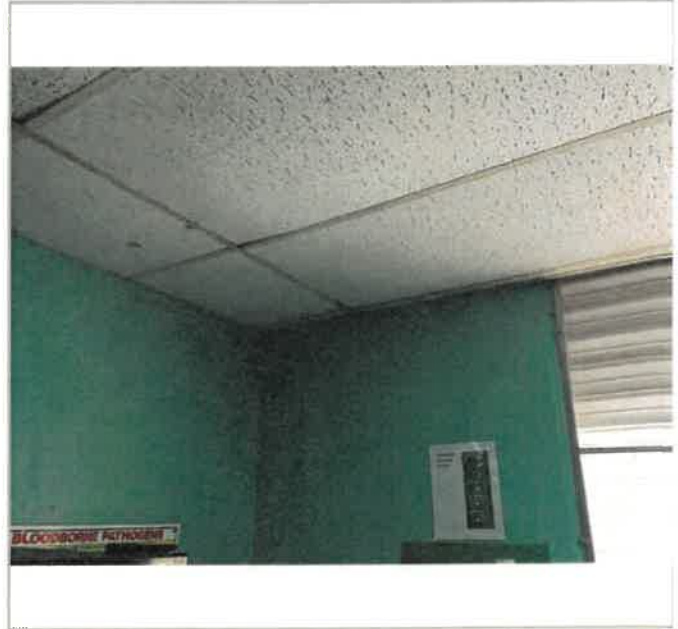
1st Floor Clinical Laboratory, 256 SF of suspended lay-in acoustic 2 x 4 ceiling tile, the first two rows next to the outside wall (this is a corner area) (8ft x 20ft) + (4ft x 24ft), water intrusion through window failure damage the tile, temporarily replaced, 0% work completed

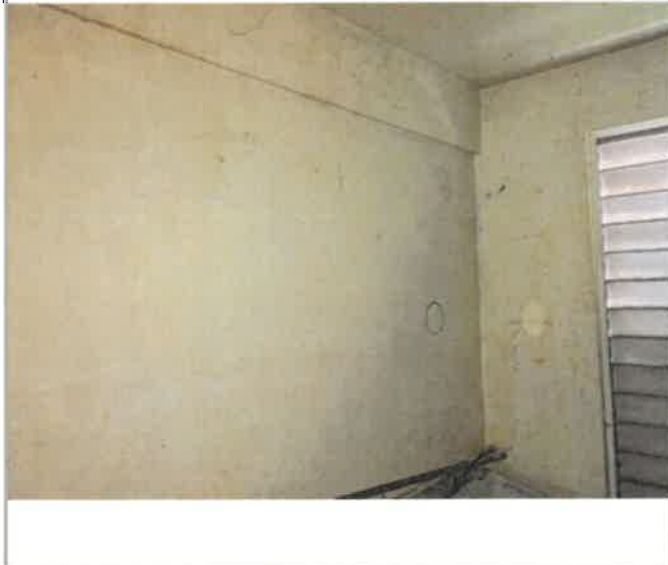
1st Floor Storage Room next to Serology, 470 SF of concrete wall paint, 54.75 LF long x 8.58 FT high, water intrusion through window failure, surface water flooding, and prolonged humidity blistered and/or peeled off the paint, 0% work completed (photo 1 of 2)

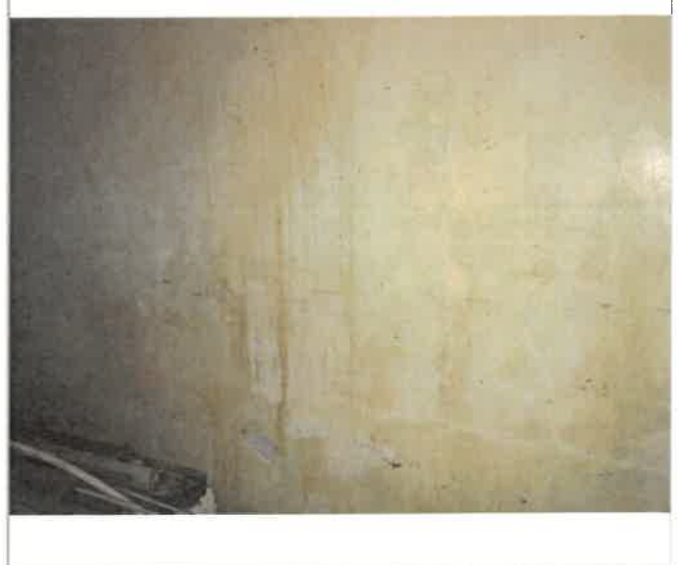
1st Floor Storage Room next to Serology, 470 SF of concrete wall paint, 54.75 LF long x 8.58 FT high, water intrusion through window failure, surface water flooding, and prolonged humidity blistered and/or peeled off the paint, 0% work completed (photo 2 of 2)

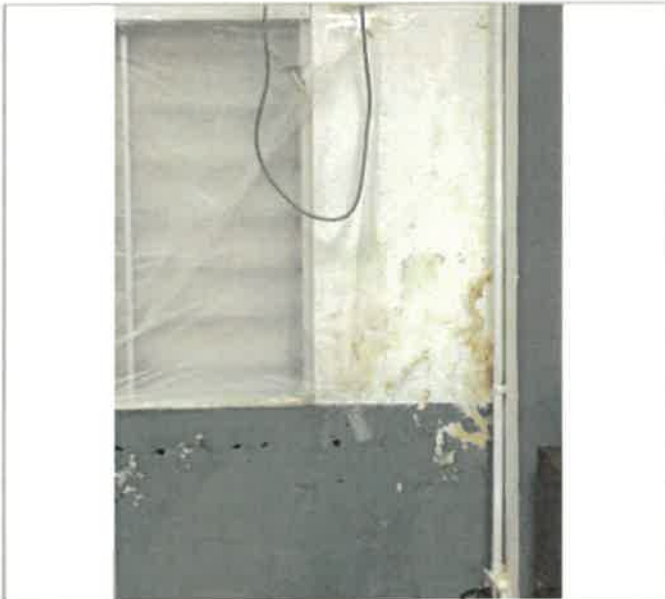
1st Floor Serology, 219 SF of Historic concrete wall paint, 24.25 FT long x 9 FT high, water intrusion through window failure and surface water flooding from water accumulated between the affected and the adjacent buildings blistered and/or peeled off the paint, ongoing problem, temporarily painted, 0% work completed (photo 1 of 2)

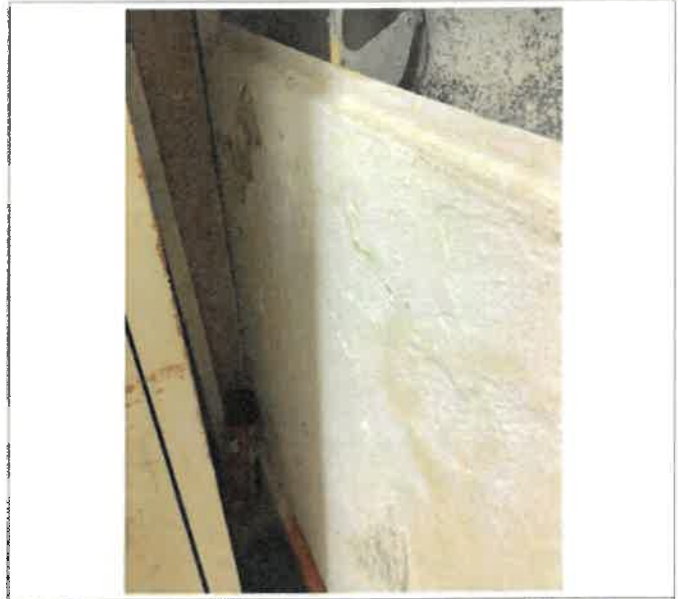
1st Floor Serology, 219 SF of Historic concrete wall paint, 24.25 FT long x 9 FT high, water intrusion through window failure and surface water flooding from water accumulated between the affected and the adjacent buildings blistered and/or peeled off the paint, ongoing problem, temporarily painted, 0% work completed (photo 2 of 2)

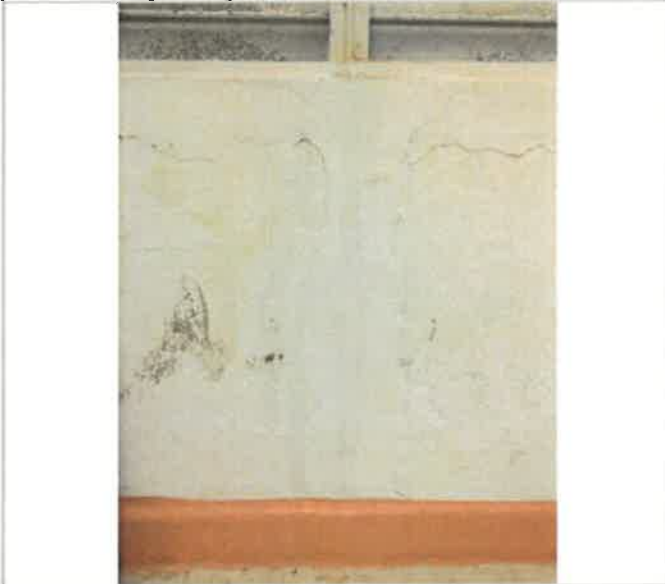
1st Floor Tuberculin Results Reading, 60 SF of Historic concrete wall paint, 6.67 FT long x 9 FT high, water intrusion through window failure and surface water flooding from water accumulated between the affected and the adjacent buildings blistered and/or peeled off the paint, ongoing problem, temporarily painted, 0% work completed

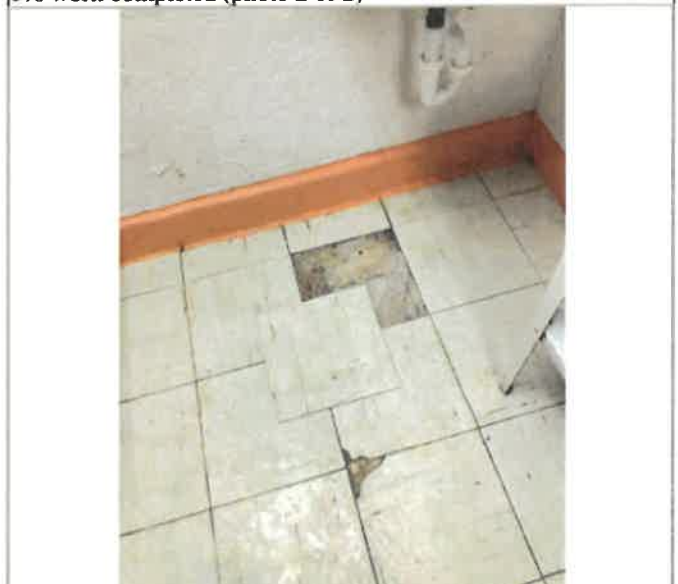
1st Floor Tuberculin Results Reading, 80 SF of vinyl composition tile (VCT) flooring, 12 FT long x 6.67 FT wide, surface water flooding, and prolonged humidity detached, lifted and stained the tiles, ongoing problem, 0% work completed (photo 1 of 2)

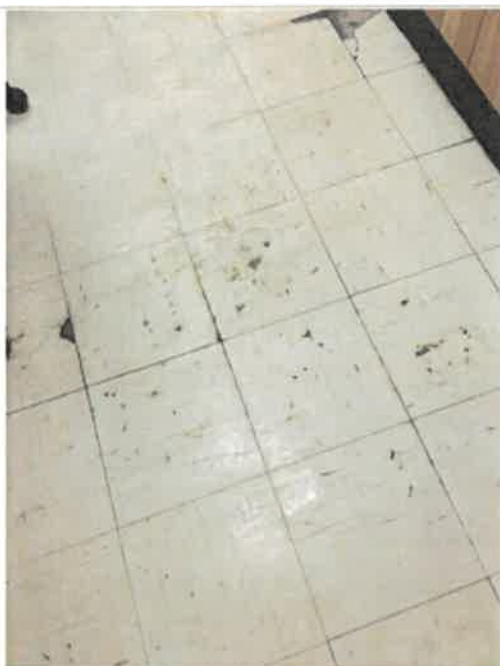
1st Floor Tuberculin Results Reading, 80 SF of vinyl composition tile (VCT) flooring, 12 FT long x 6.67 FT wide, surface water flooding, and prolonged humidity detached, lifted and stained the tiles, ongoing problem, 0% work completed (photo 2 of 2)

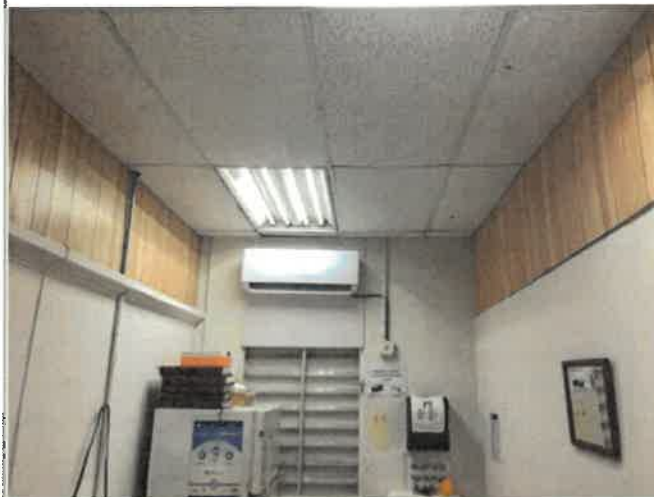
1st Floor Tuberculin Results Reading, 1 each of window mounted 12,000 BTU A/C unit, high winds, wind driven rain, wind blown debris and water intrusion damage the unit, replaced with Air-Con AEDEM4C4512 split unit, 100% work completed (photo 1 of 2)

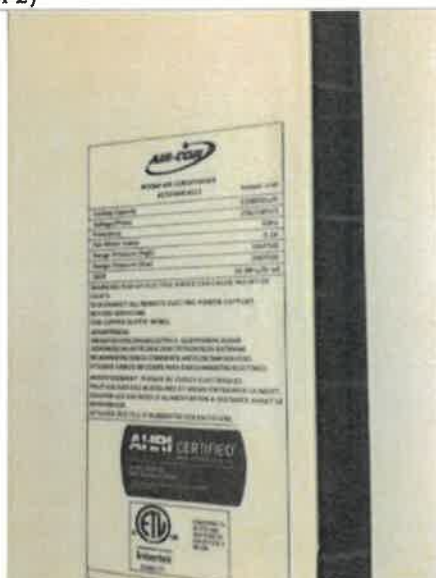
1st Floor Tuberculin Results Reading, 1 each of window mounted 12,000 BTU A/C unit, high winds, wind driven rain, wind blown debris and water intrusion damage the unit, replaced with Air-Con AEDEM4C4512 split unit, 100% work completed (photo 2 of 2)

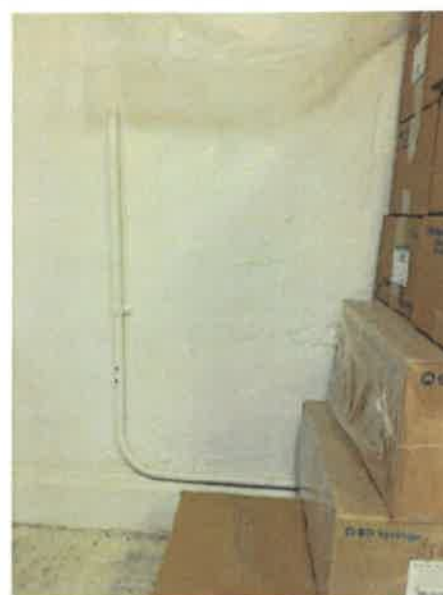
1st Floor Storage Room, 405 SF of Historic concrete wall paint, 45 FT long x 9 FT high, water intrusion through window failure and surface water flooding blistered and/or peeled off the paint, 0% work completed (photo 1 of 3)

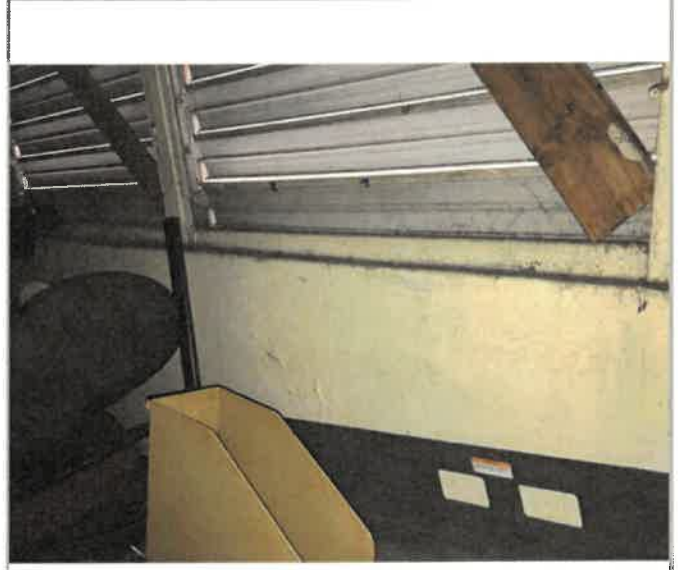
1st Floor Storage Room, 405 SF of Historic concrete wall paint, 45 FT long x 9 FT high, water intrusion through window failure and surface water flooding blistered and/or peeled off the paint, 0% work completed (photo 2 of 3)

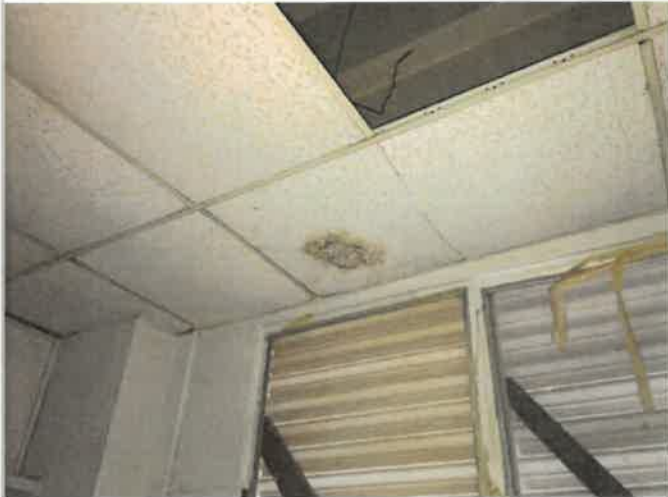
1st Floor Storage Room, 405 SF of Historic concrete wall paint, 45 FT long x 9 FT high, water intrusion through window failure and surface water flooding blistered and/or peeled off the paint, 0% work completed (photo 3 of 3)

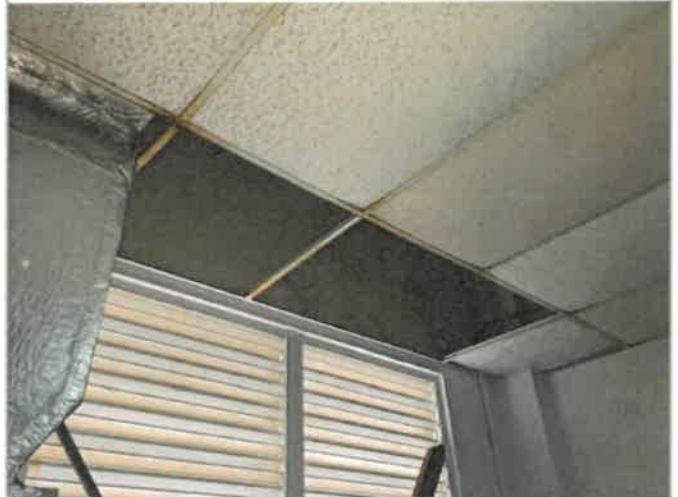
1st Floor Storage Room, 270 SF of suspended lay-in acoustic 2 x 4 ceiling tile, 45 FT long x 6 FT wide, the first two rows next to the outside wall, water intrusion through window failure damage the tile, 0% work completed (photo 1 of 2)

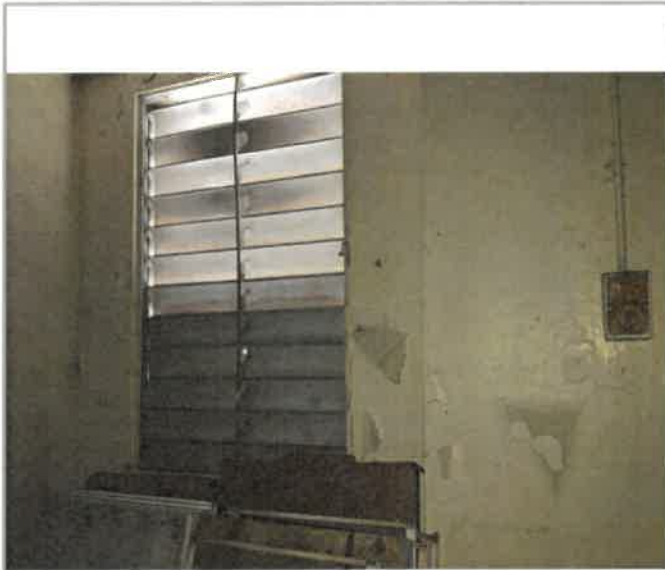
1st Floor Storage Room, 270 SF of suspended lay-in acoustic 2 x 4 ceiling tile, 45 FT long x 6 FT wide, the first two rows next to the outside wall, water intrusion through window failure damage the tile, 0% work completed (photo 2 of 2)

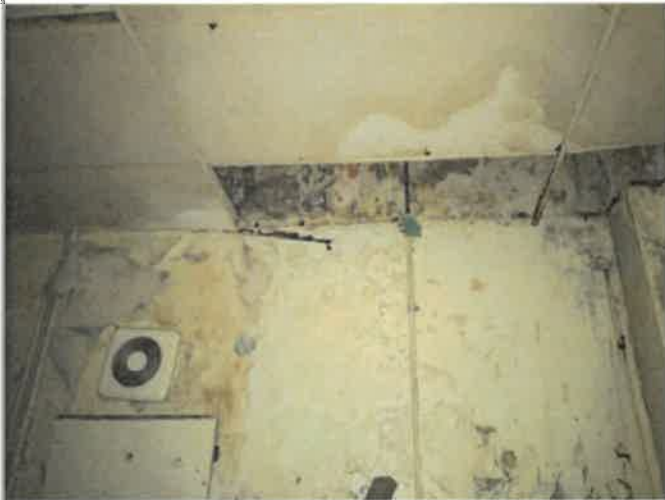
1st Floor Maintenance Storage Area, 815 SF of Historic concrete wall paint, 90.5 LF long x 9 FT high, water intrusion through window failure blistered and/or peeled off the paint, 0% work completed

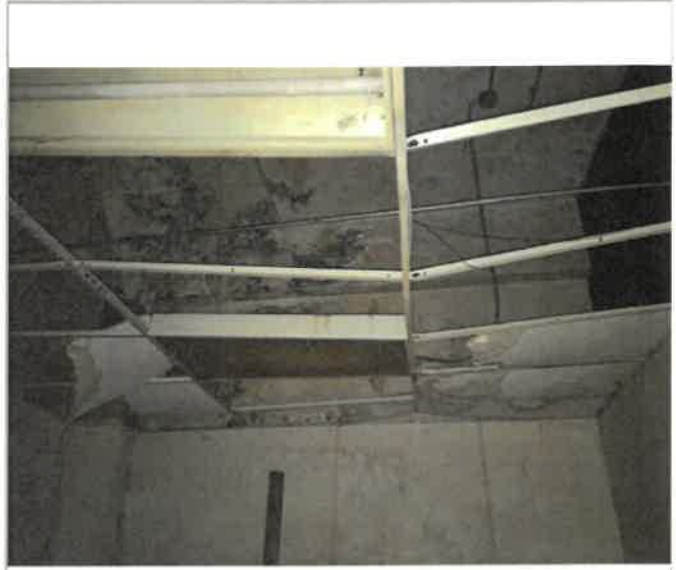
1st Floor Lunch Area, 162 SF of Historic concrete wall paint, 18 FT long x 9 FT high, and 144 SF of suspended lay-in acoustic 2 x 4 ceiling tile, 18 FT long x 8 FT wide, the first two rows next to the outside wall, excessive humidity caused damage, 0% work completed

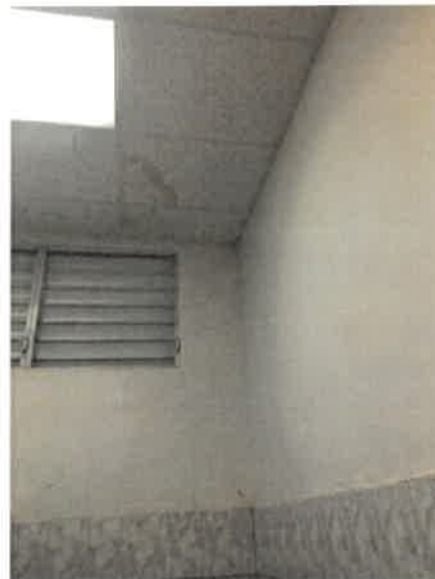
1st Floor Maintenance Storage Area, 544 SF of suspended lay-in acoustic 2 x 4 ceiling tile, the first three rows next to the outside wall (this is a corner area) (64ft x 6ft) + (20ft x 8ft), water intrusion through window failure damage the tile, 0% work completed

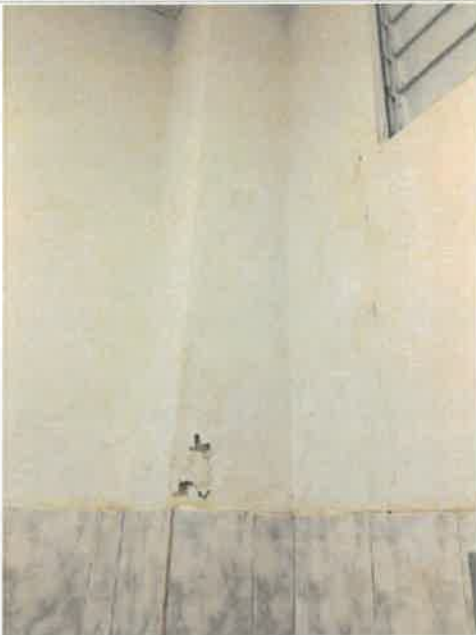
1st Floor Men's Restroom, 48 SF of suspended lay-in acoustic 2 x 4 ceiling tile, 9.5 FT long x 5 FT wide, the first two rows next to the outside wall, water intrusion through window failure damage the tile, ongoing problem, 0% work completed

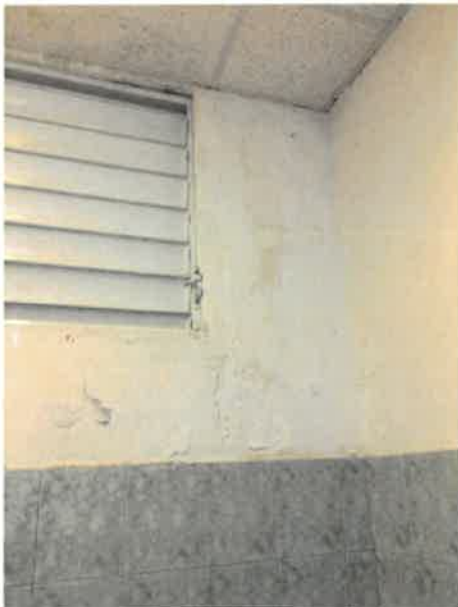
1st Floor Men's Restroom, 54 SF of Historic concrete wall paint, 9.5 FT long x 5.67 FT high, there are glazed tiles on the lower part of the wall, water intrusion through window failure blistered and/or peeled off the paint, ongoing problem, 0% work completed

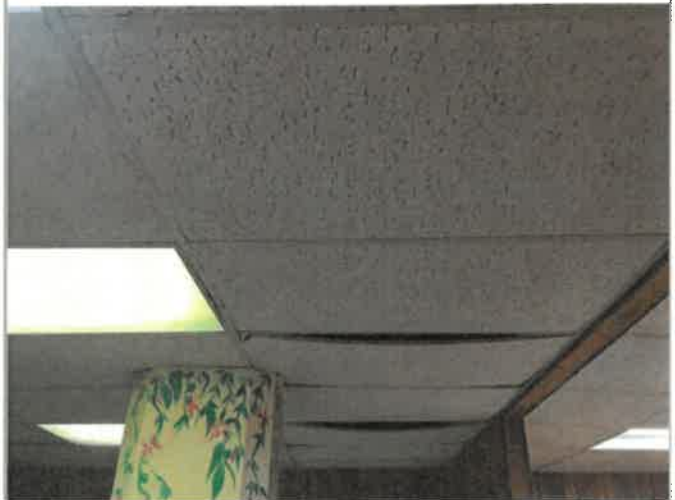
1st Floor Women's Restroom, 44 SF of suspended lay-in acoustic 2 x 4 ceiling tile, 8.67 FT long x 5 FT wide, the first two rows next to the outside wall, water intrusion through window failure damage the tile, ongoing problem, 0% work complete

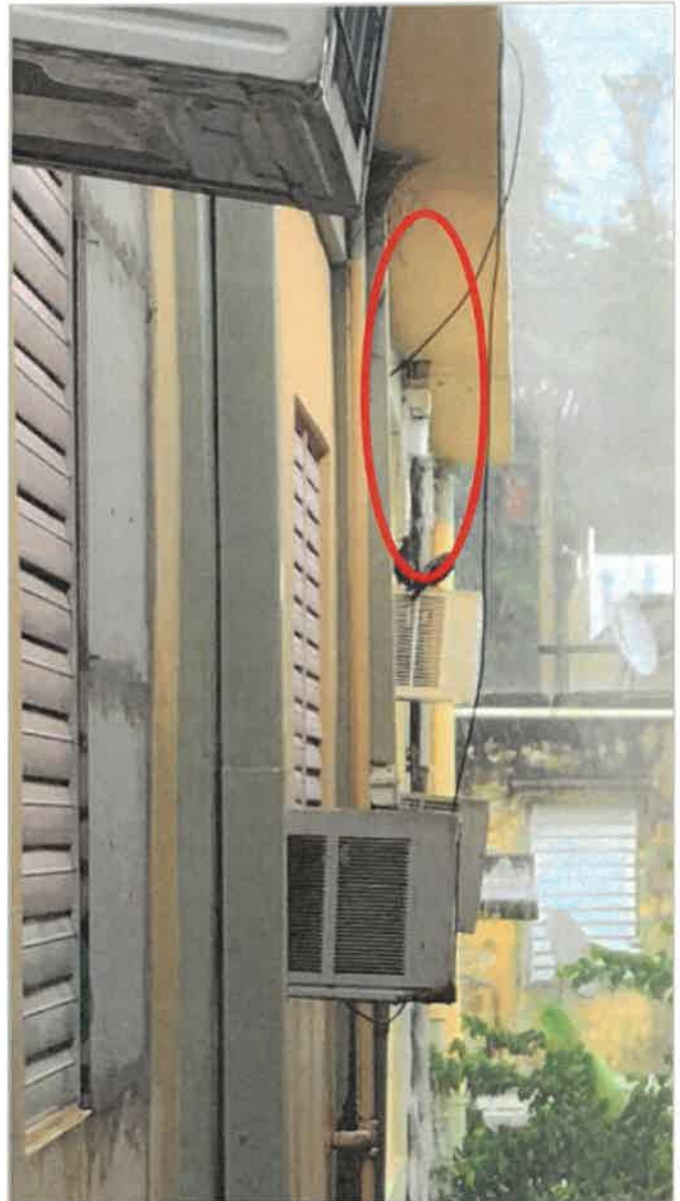
South Side Wall Exterior, metal 4in x 6in downspout, 90 LF long (view of an opening on the roof where the downspout was), wind driven rain, and wind blown debris blew off three 30ft long pieces, 0% work completed (photo 2 of 3)

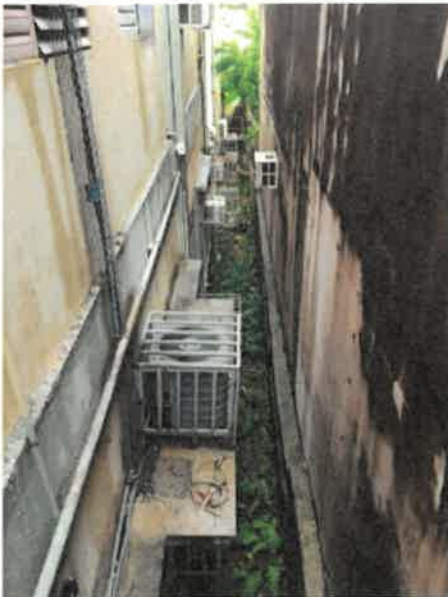
South Side Wall Exterior, metal 4in x 6in downspout, 90 LF long (view of another missing downspout and water falling profusely), high winds, wind driven rain, and wind blown debris blew off three 30ft long pieces, possible mitigation to effectively drain the south side of the building because all the roof drainage is on that side (where another building structure is erected just 5 ft apart) plus the emergency concrete stairs are on that side of the building, closing more that drainage area, 0% work completed (photo 3 of 3)

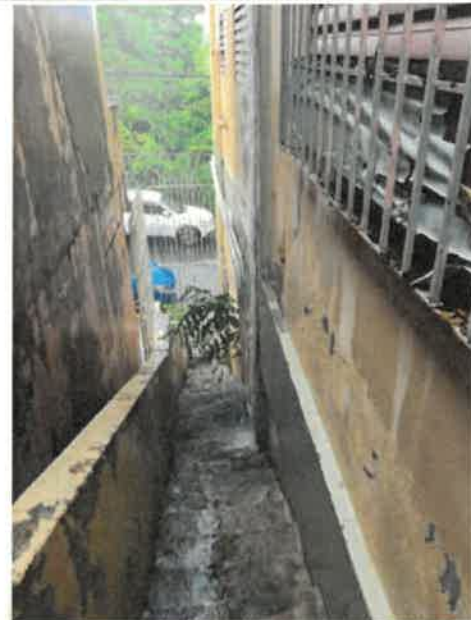
South Side Wall Exterior, view of the narrow space between the affected building and the adjacent building, which serves as the roof water drainage area to the outside of the property, possible mitigation (photo 1 of 3)
