ENMIENDA NÚM. 3

SUBASTA FORMAL 23J-16945 PARA REALIZAR MEJORAS EN EL PRIMER PISO DE LA UNIDAD DE SALUD PÚBLICA (USP) DE RÍO PIEDRAS, ADSCRITA AL DEPARTAMENTO DE SALUD DEL GOBIERNO DE PUERTO RICO

Damage Description and Dimensions

Damage #151656; USP Rio Piedras

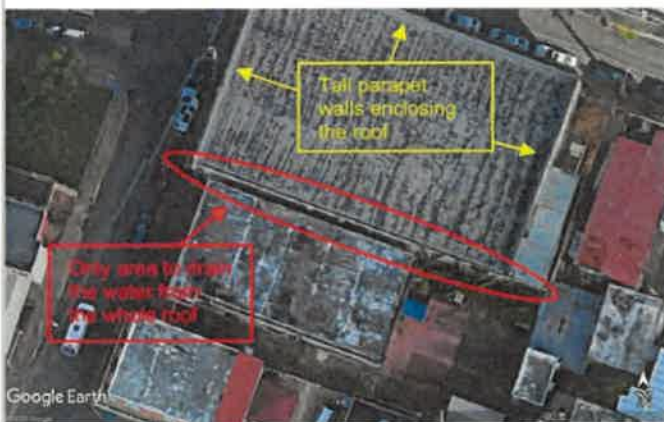
South Side Wall Exterior, view of the narrow space (few inches) between the affected building stairs and the adjacent building, which serves as the roof water drainage area to the outside of the property, possible mitigation (photo 2 of 3)

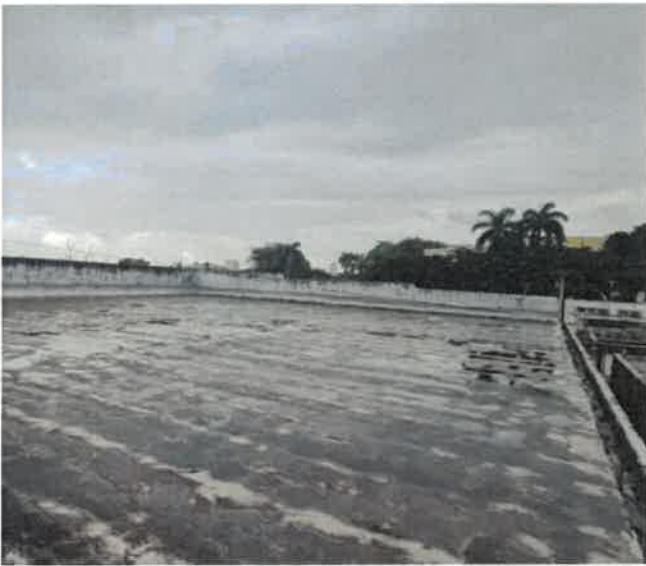
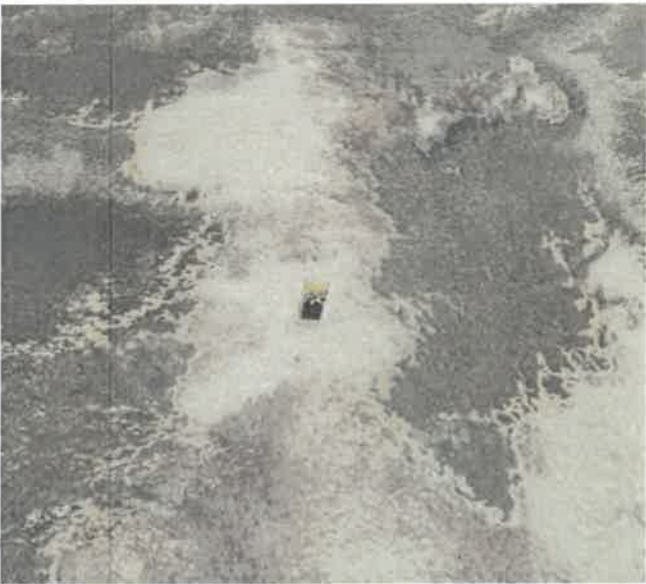
**Asbestos Containing Roof Built-Up
for Structure's Main Roof**
