ASBESTOS CONTAINING MATERIALS INSPECTION REPORT

CDT Maunabo

DEPARTAMENTO DE
SALUD

May 9, 2022

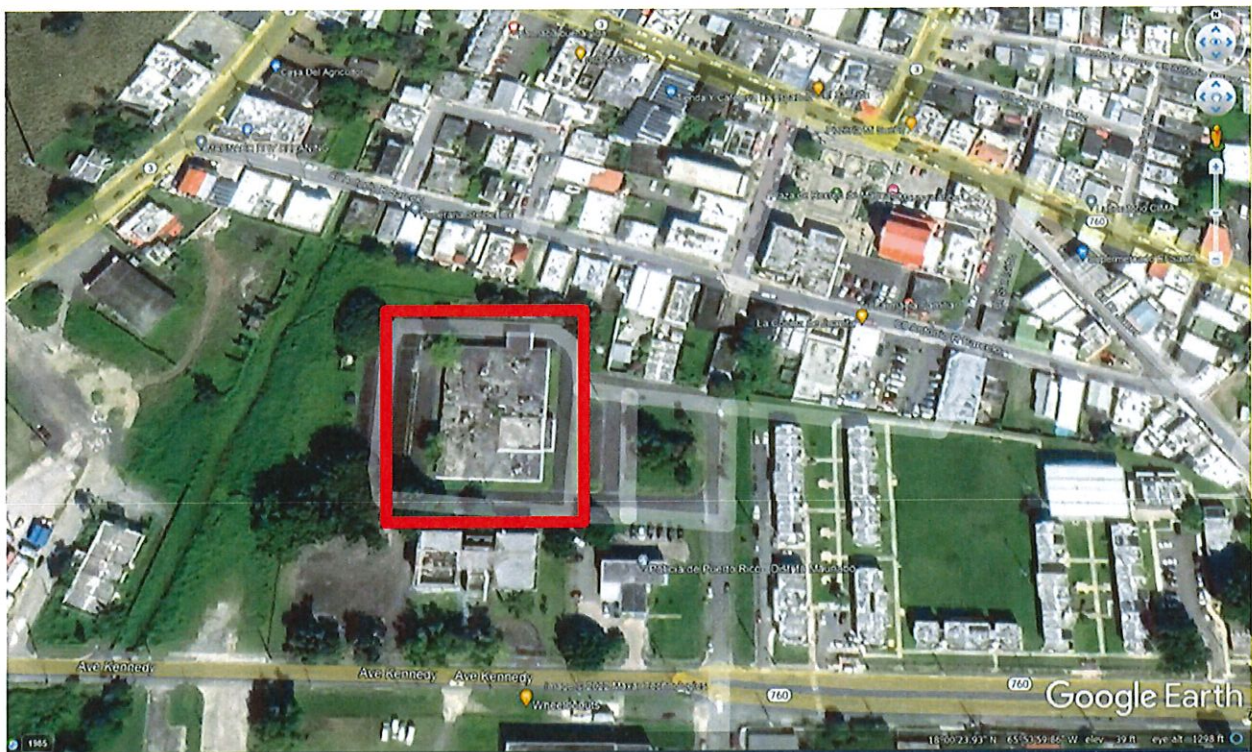
Figure Number 1 – Aerial Photo

An environmental survey for Asbestos Containing Materials (ACM) was conducted by Puerto Rico Department of Natural and Environmental Resources (DNER) registered Asbestos Inspectors. The survey was conducted on May 3, 4 and 6, 2022, at the CDT Maunabo, Puerto Rico. This structure was impacted by Hurricane Maria in 2017, since then it was abandoned. **Figure Number 1** show an aerial photo of the inspected areas.
