**PROJECT:** Urb. Las Mercedes Damage Repair

**City:** Las Piedras

## **Urb. Las Mercedes Facility Damages Repair**

**Multisport Court Repair Scope of Work**  
**Multisport Acrylic Synthetic Flooring System**  
**Technical Specification**

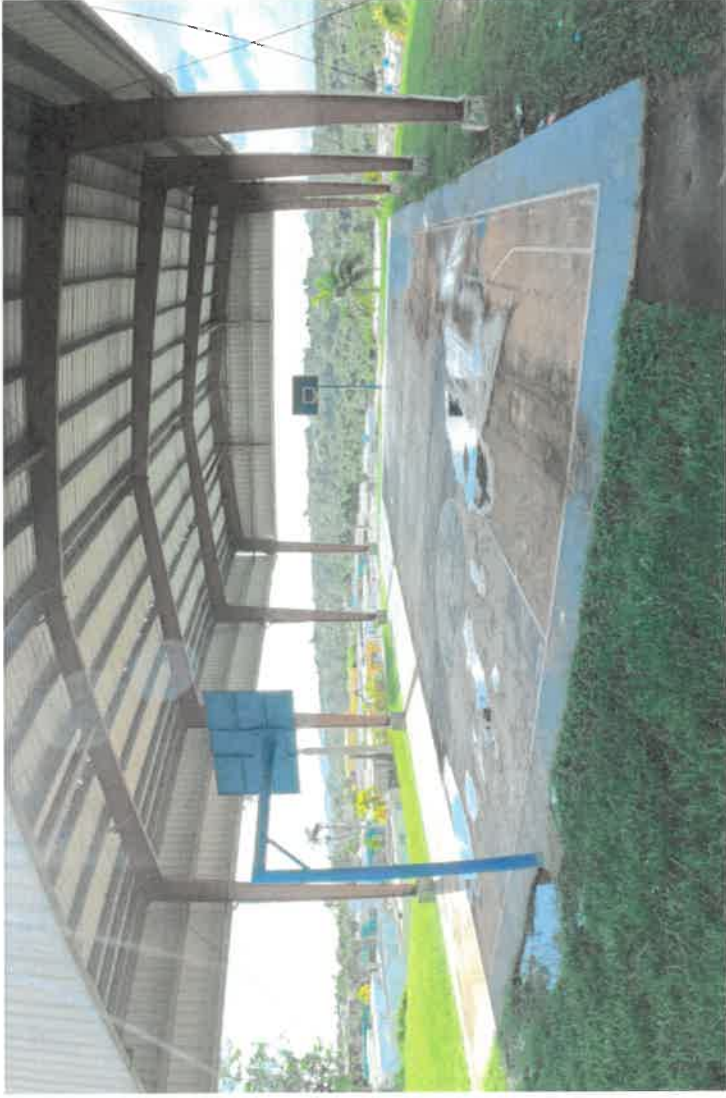
# Basketball Court Repairs:

- Replace existing roof panels, sidings, trims gutters and downspouts.
- Paint existing steel structure and goals.
- Paint Basketball court area
- Paint concrete surfaces.
- Install new Volleyball Post Net System

- 1) Remove approximately 6000 SF of metal roof deck.
- 2) Install Metal roof. Approximately 6000 SF
- 3) Install new 4' siding. Approximately 320 LF.
- 4) Install aluminum Downspouts. Approximately 120 LF. See typical details included.

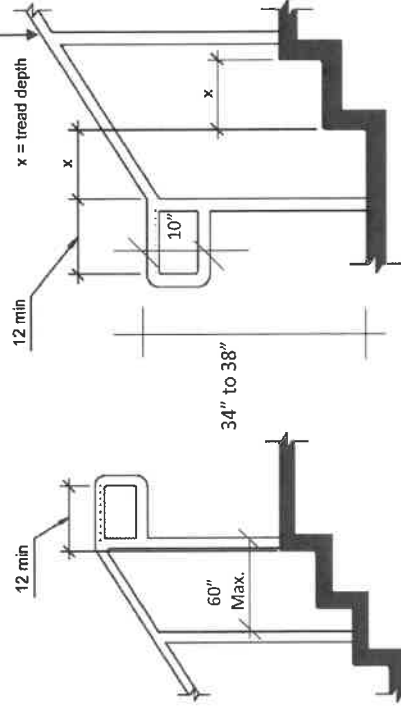
# Railing Detail

2" Galv. Steel Railing

GA 12

Top Handrail Extensions at Stairs

Bottom Handrail Extensions at Stairs

- 1) Install new 2" diameter steel handrail double pipe. by the stairs. Include footings. Meet the standard height. See detail. (40 LF Aprox.)

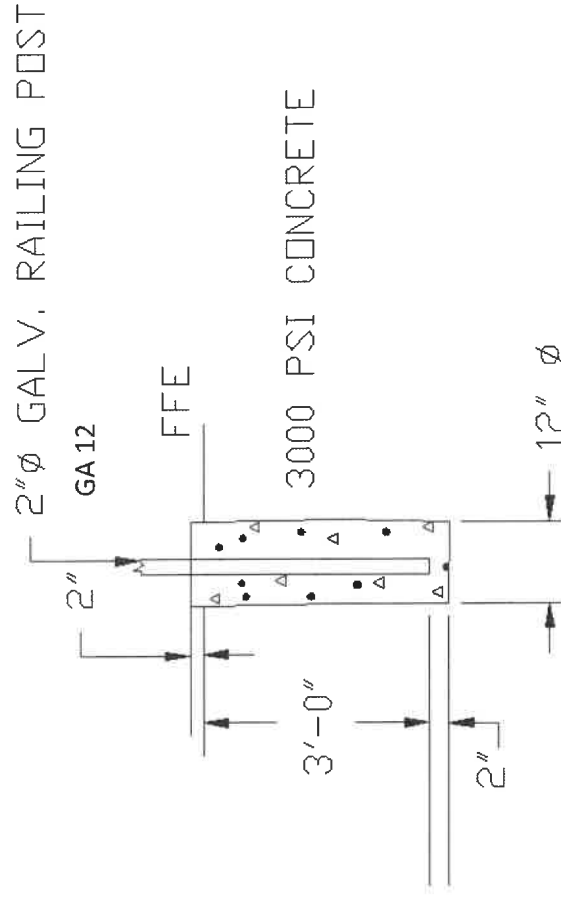
RAILING CONCRETE BASE

2"  $\varnothing$  GALV. RAILING POST

GA 12

3000 PSI CONCRETE

3'-0"

12"  $\varnothing$

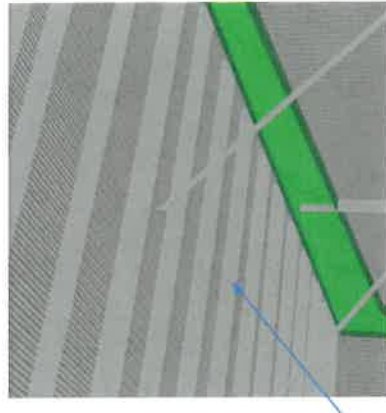
# Basketball Court Paint

Main Steel Structure

- b. Steel Structures: Similar or equal to Sherwin Williams Pro Industrial DTM Acrylic Primer/Finish. Apply two (2) coats.
    - c. Exterior Wall Paint: Similar or equal to Sherwin-Williams Quick Dry Interior/ Exterior Stain Blocking Primer. Apply One (1) coat. of primer. A-100 Exterior acrylic Latex. Apply two (2) coats of paint.

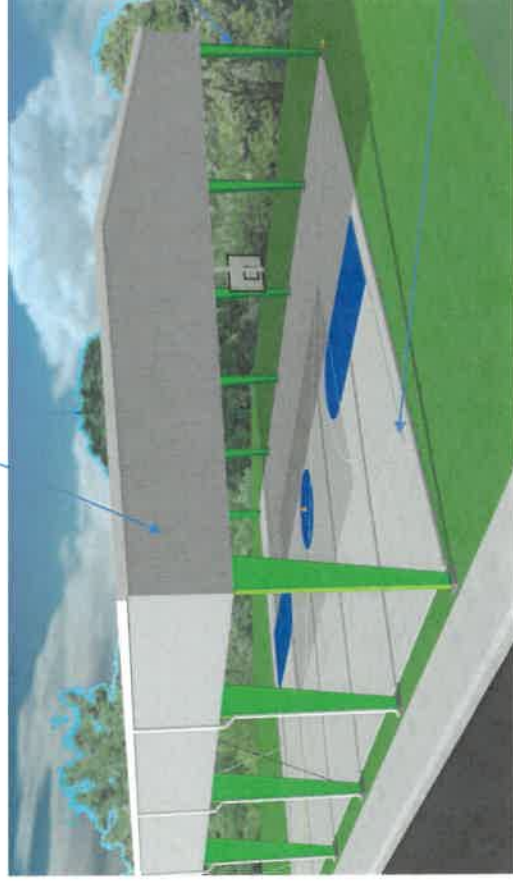
Floor Acrylic Synthetic System  
See color pattern and specifications.

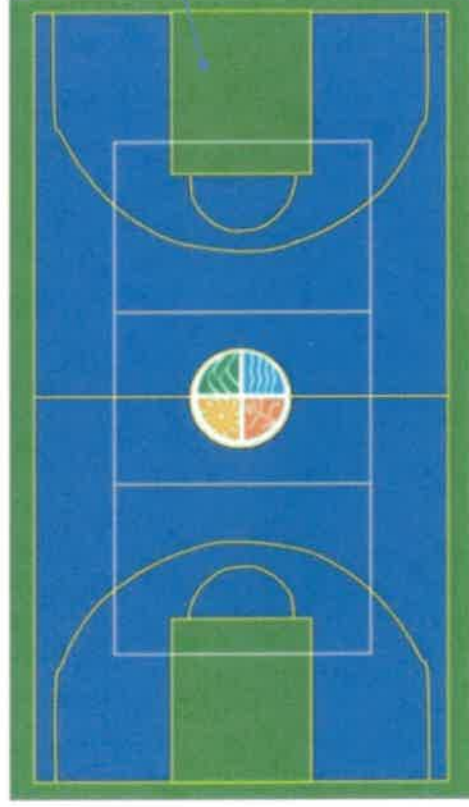
# Basketball Court Floor Paint Color

Floor Acrylic Synthetic System  
See specifications.

\* Logo Art will be provided by owner

Color Pattern

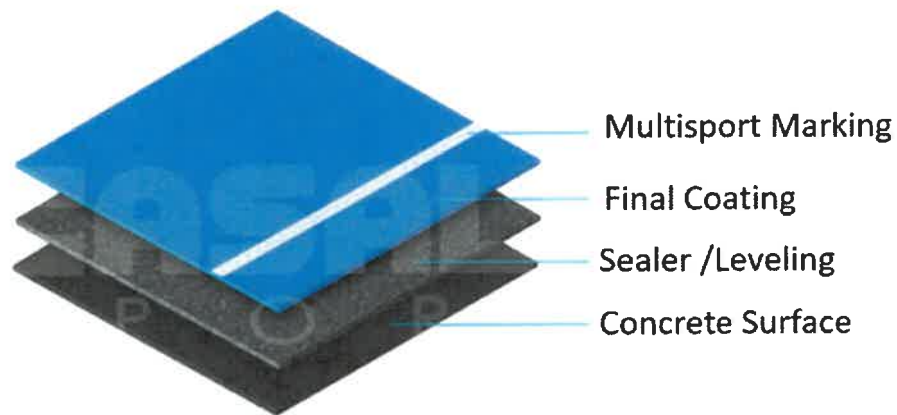
***Basketball Court Surface Preparation***

- Remove existing surface paint with paint removal product.
- Product should be compatible with acrylic system product.
- Scarify existing concrete.
- Pressure washes existing scarified concrete surface to remove all remaining dust.
- Treat all concrete cracks with product compatible and recommended by system's manufacturer.
- Seal existing concrete surface applying a synthetic resin-based filler using an acrylic resin based coating containing select sands, in water emulsion, especially formulated to seal concrete surfaces. Be sure that the product is compatible and recommended by system's manufacturer.

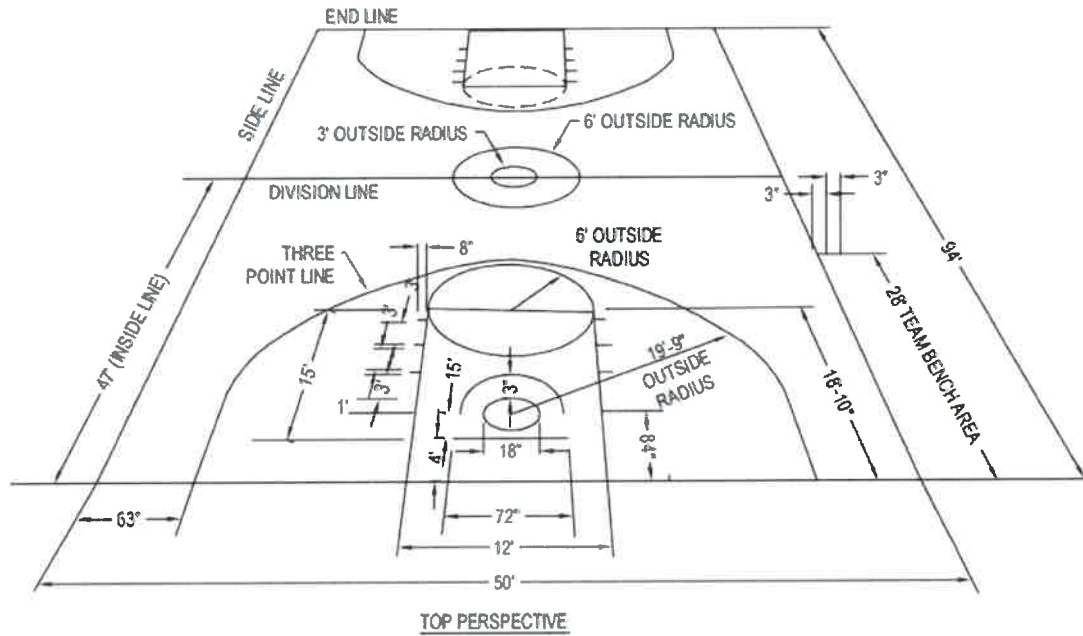
1. ALL DIMENSIONS ARE TO THE OUTSIDE EDGE OF THE LINES.
2. INSTALLATION TO BE COMPLETED IN ACCORDANCE WITH MANUFACTURER'S SPECIFICATIONS.
3. DO NOT SCALE DRAWING.

BASKETBALL

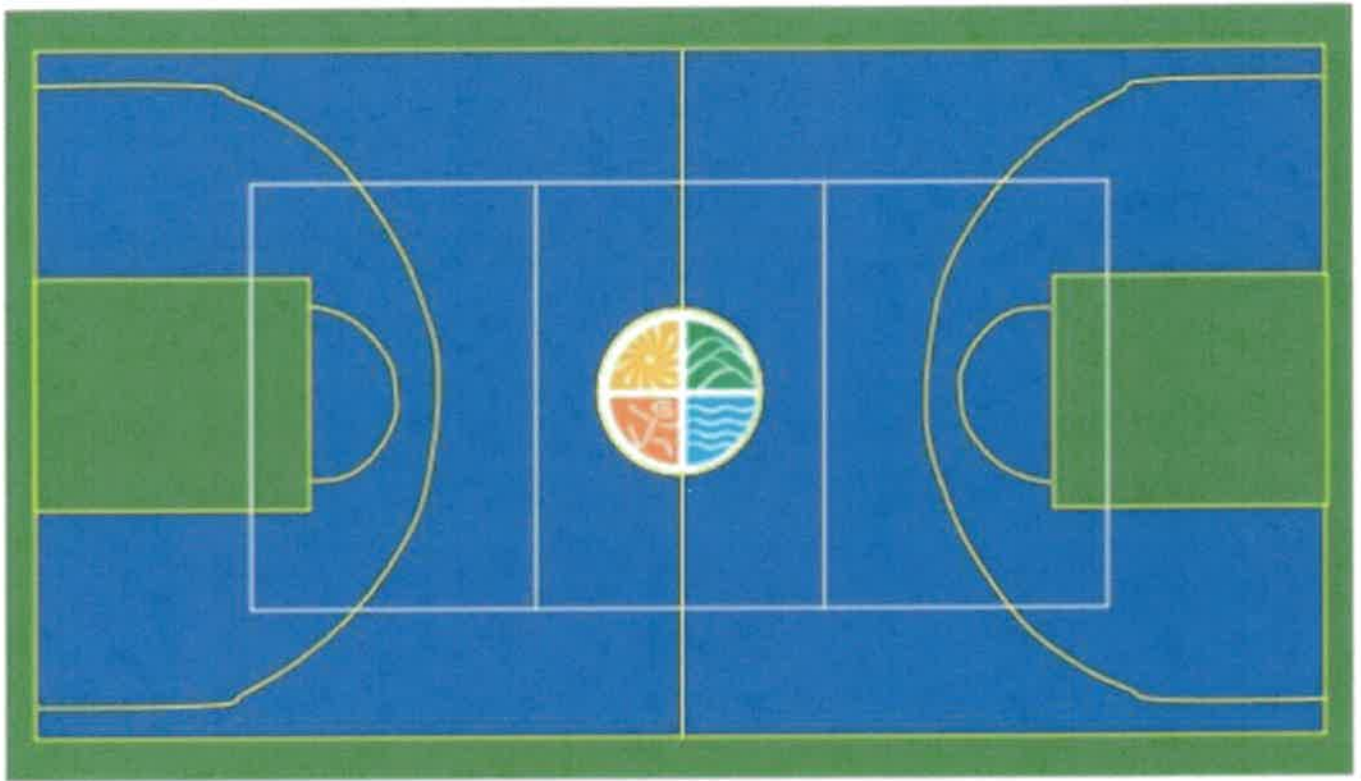
# Color Pattern

All line markings on the floor are  
2 inches wide

\*Logo art will be provided by owner

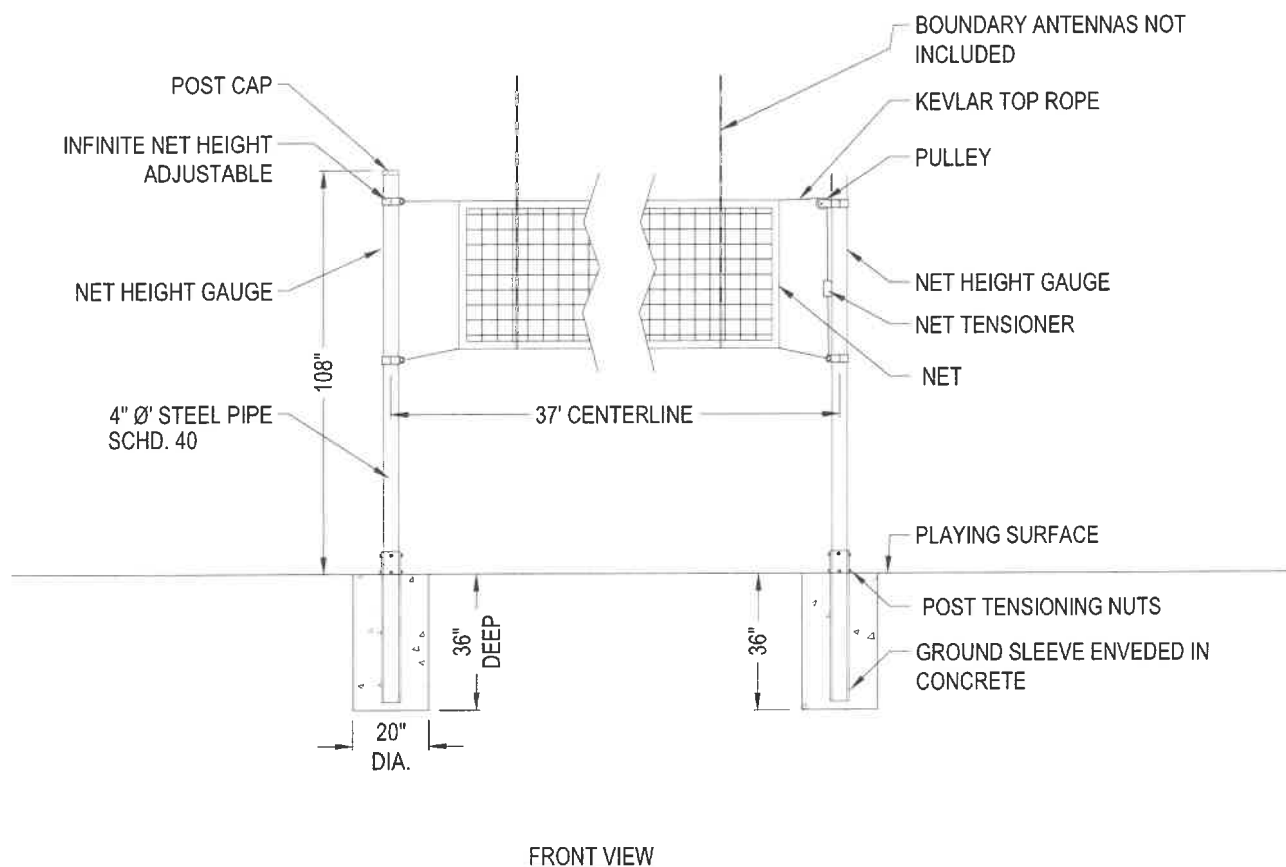
Equal or Similar to Model:  
Worm-Gear Winch by United Volleyball Supply

- 5) All basketball court marking paint must be Multisport Court (Basketball and Volleyball) as specified. Where volleyball pole system is missing, the contractor must include the new volleyball net pole system as per specifications.

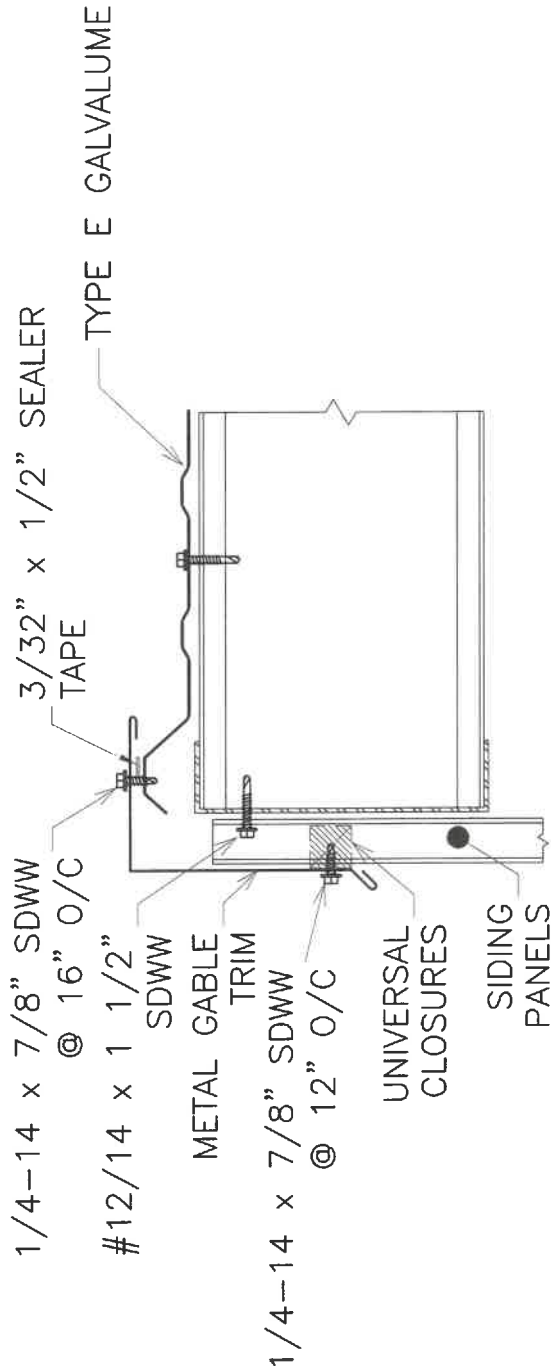
# METAL ROOF END CLOSURE TRIM DETAIL

PANEL TO JOIST FASTENER  
AT 2" AT END LAPS.

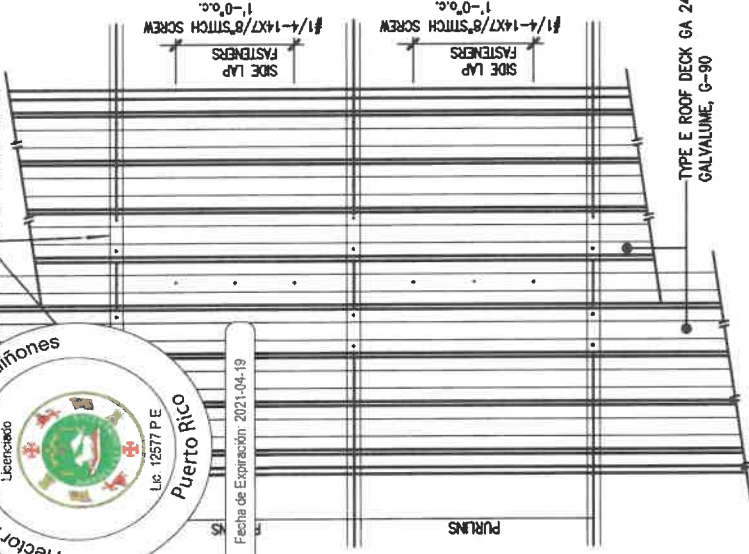
### INSTALLATION DETAIL OF STEEL ROOF DECK (NOT TO SCALE)

#1/4-14X7/8\" STITCH  
CREW(1'-0\" o.c.)
