## ENMIENDA NÚM. 2

### SUBASTA FORMAL 23J-09742

#### PARA MEJORAS AL SISTEMA DE RIEGO DE PIVOTE EN EL MUNICIPIO DE SALINAS PARA LA AUTORIDAD DE TIERRAS DEL GOBIERNO DE PUERTO RICO

### **ANEJO V** **ENMENDADO I**

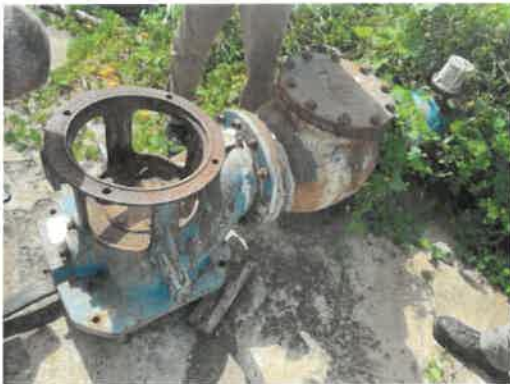
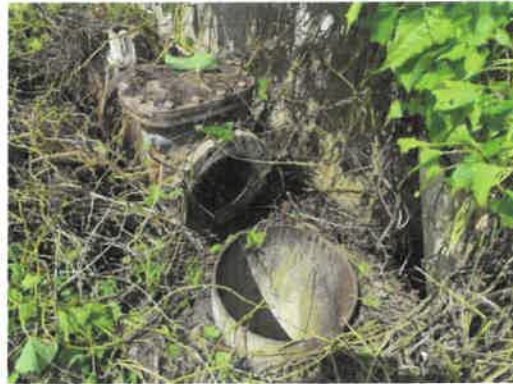
Photo 1: Submersible Pump, Check Valve, Strainer

- A. Construct new 10ft x 10 ft x8ft Pump house (photos 3)
  - I. Construct new metal clad walls and roof, supply and install new wood door 36"x 84" (Include Heavy duty hardware for exterior), exterior and interior first quality paint.
- B. Pumps, electrical and control system: (photos 1)
  - I. Remove and replace submersible Pump, 1 ea 100 hp, 3ph, 1,000 GPM
  - II. Remove, supply and install new electrical and control system for pump and pivot.
  - III. Remove, supply and install motor electrical panel 480 V, 3ph, meter base weather head, 3ea 75 Kva transformers.

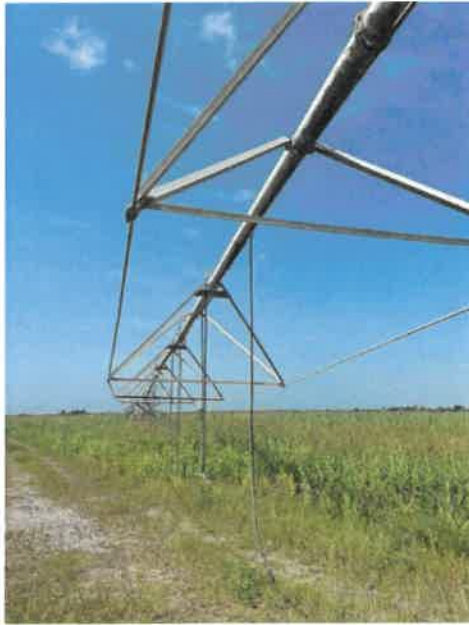
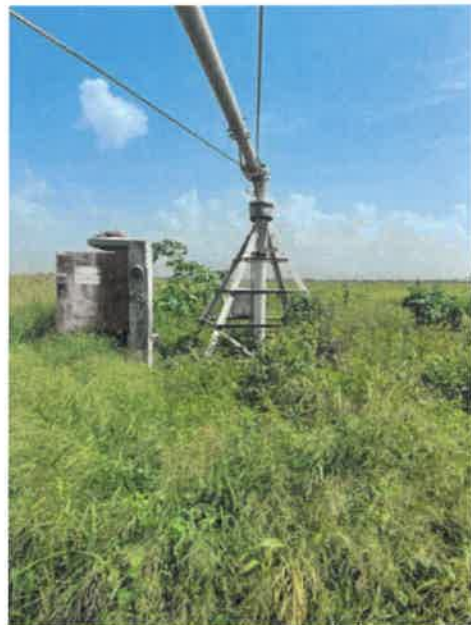
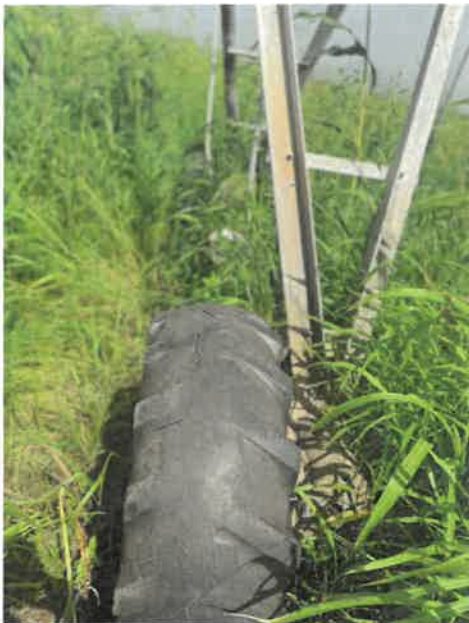
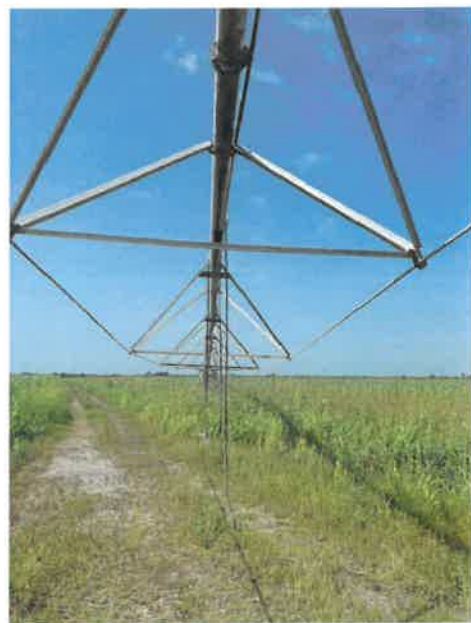
Photo 2: Water Hose Irrigation System

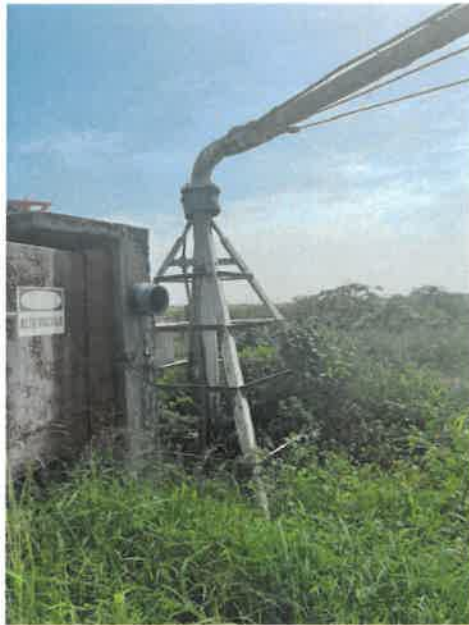
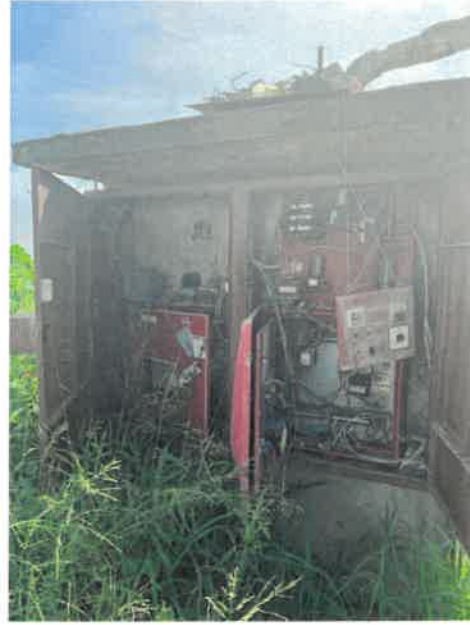
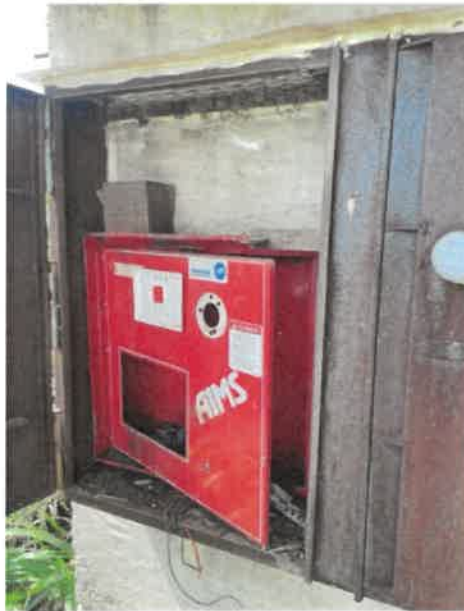
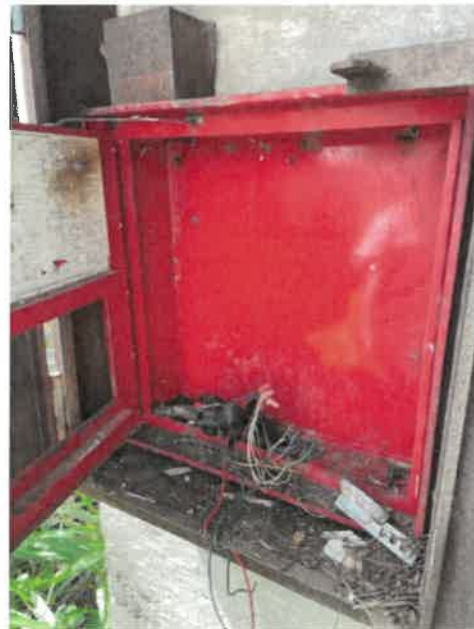
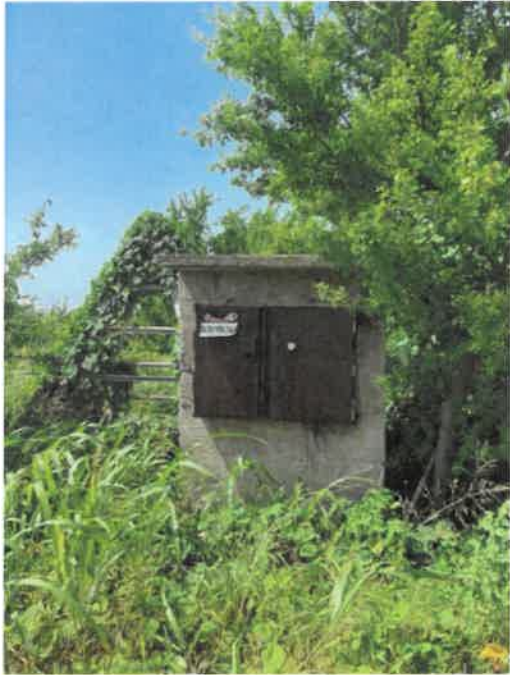
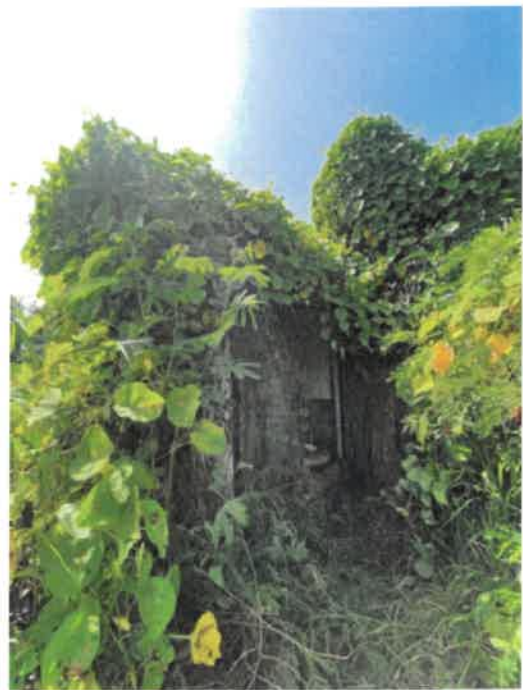
Photo 3: Existing Pump House

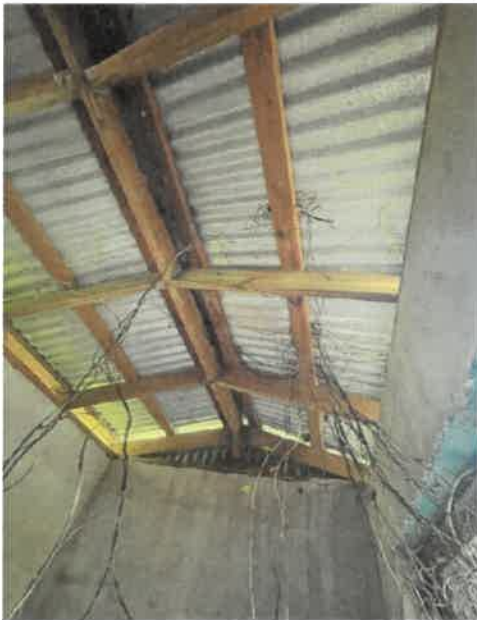
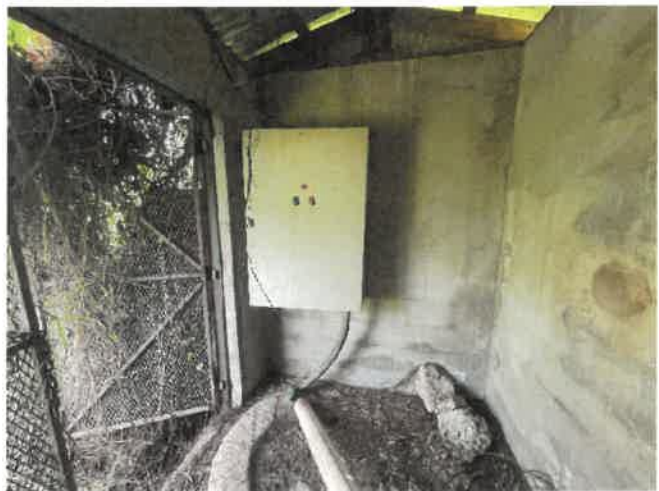
Photo 4: Existing Pump House

- A. Remove and replace Roof System using Galv square pipe 3"x3" and metal deck ga 16. (75SF) (See Photo 4).
- B. Prepare and Paint (600sq) the existing pump house. (Interior / Exterior).
- C. Remove and Replace metal gate. (8ft X 6ft) Similar to existing Gate. (see Photo 4).
- D. Supply and Install submersible Pump, 1 ea 100 hp, 3ph, 1,000 GPM
